FLOW 2015
Portland, Oregon, April 29th, 2015

**Solutions to Accommodate Extreme
Ranges of Available Flows under a
Changing Climate and Competition for
a Diminished Water Supply**

*Dave Rosgen, P.H., Ph.D.
Wildland Hydrology
Fort Collins, Colorado*

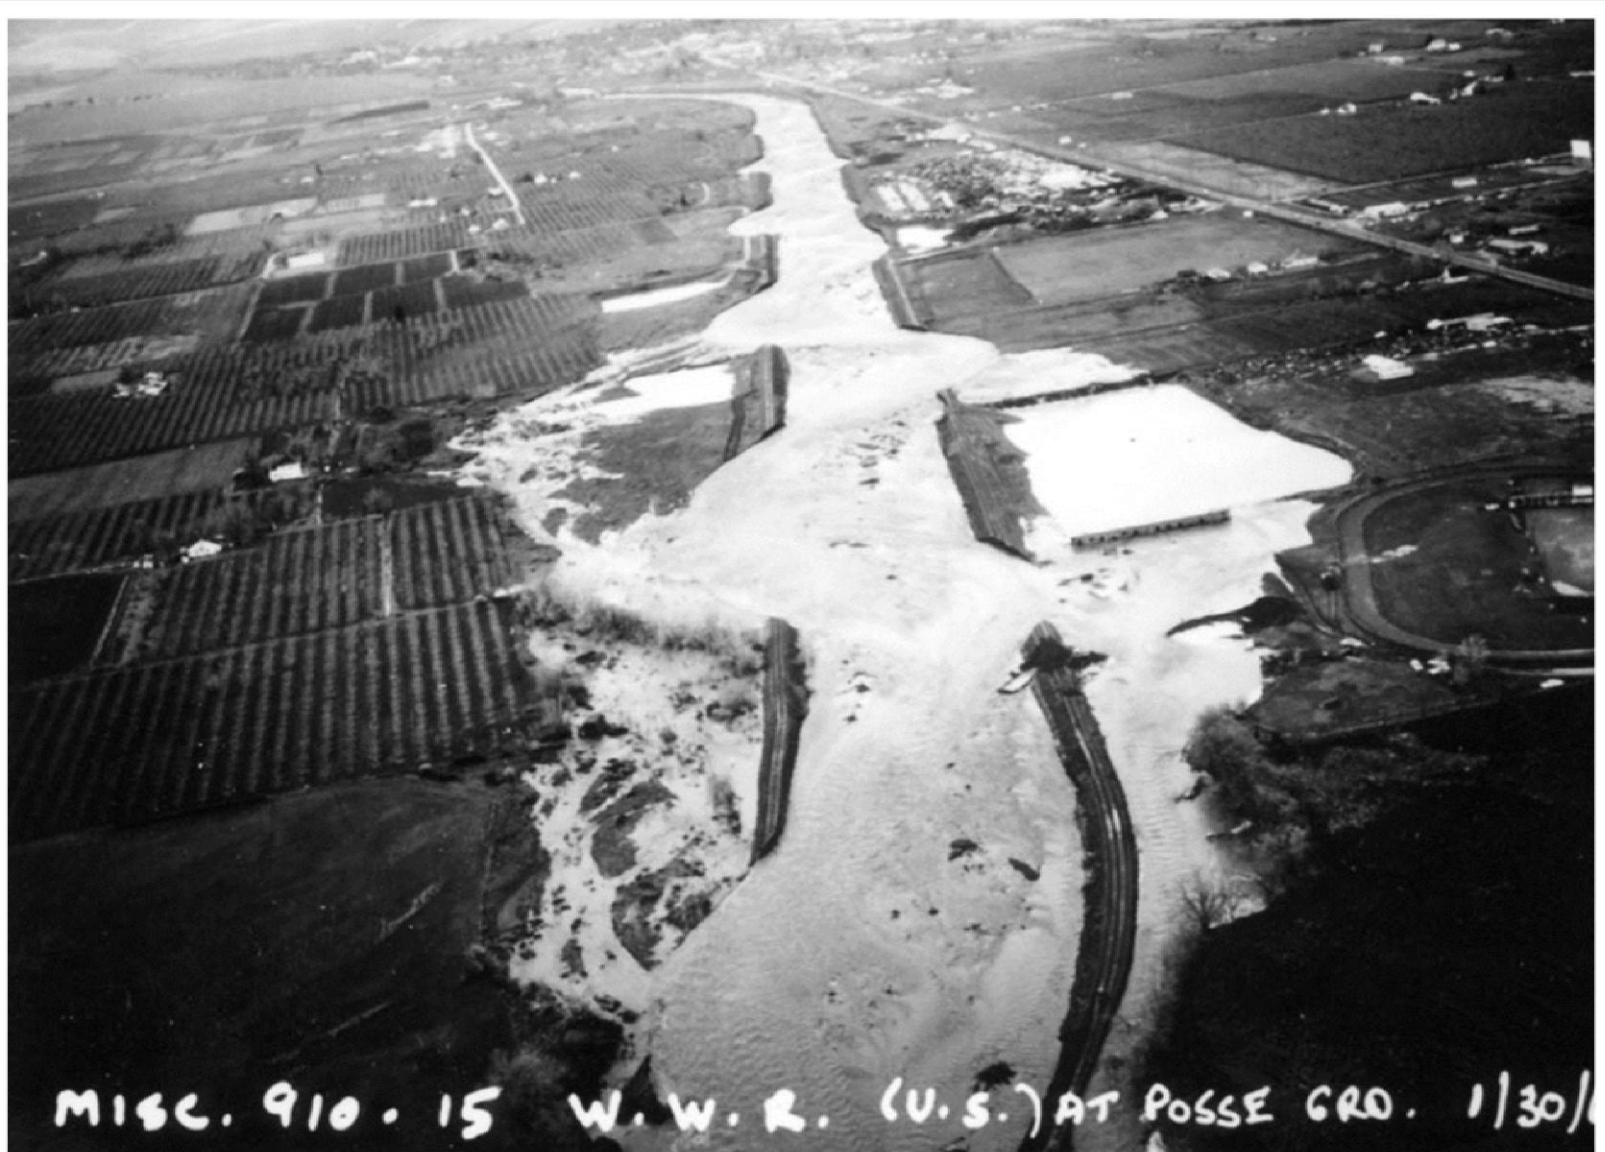
Walla Walla River following the 1964 flood — What is the river telling us?

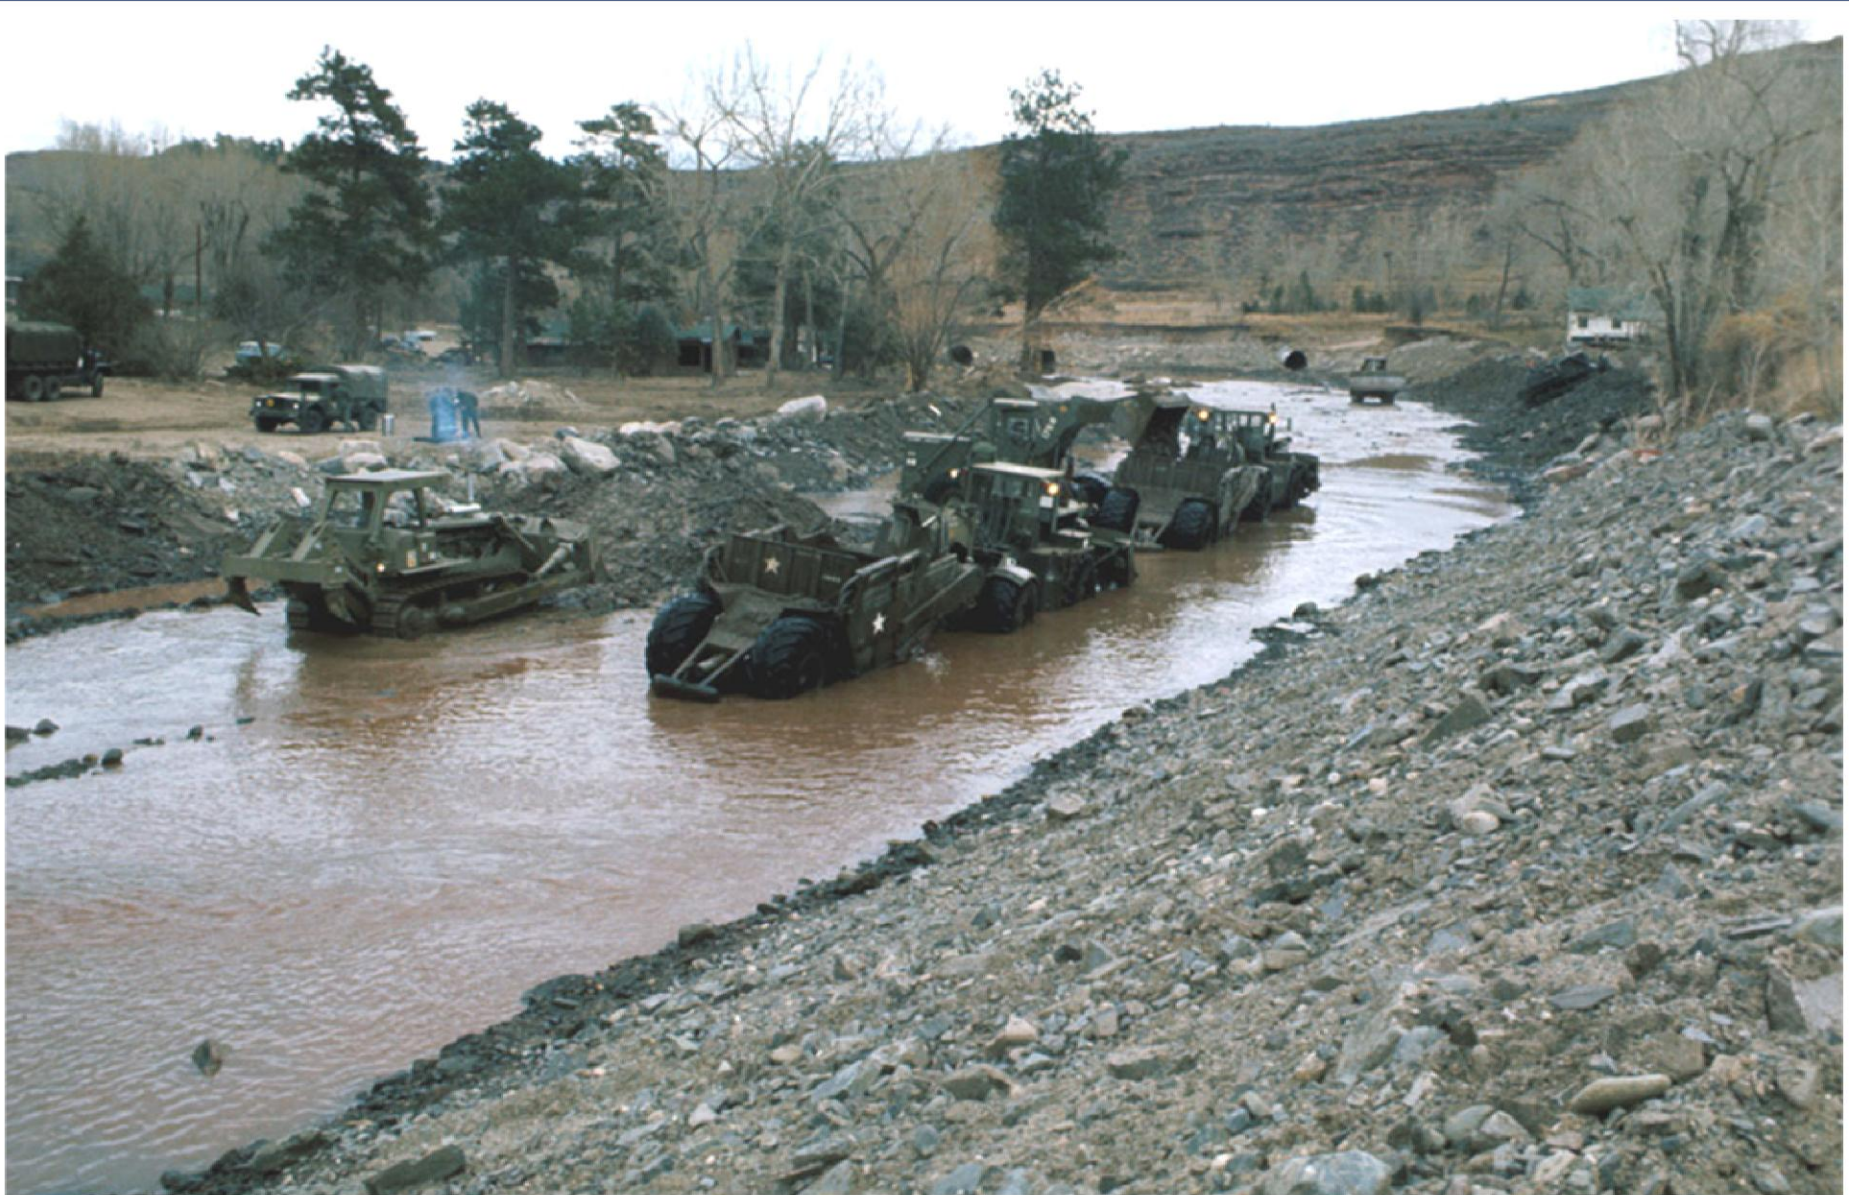
Traditional trapezoidal, over-wide conveyance channel, US Army Corps of Engineers, 1976, Big Thompson

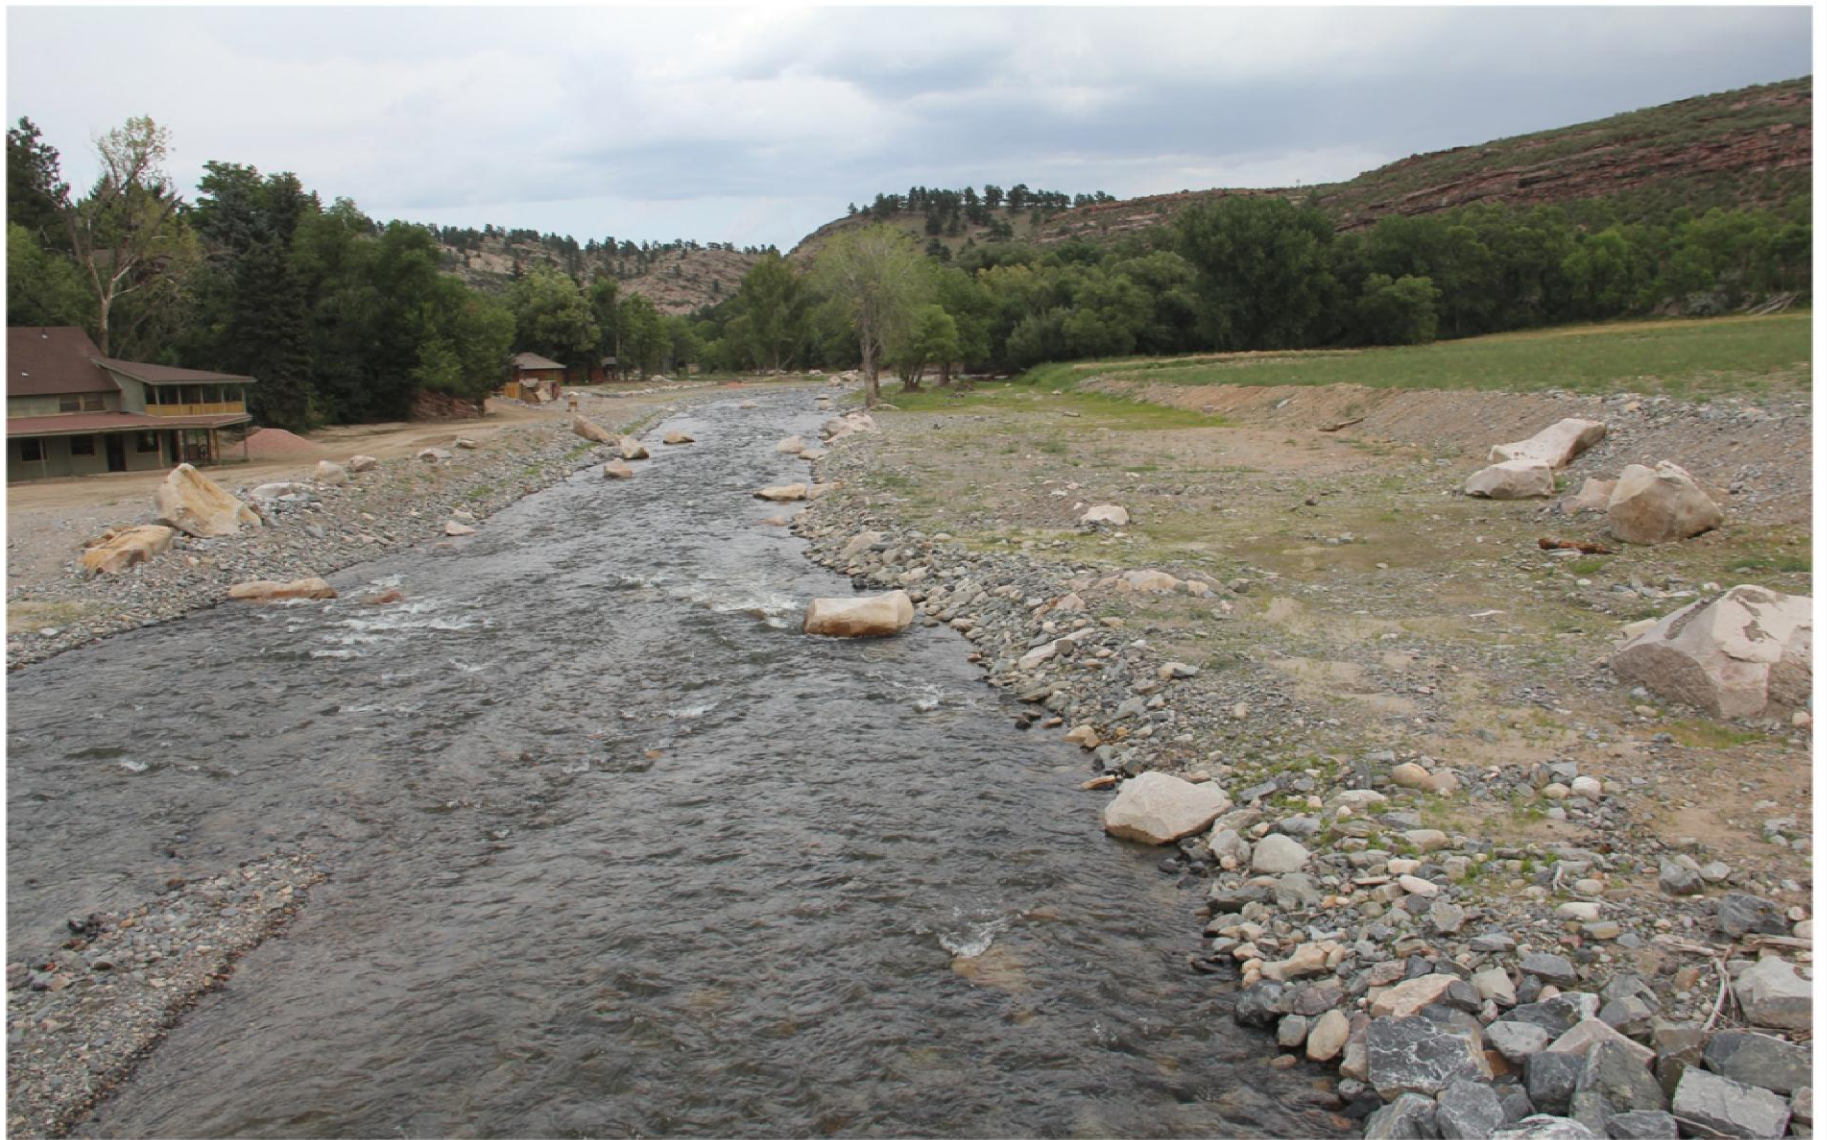
Straightened, over-wide channel, Big Thompson, 2014

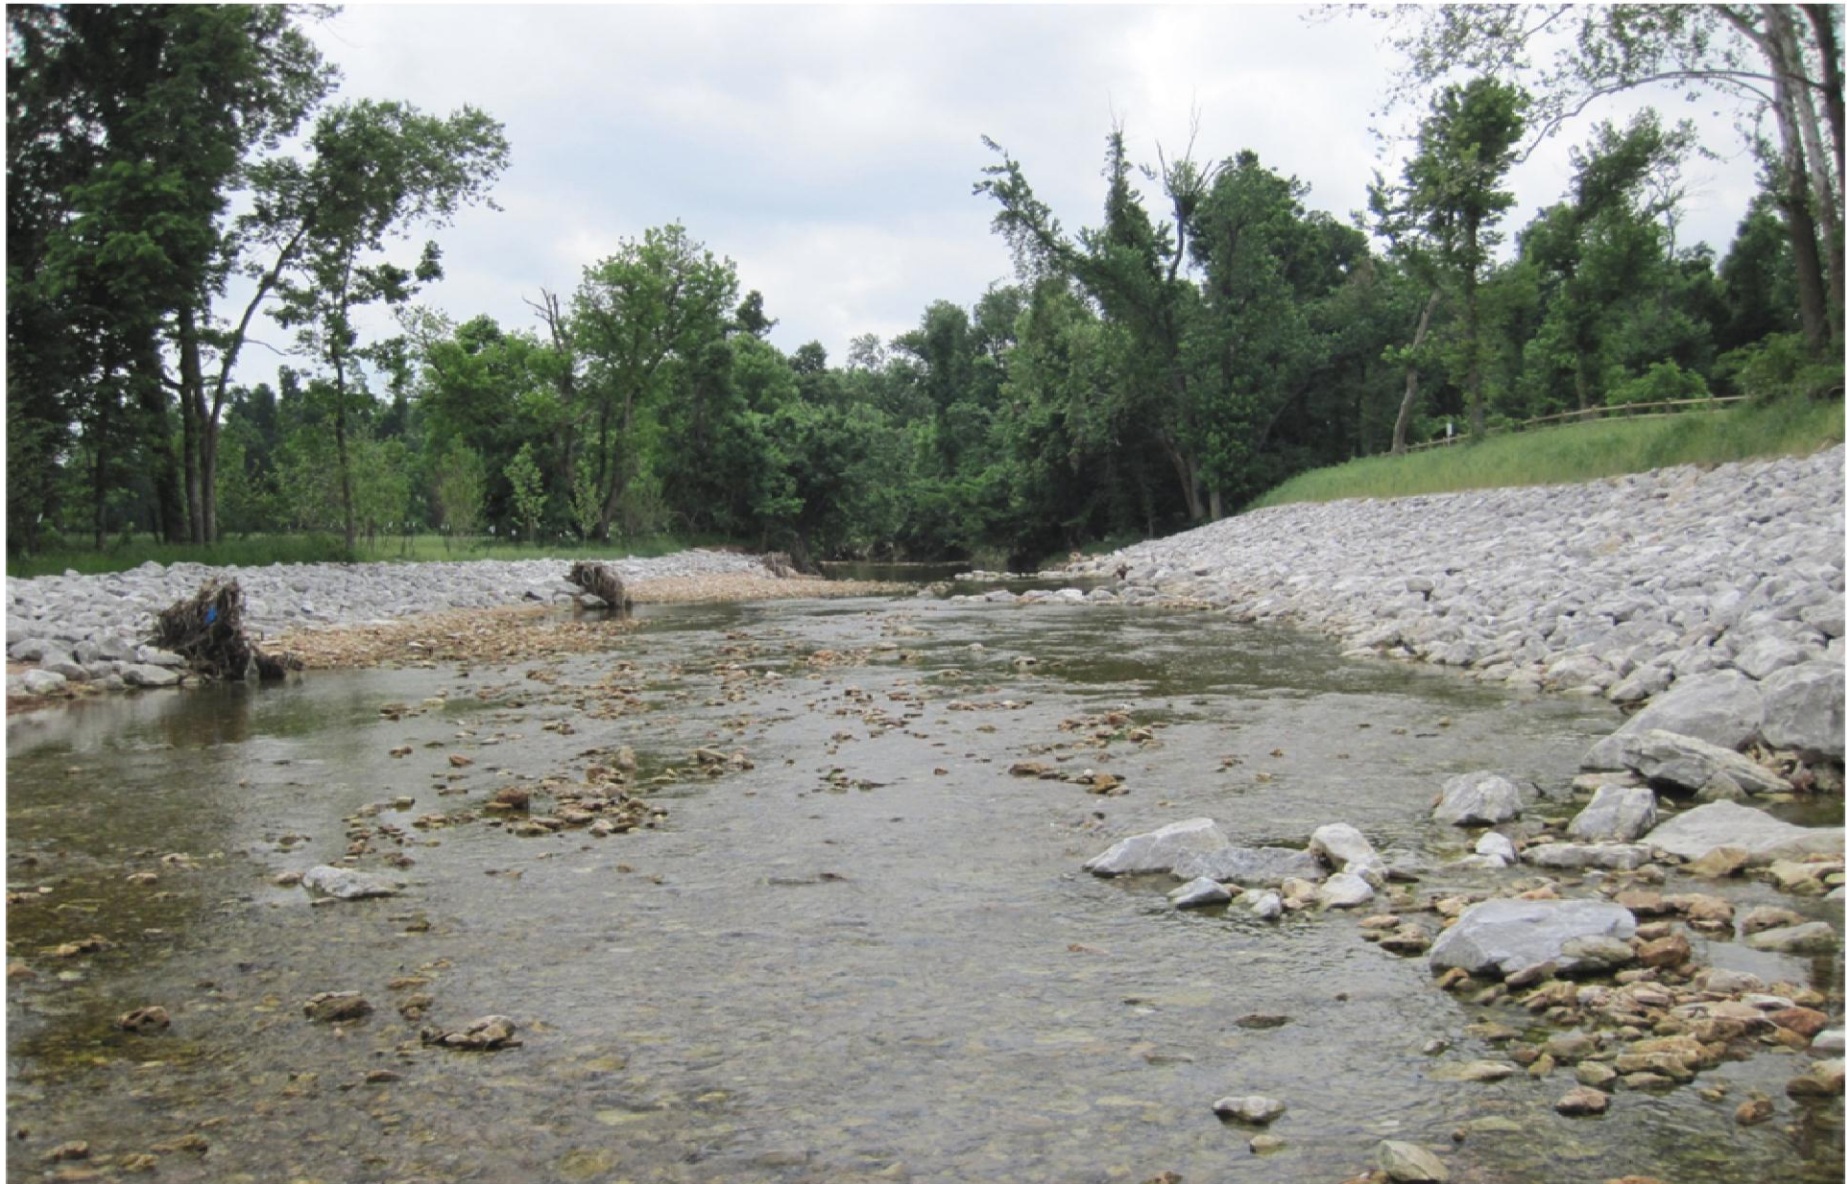
Over-widened, hardened & un-natural Spring Creek “Restoration” ...even with the root wads

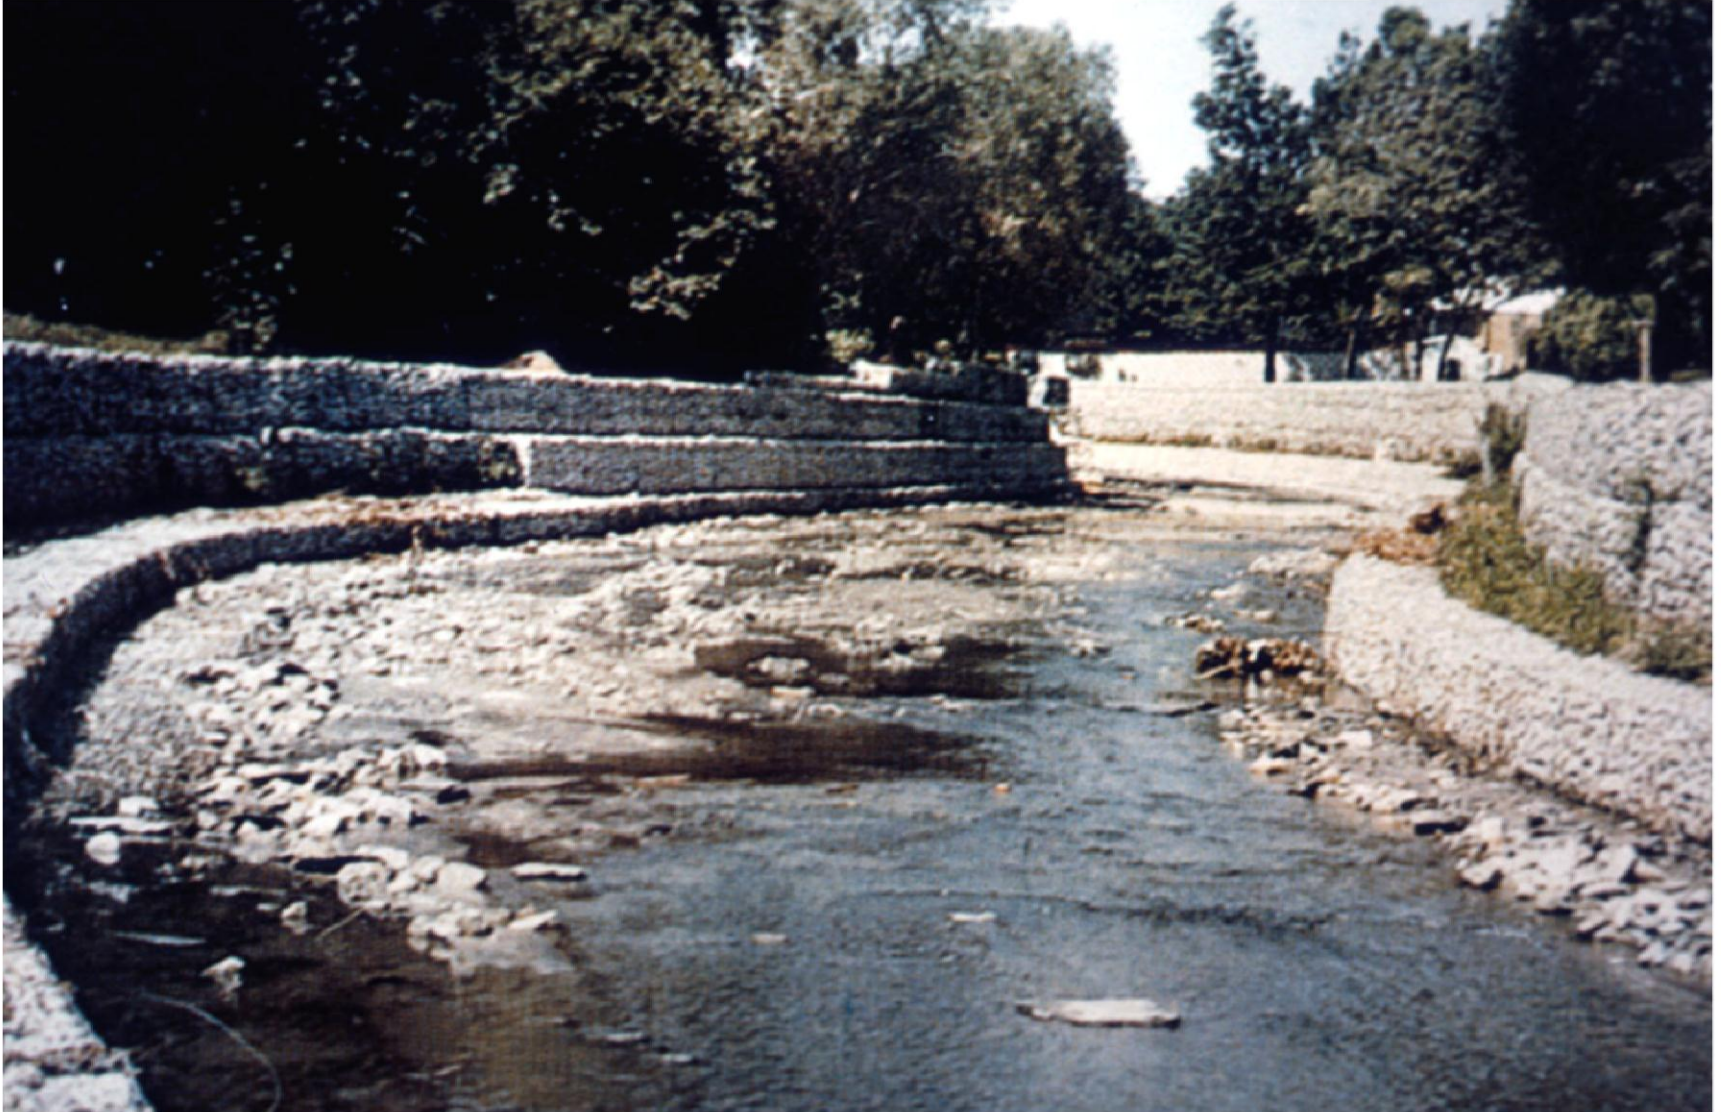
Traditional, over-wide channel showing automatic time-release bedload capsules

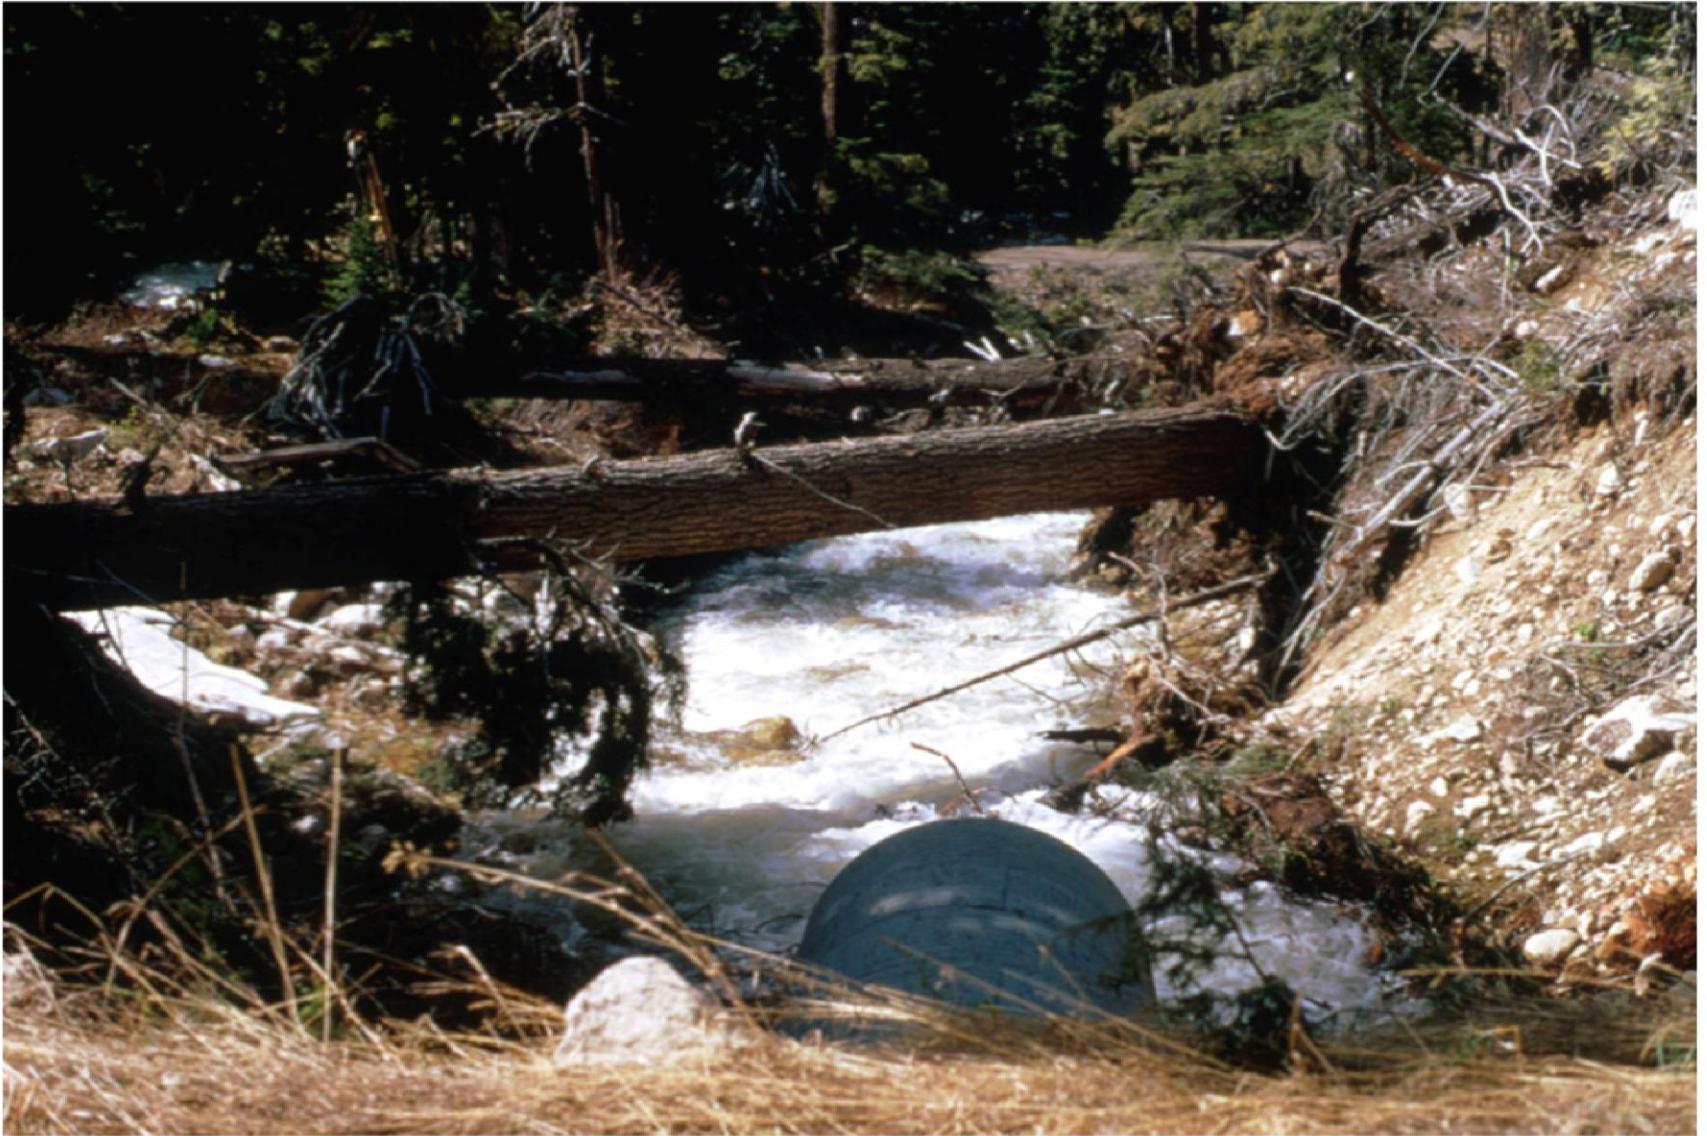
Degradation caused by culvert, shifting B4 → G4 stream type

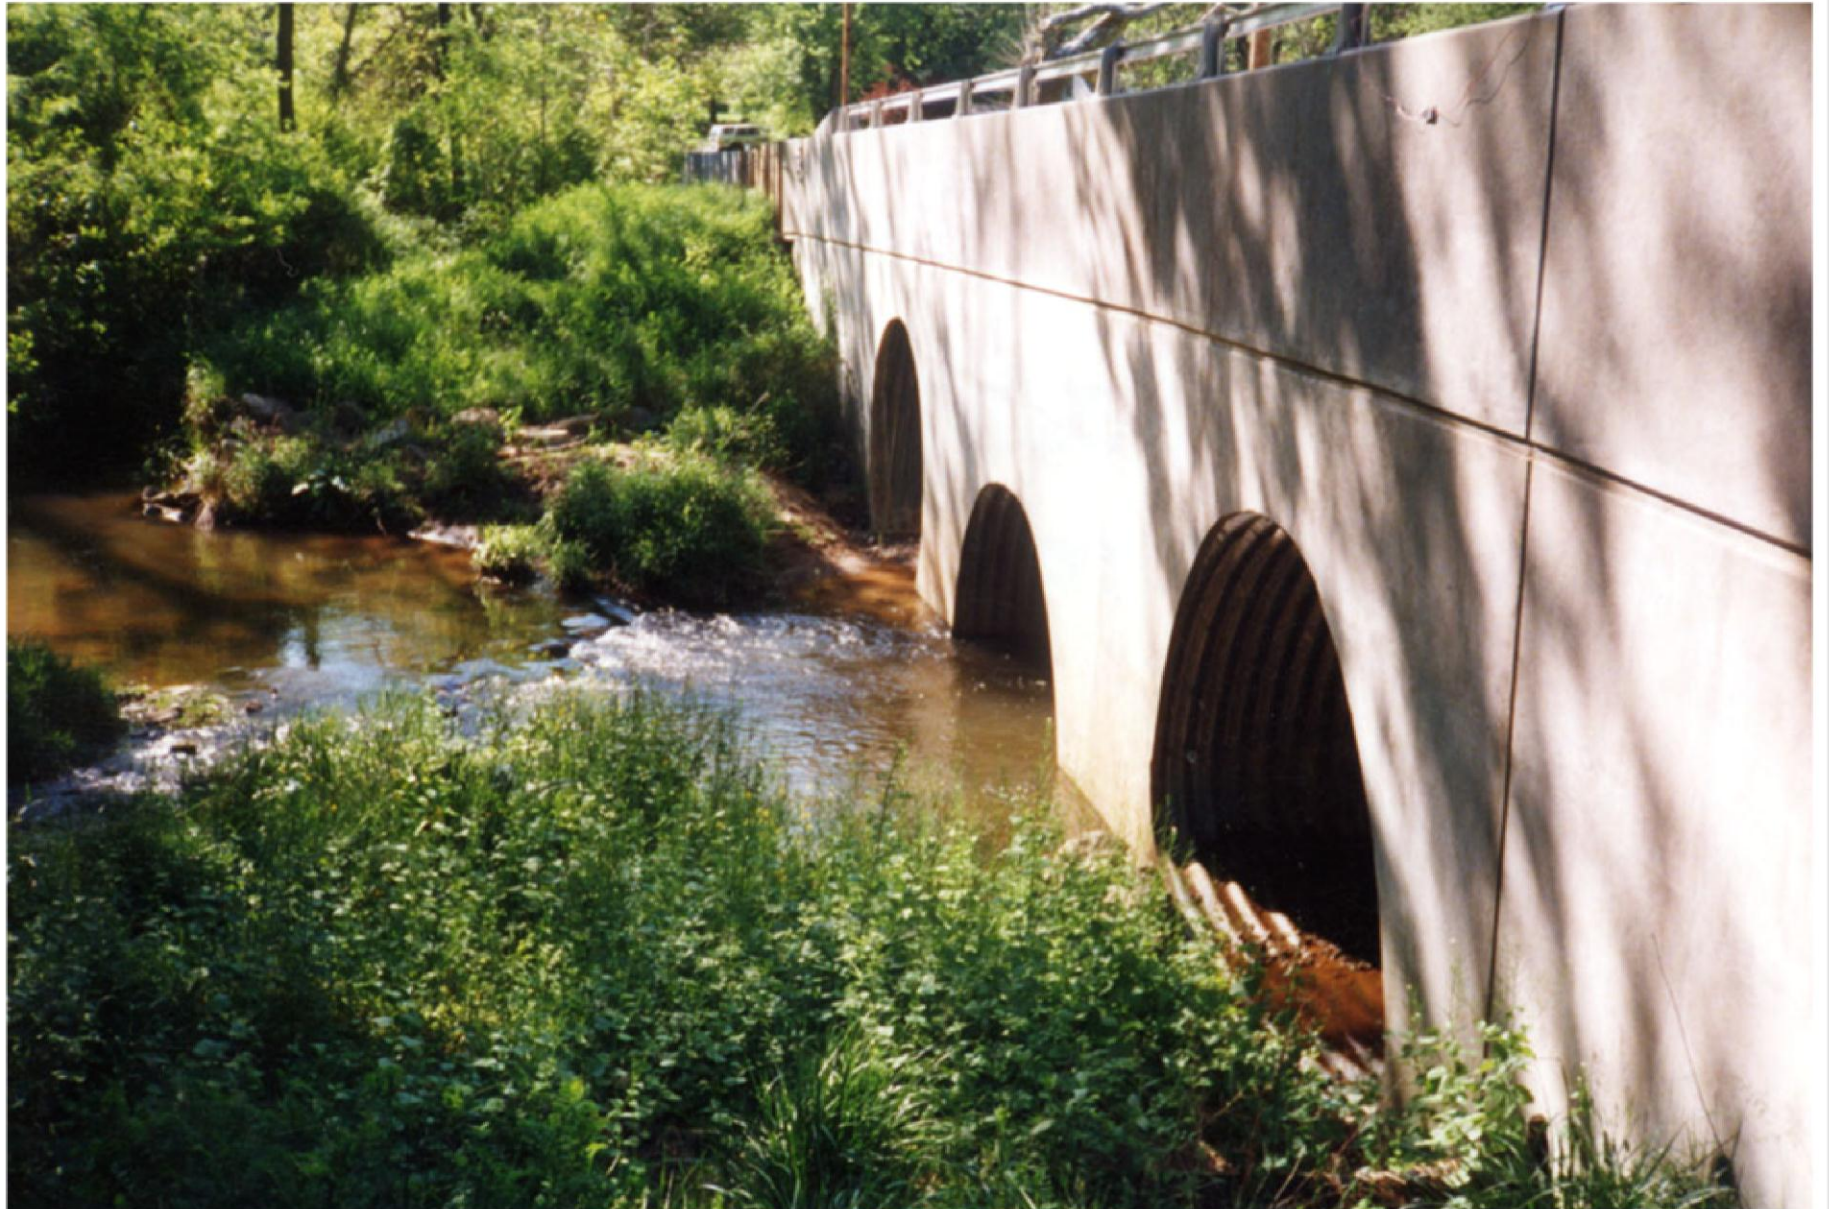
Floodplain drain culvert design

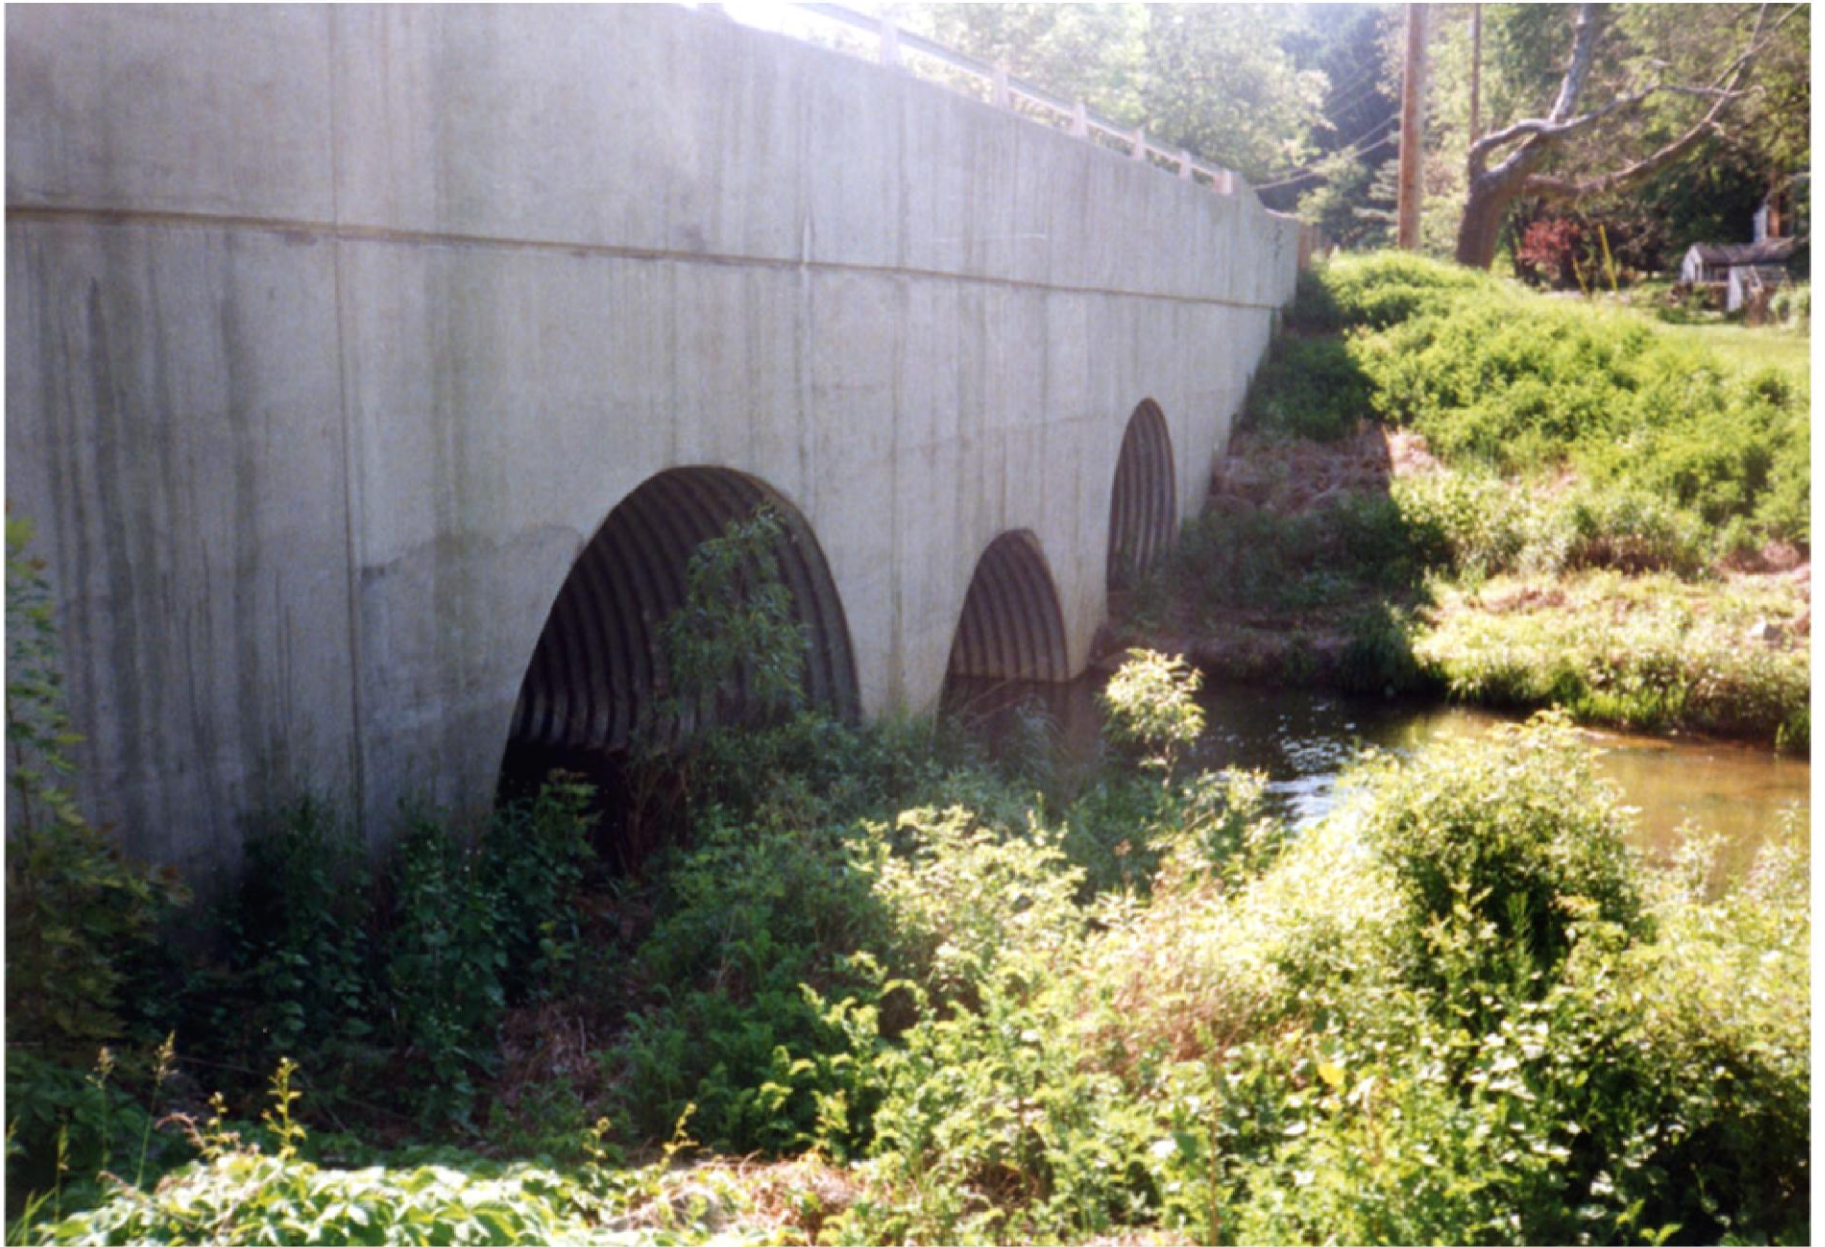
Floodplain drain culvert design

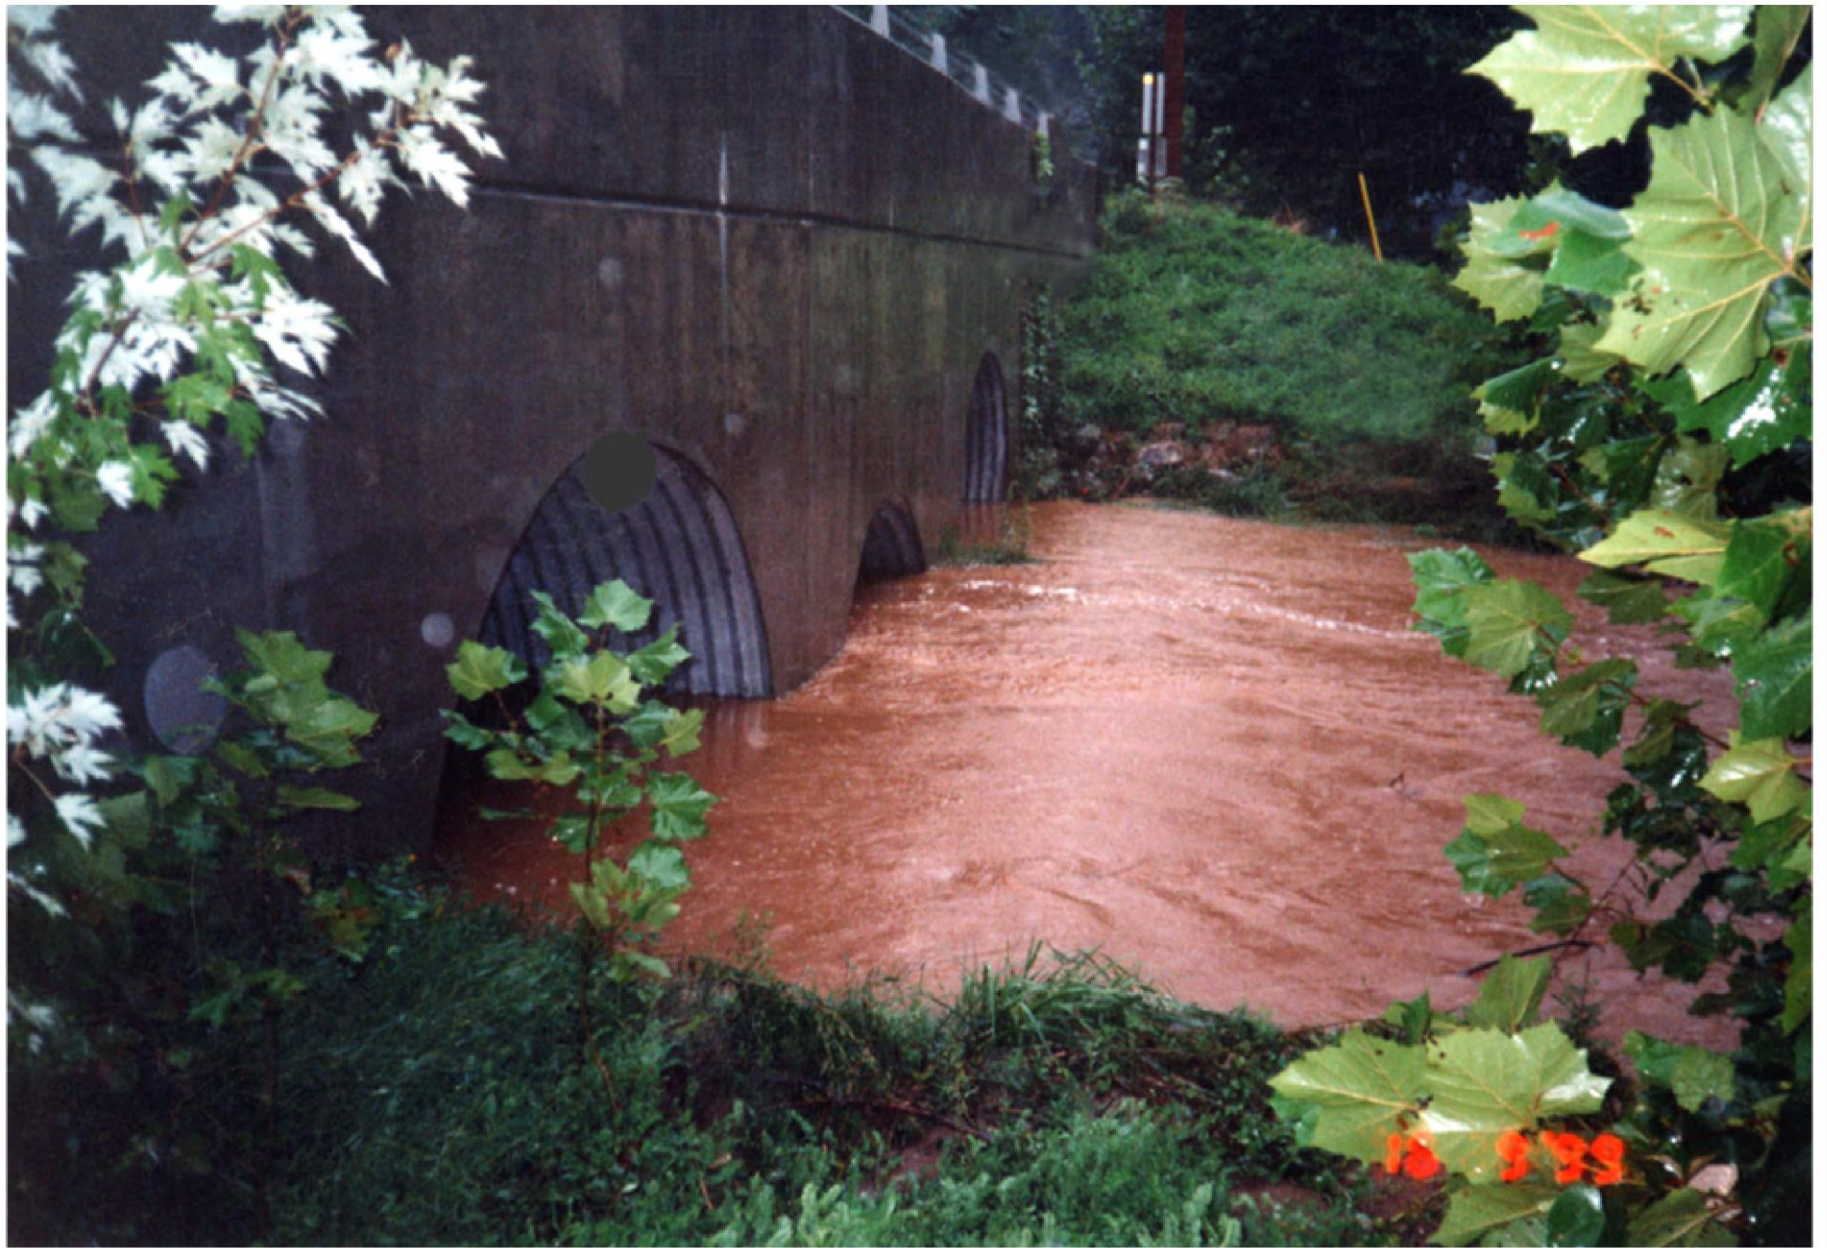
High flow performance

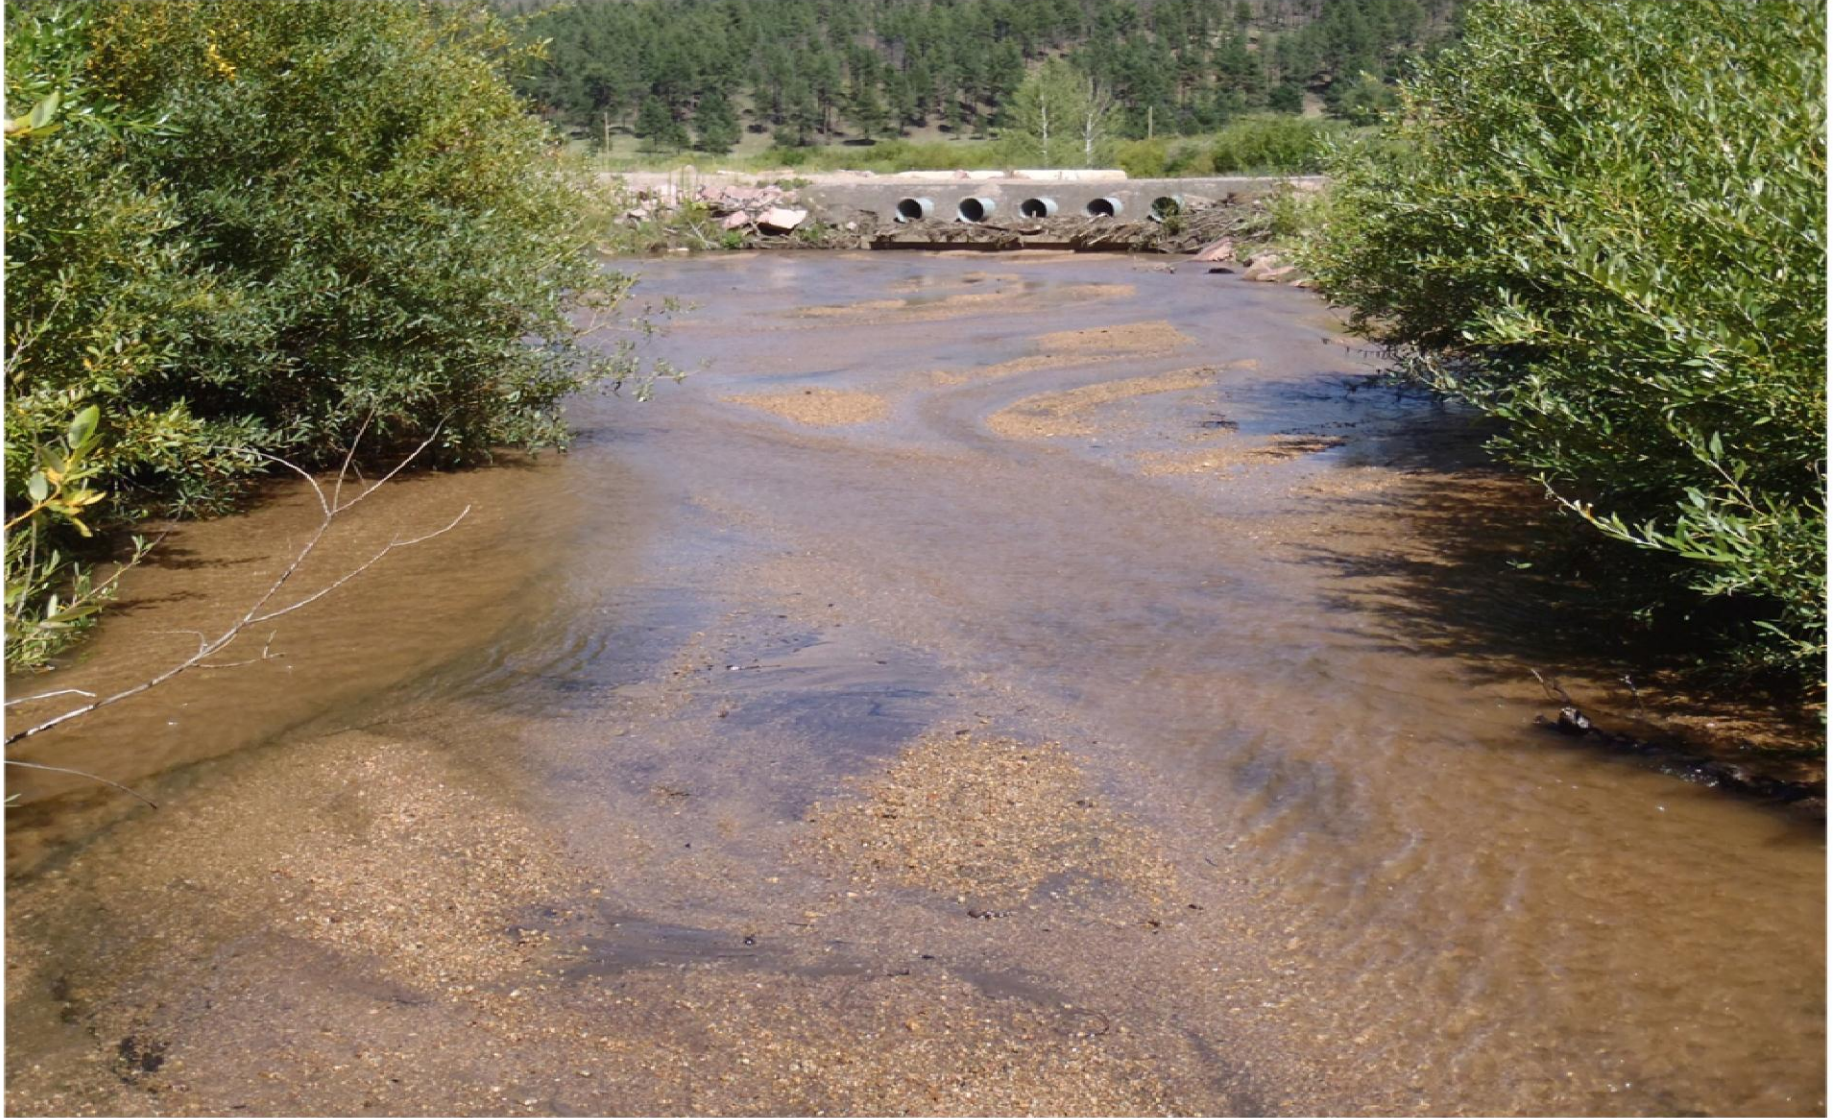
6' x 20' box culvert filled with sediment due to high w/d ratio and high sediment supply; a barrier to fish passage

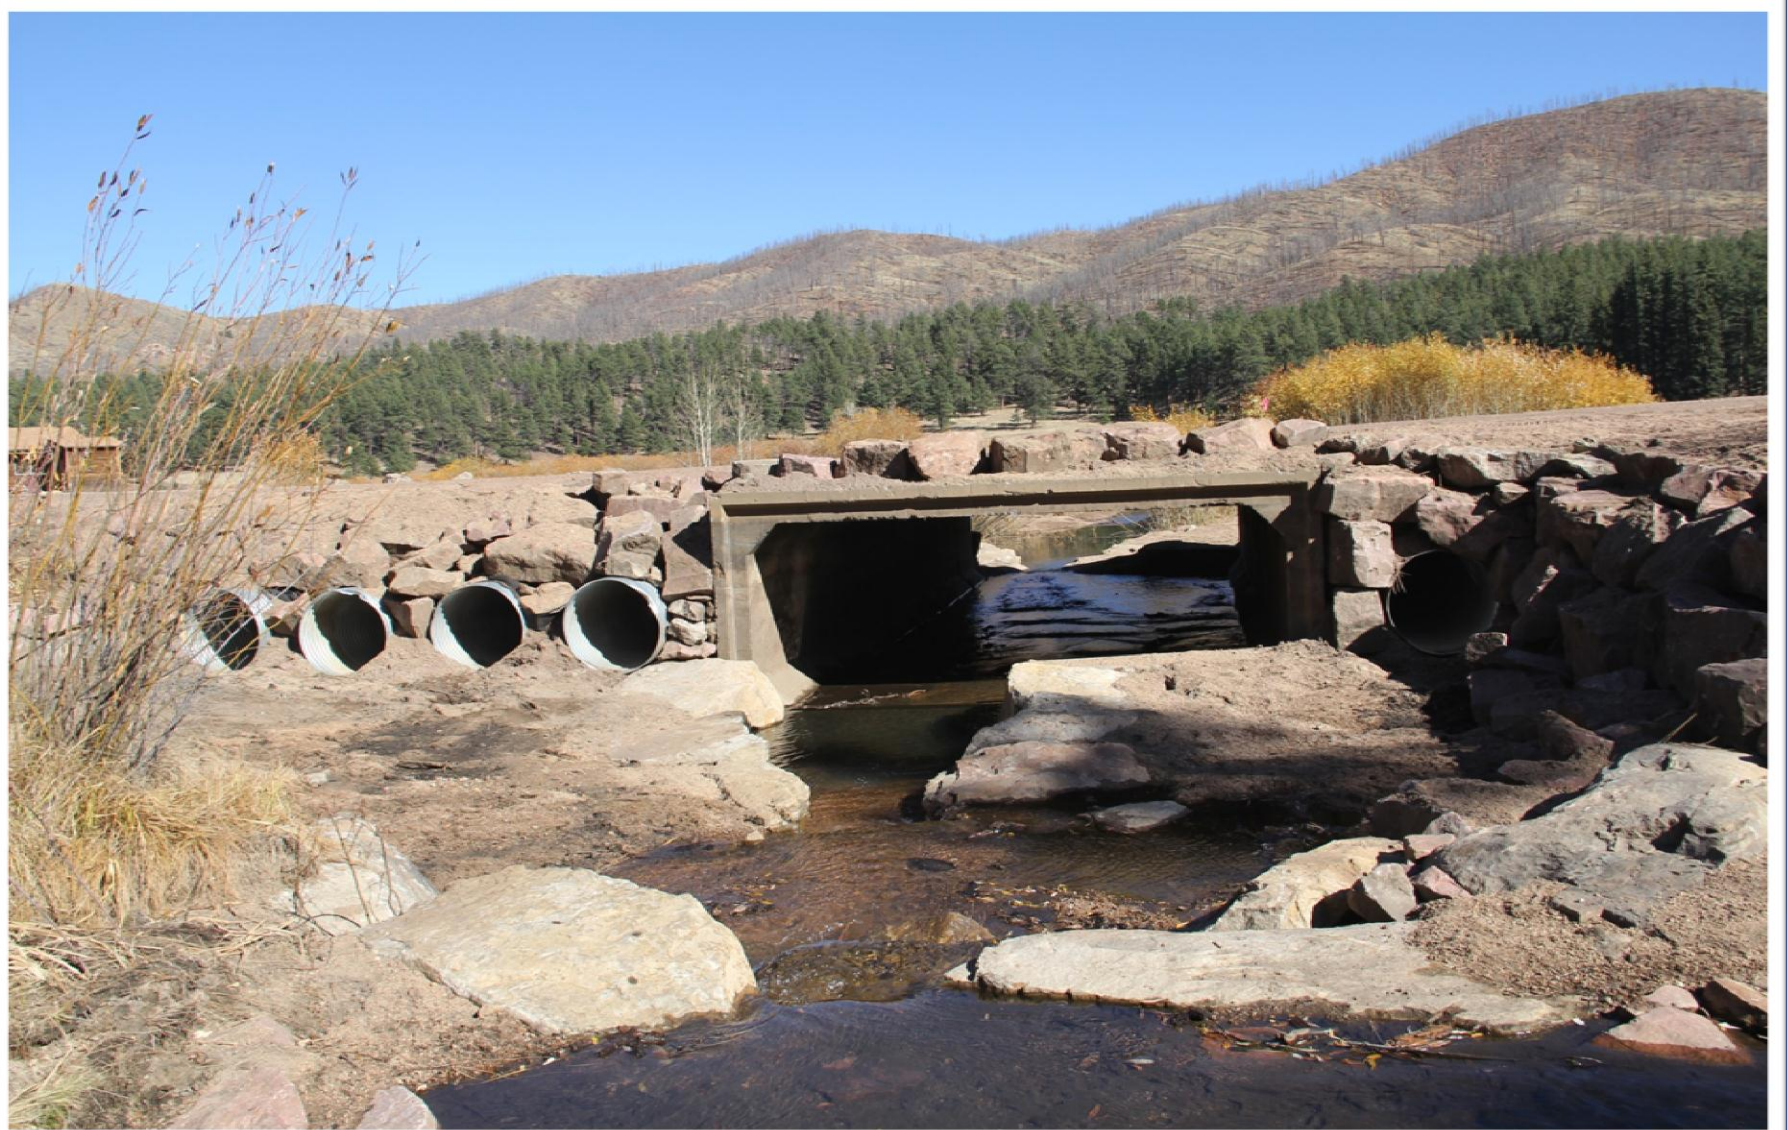
Restoration of box culvert with a low w/d ratio and floodplain connectivity, Trail Creek, Colorado
