FLOW 2015
Portland, Oregon, April 29th, 2015

**Solutions to Accommodate Extreme
Ranges of Available Flows under a
Changing Climate and Competition for
a Diminished Water Supply**

*Dave Rosgen, P.H., Ph.D.
Wildland Hydrology
Fort Collins, Colorado*

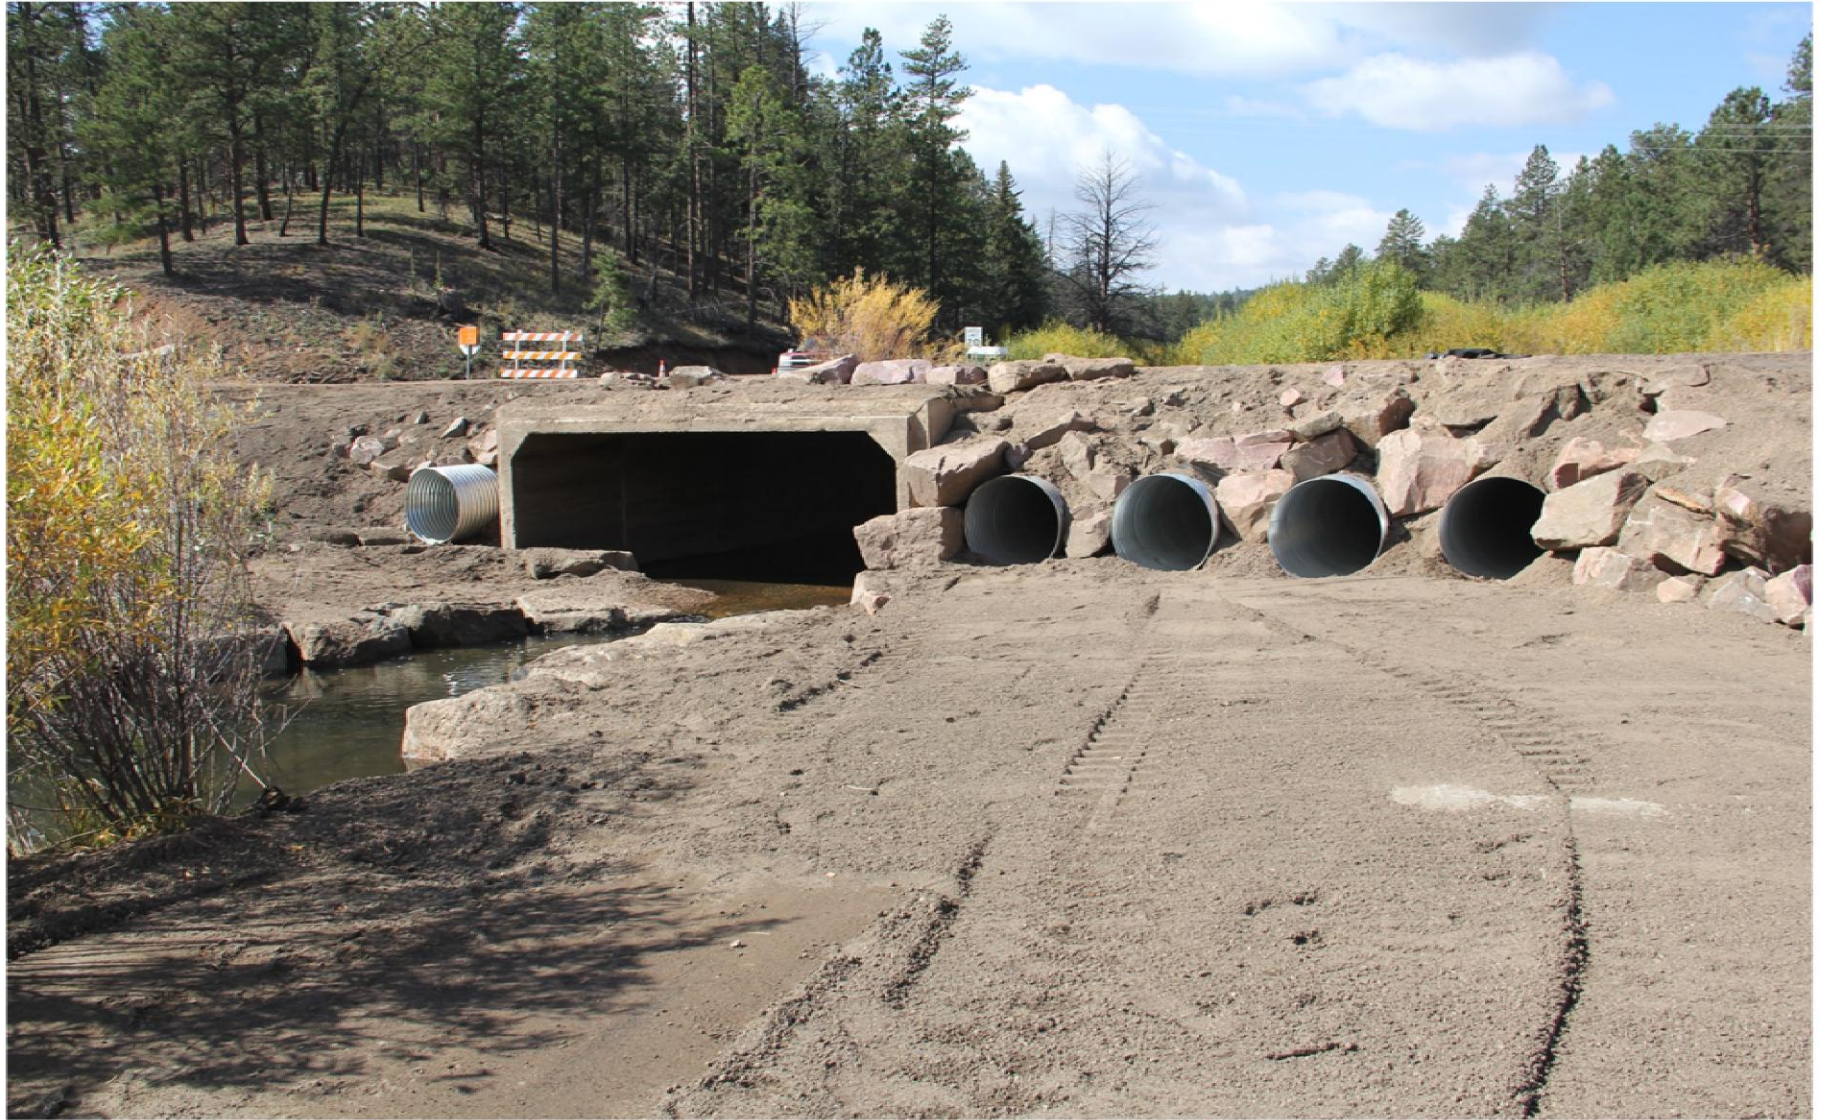
Looking upstream showing new channel and floodplain with floodplain drain culverts

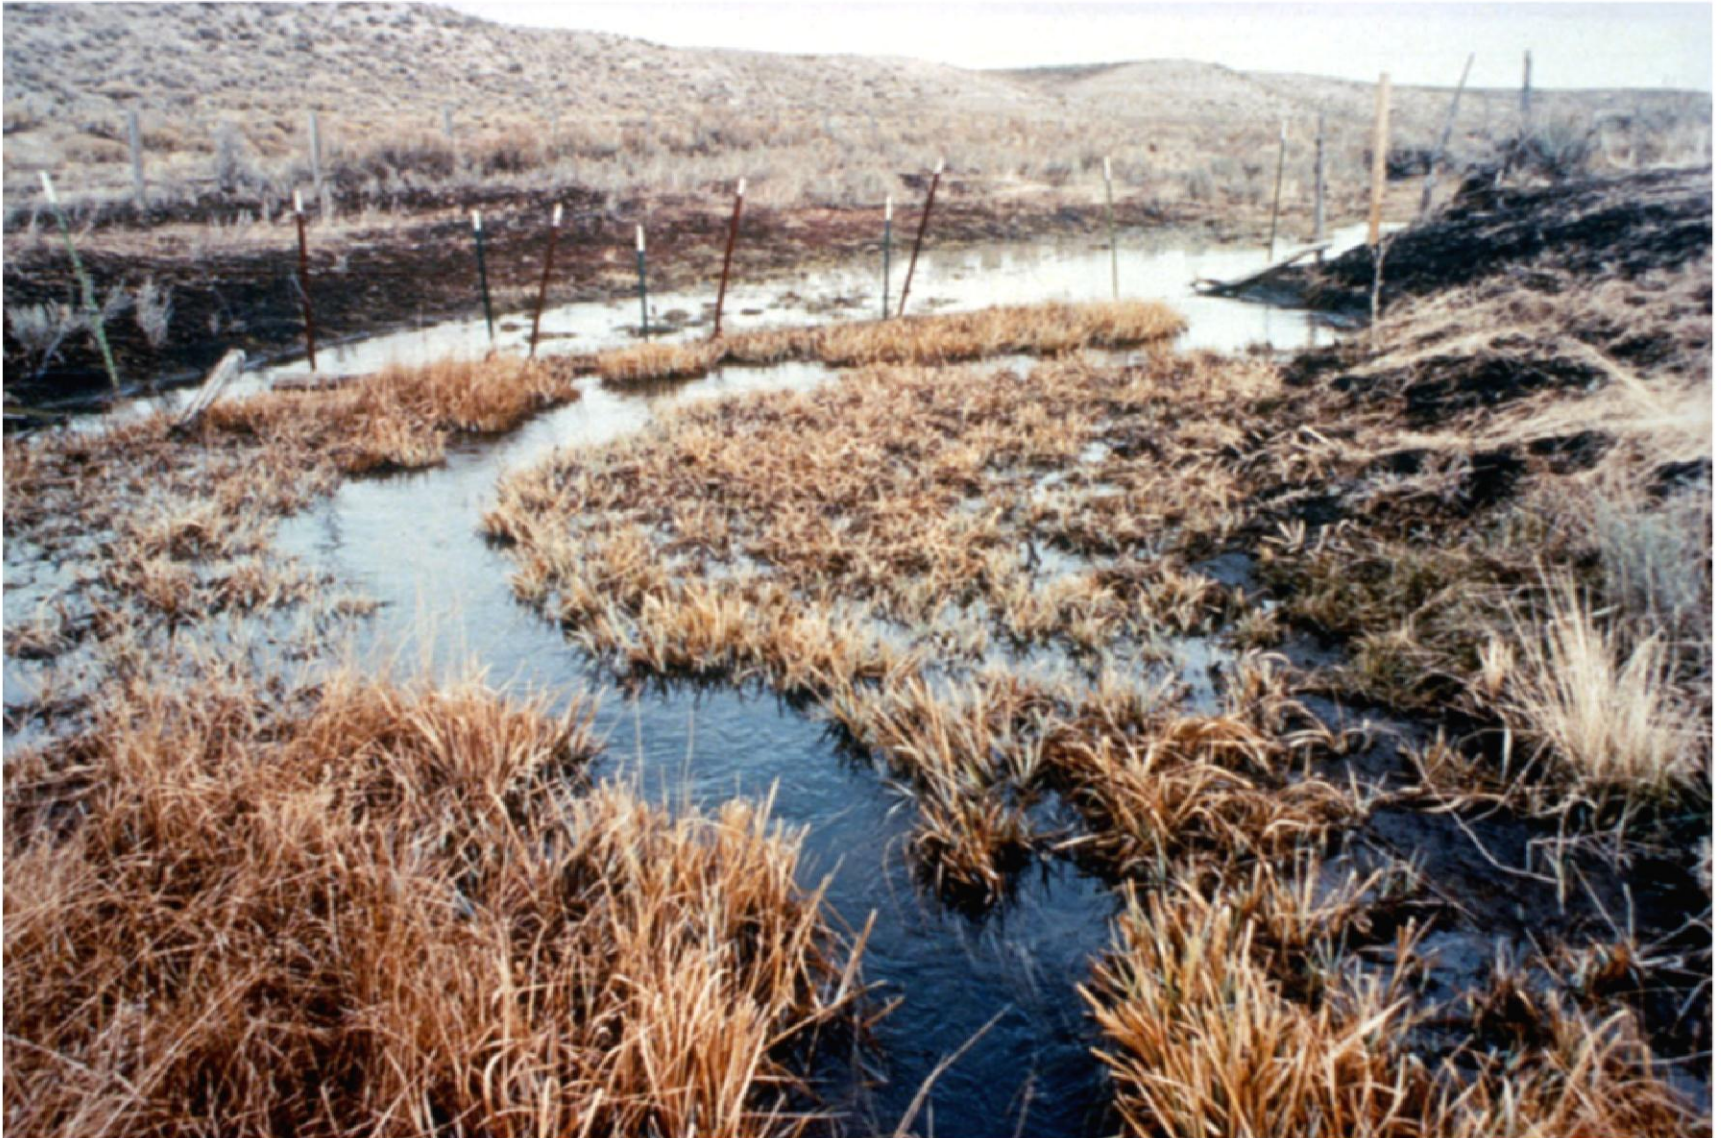
Proper grazing management system below fence line: F4→C4→E4

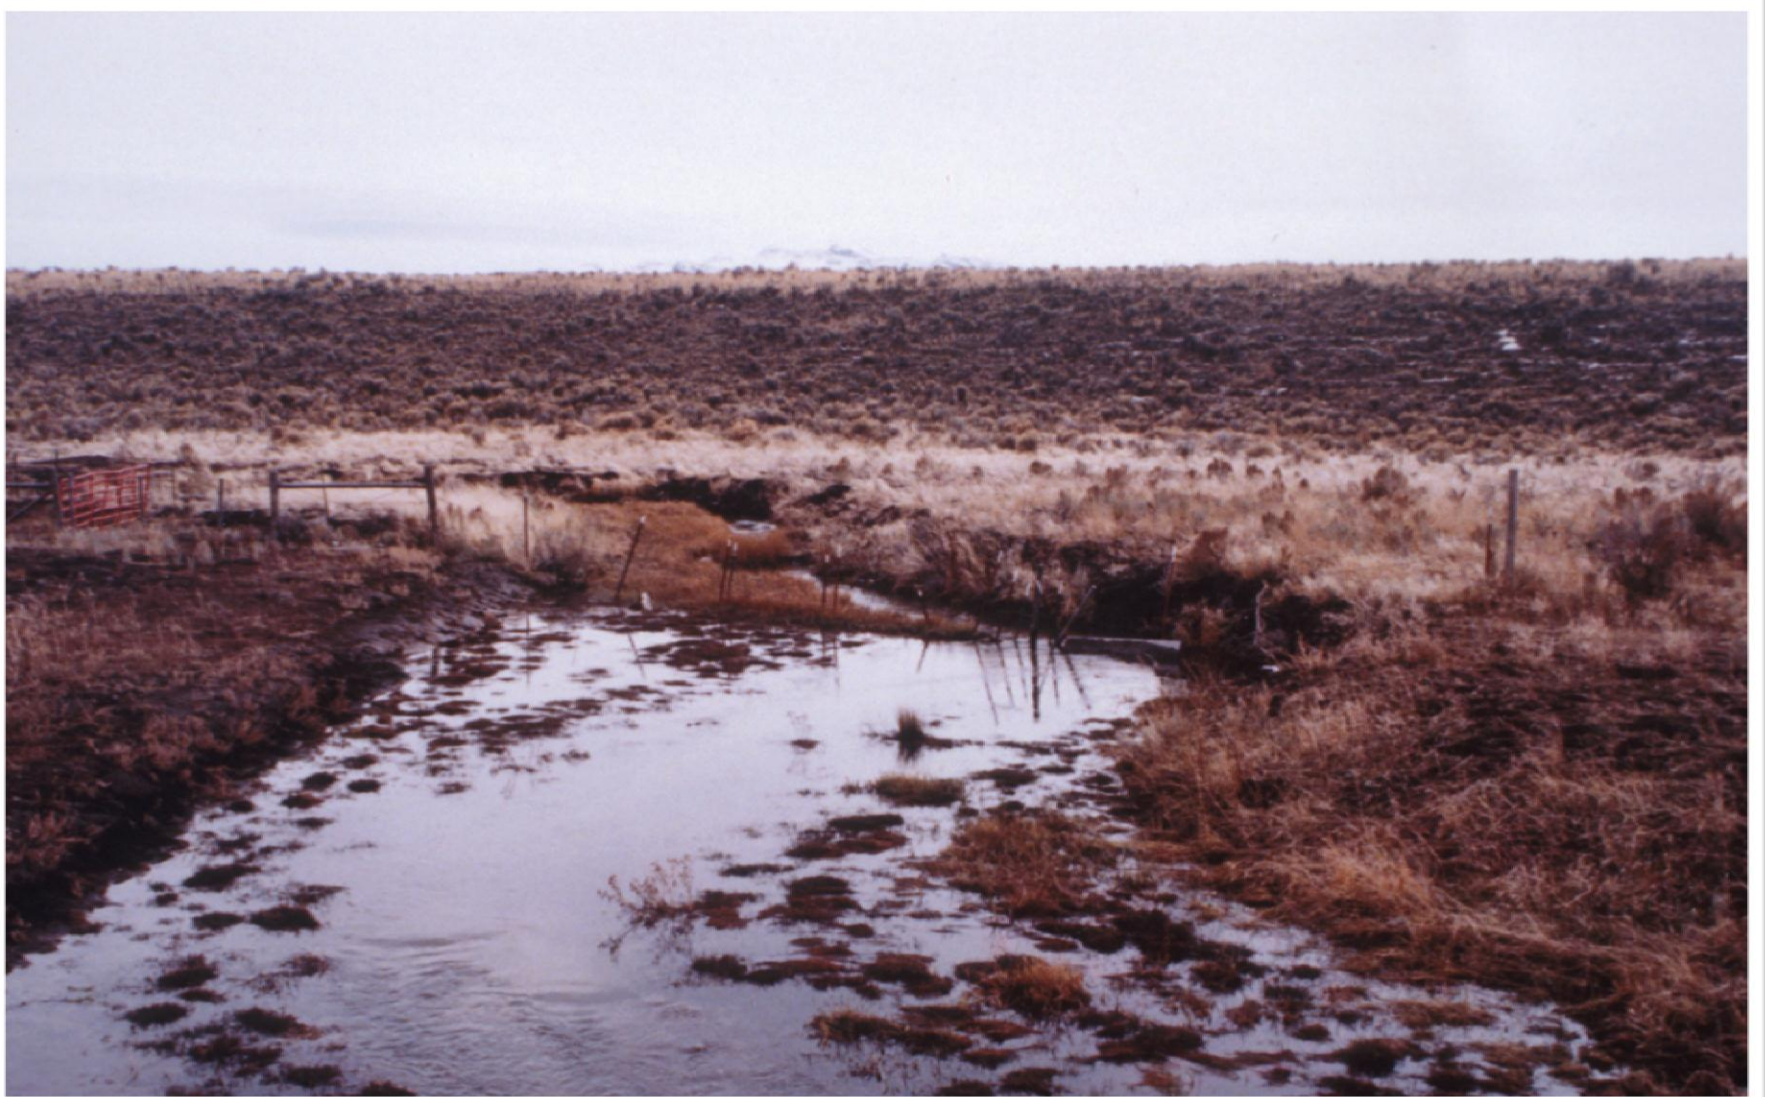
Fence-line contrast showing E4 to C4 stream type conversion

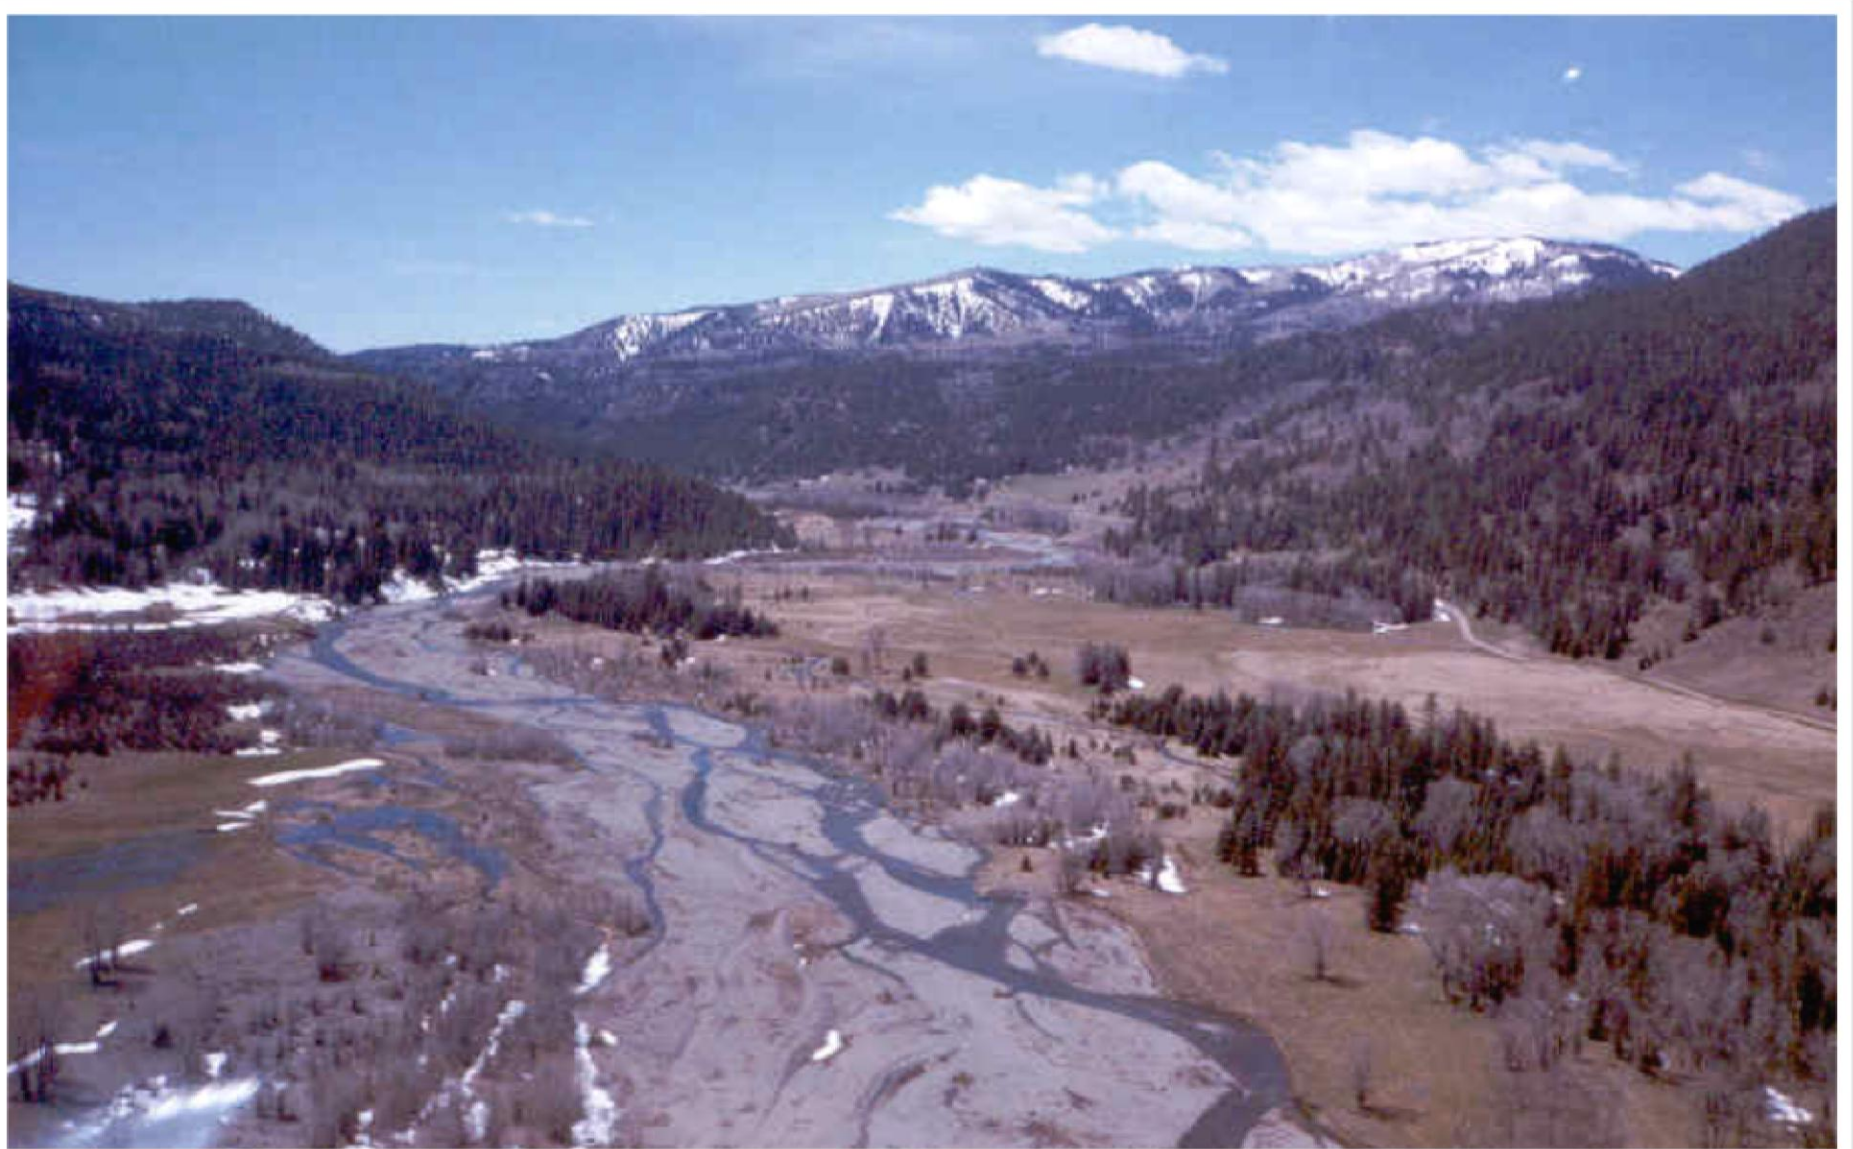
East Fork San Juan River showing braided condition from clearing willows in the early 1930s

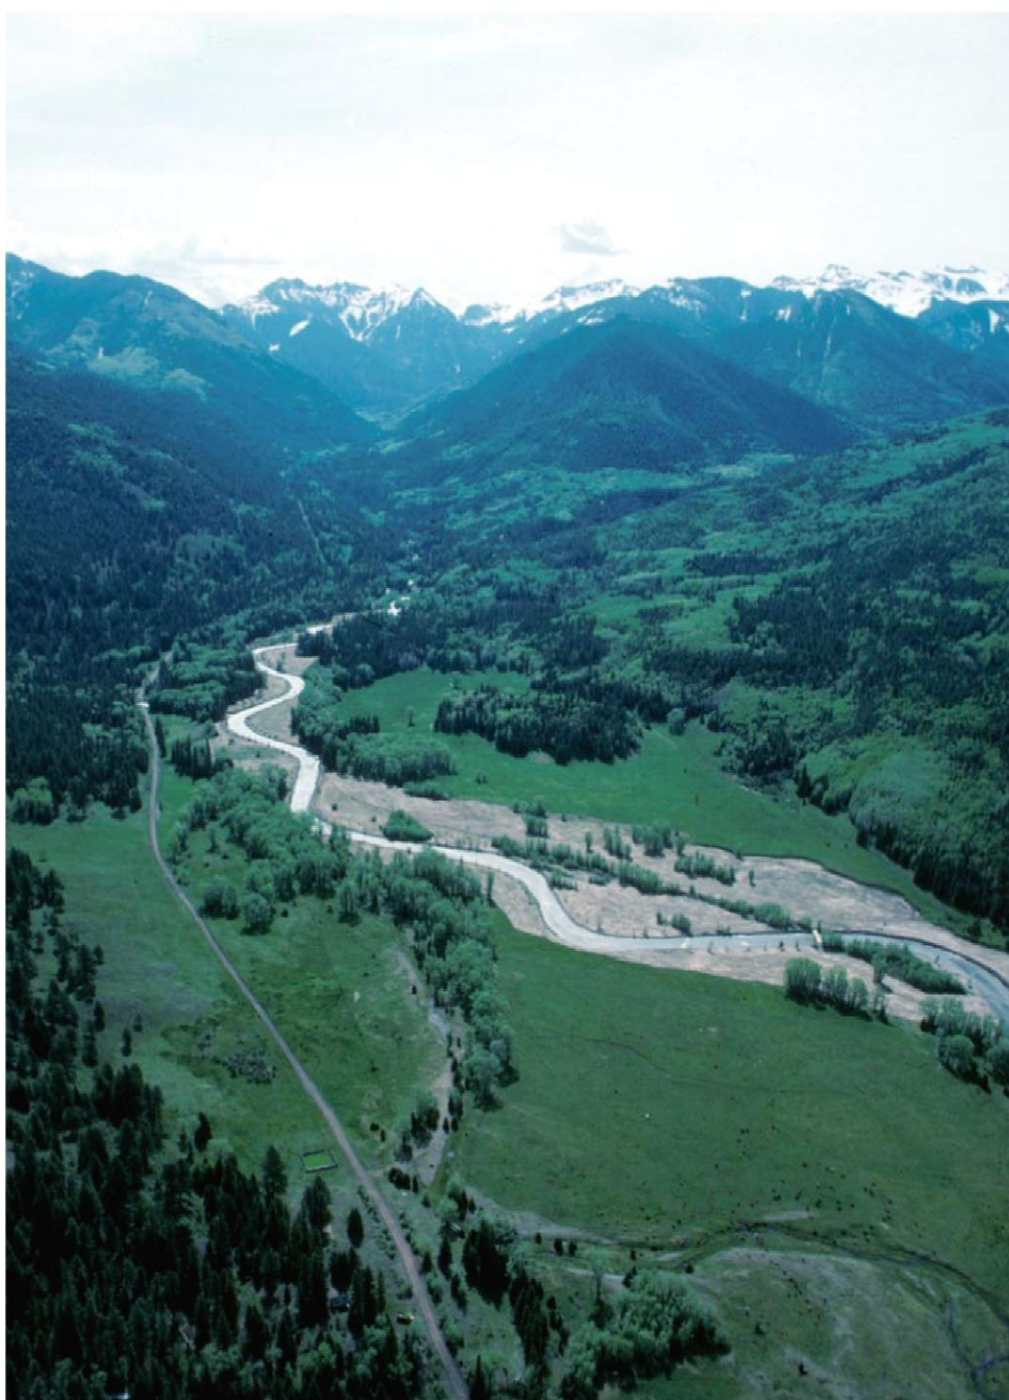
East Fork River
meander pattern
of the new C4
stream type at
bankfull stage –
June, 1987

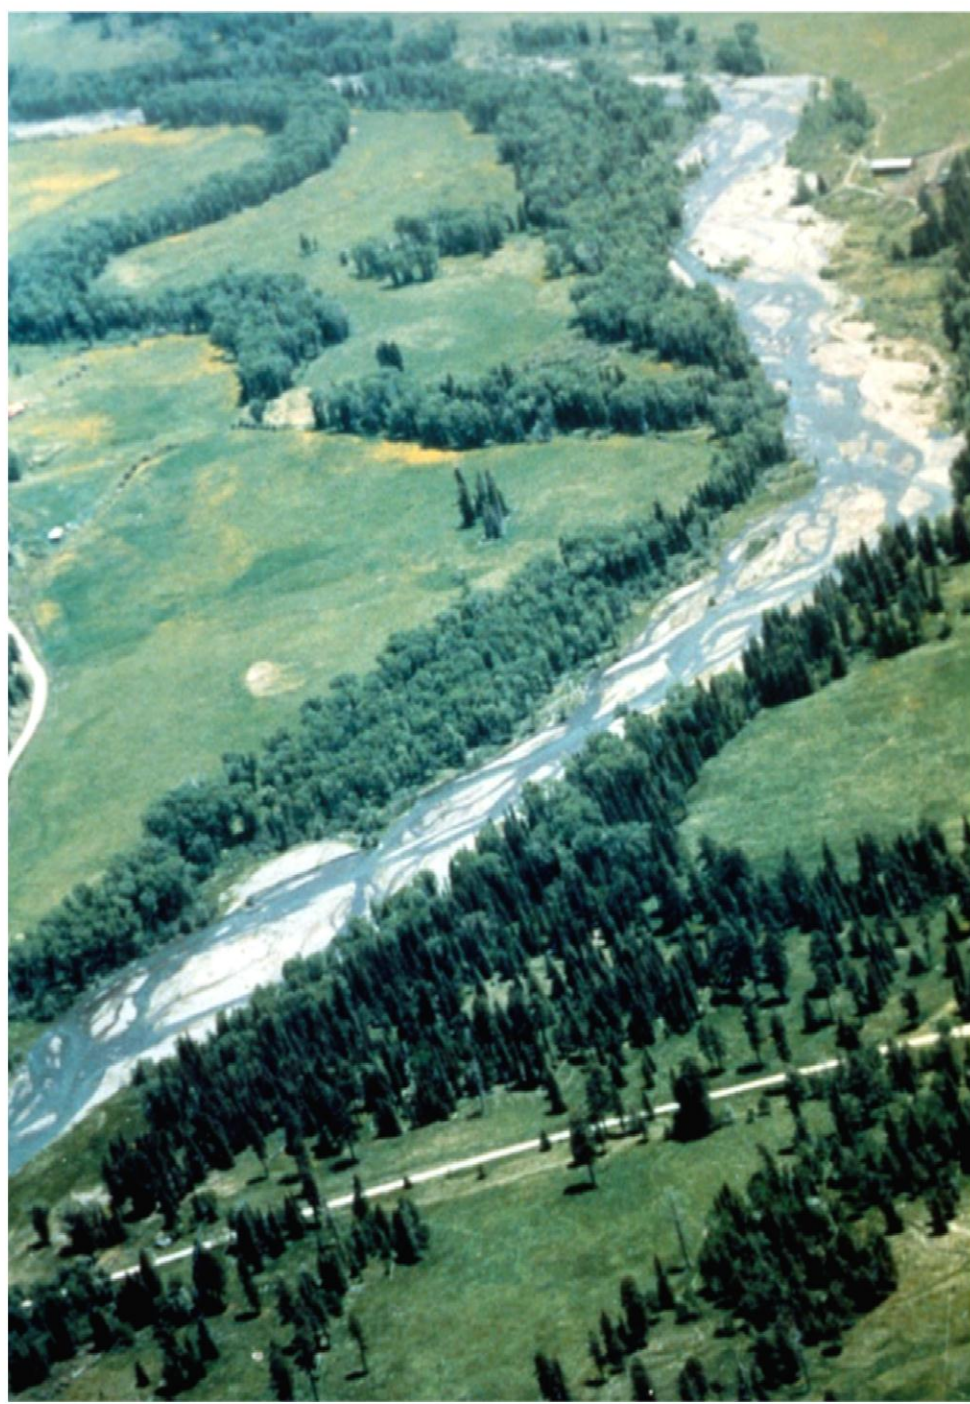
Blanco River
(D4 stream type)
prior to restoration,
1987, looking
upstream

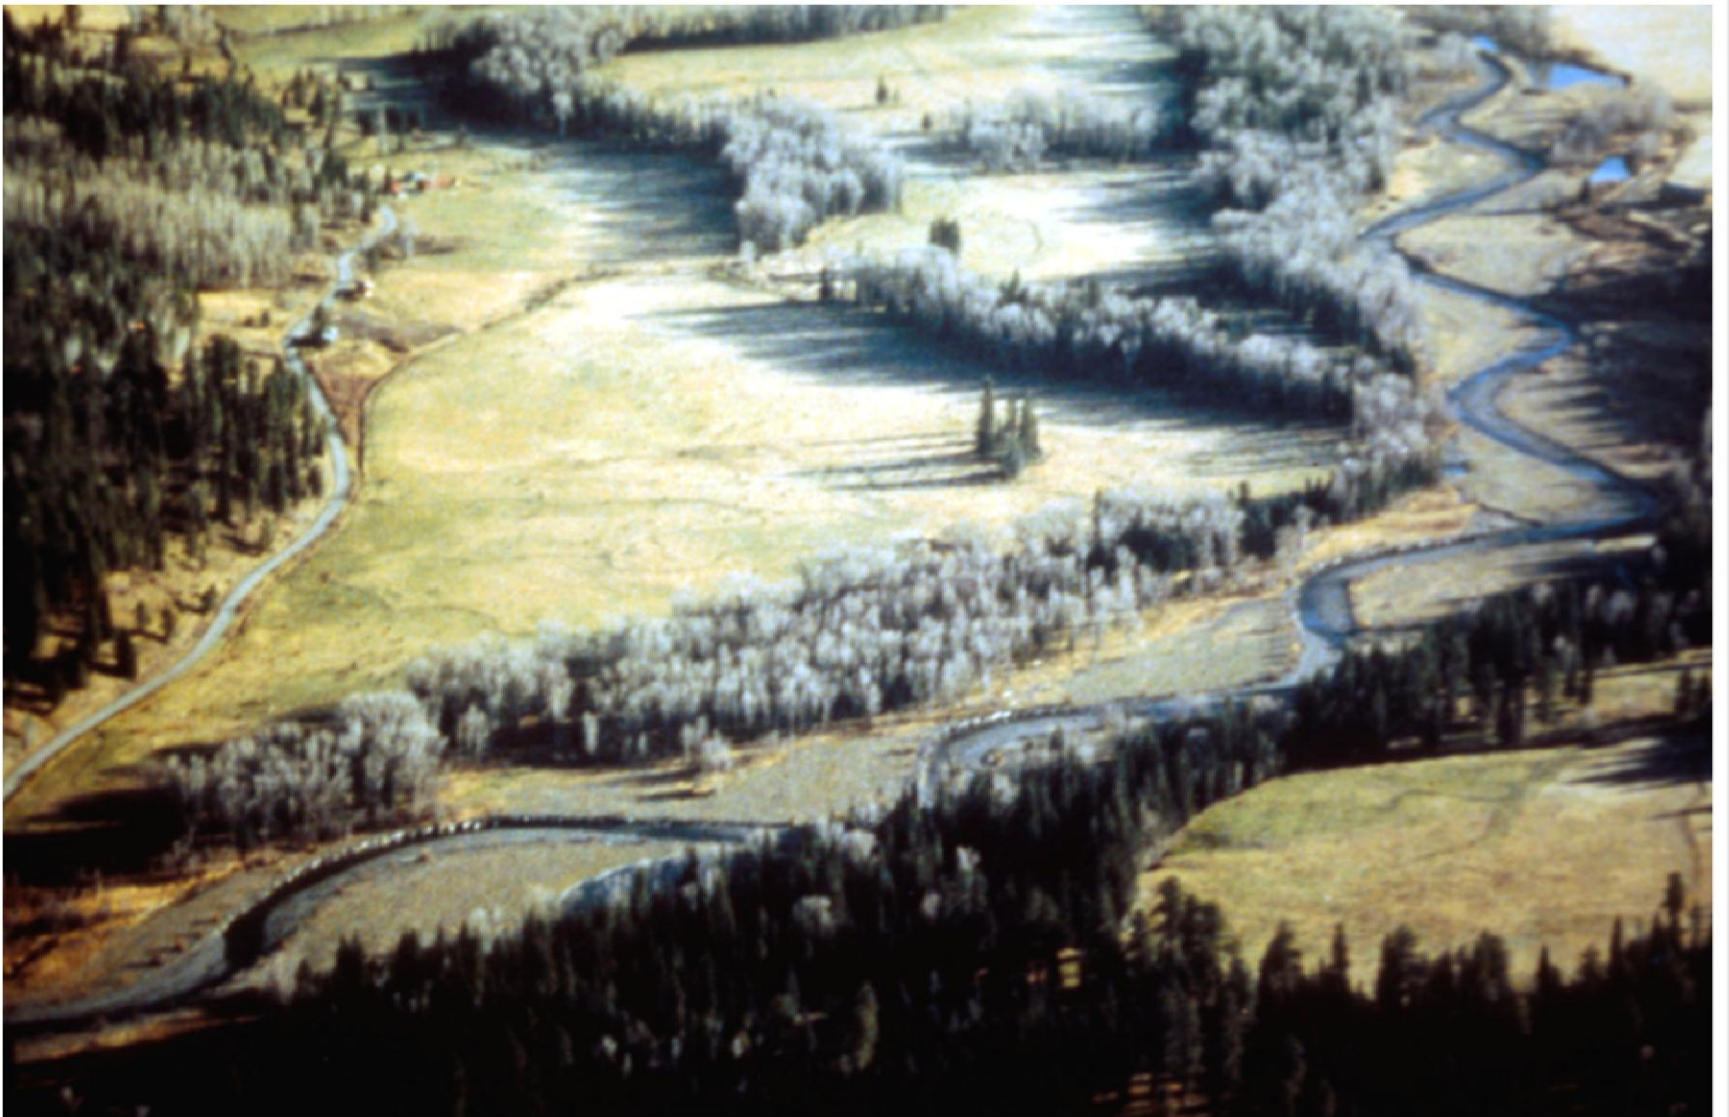
Post runoff restoration – Blanco River, 1990, looking upstream, C4 stream type

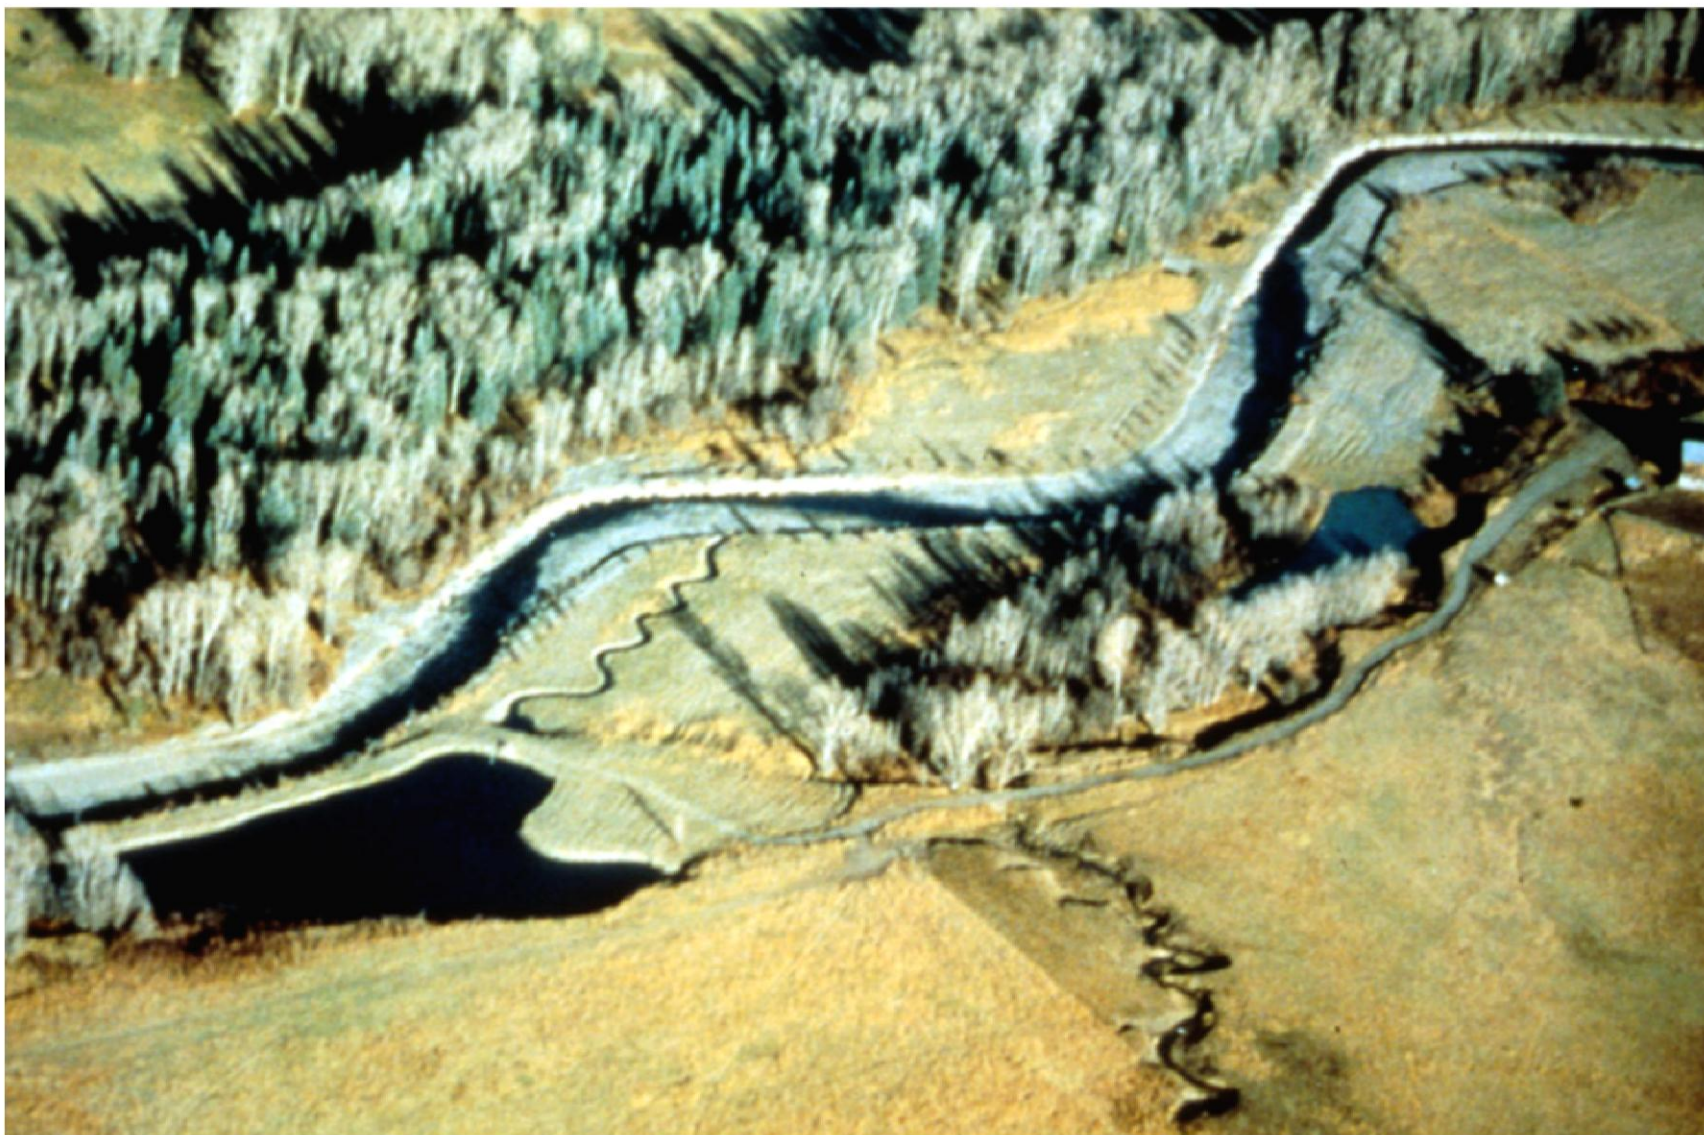
Post-restoration reach – Blanco River

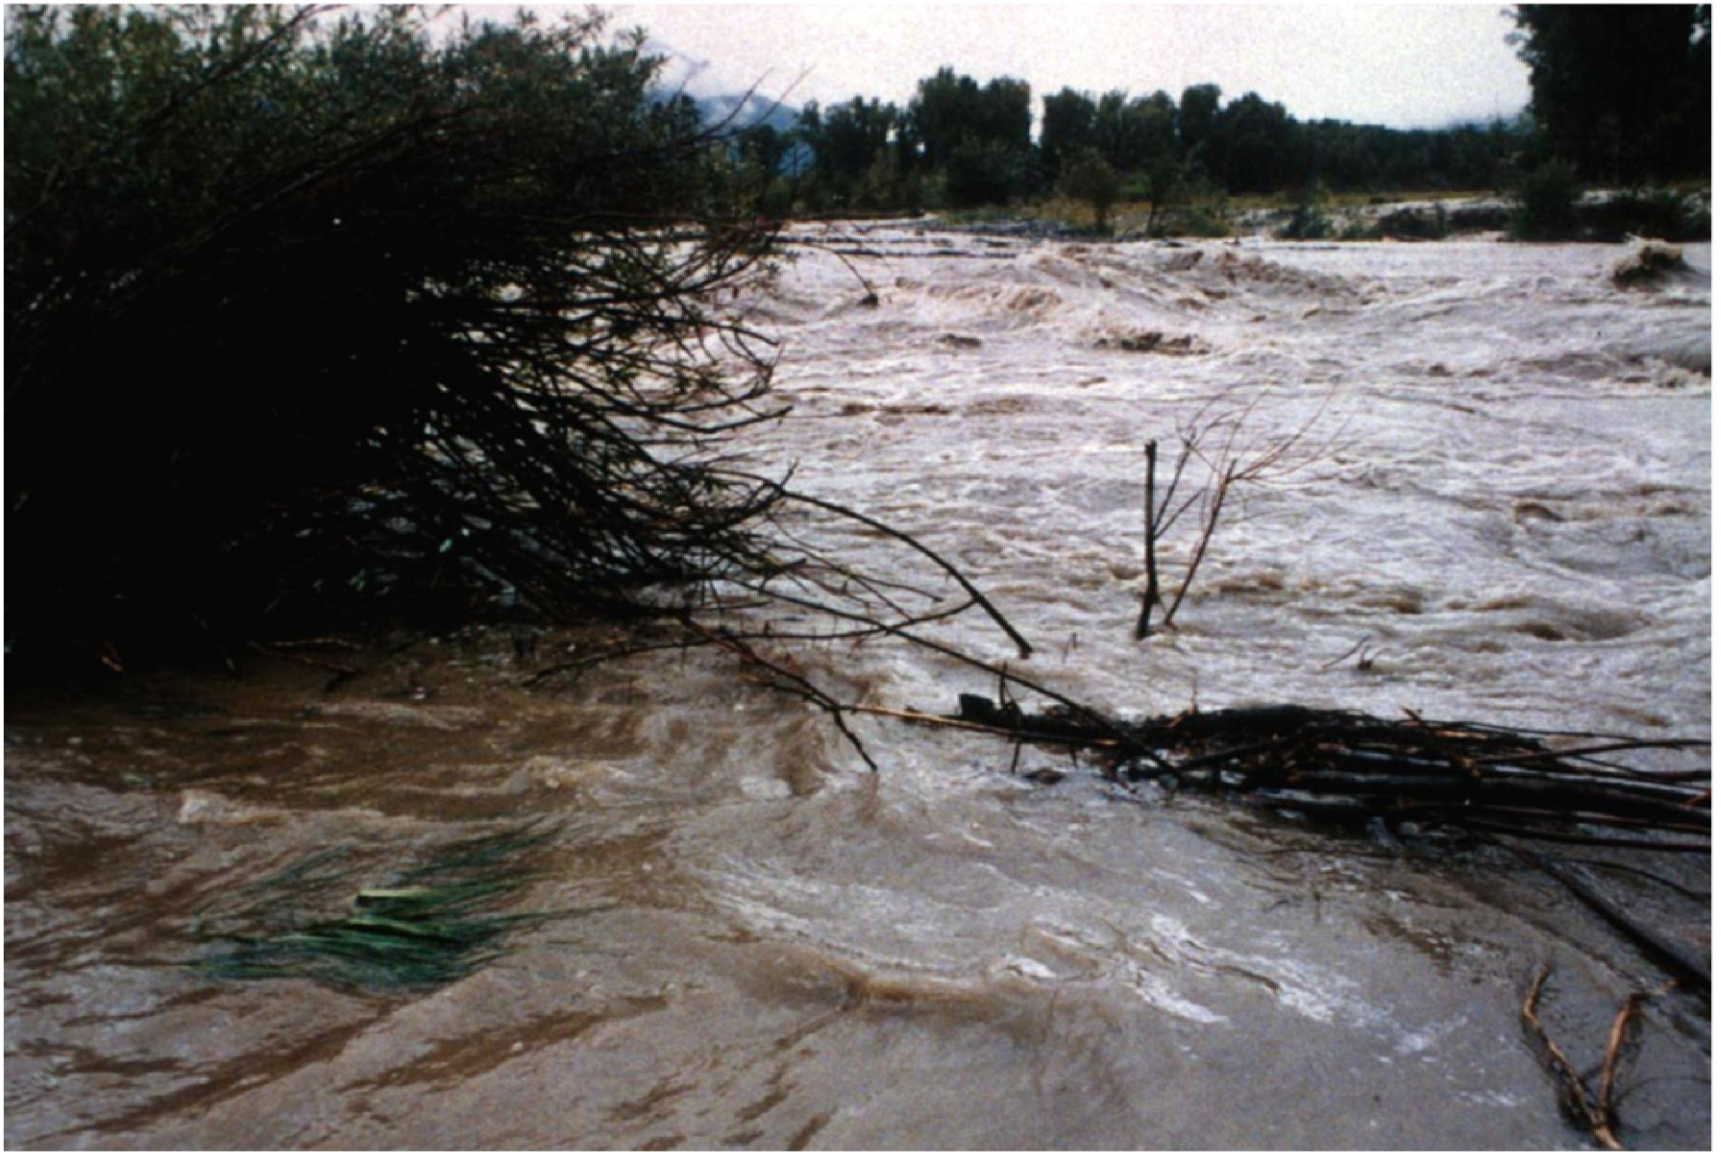
Blanco River flood 4x bankfull, 1995

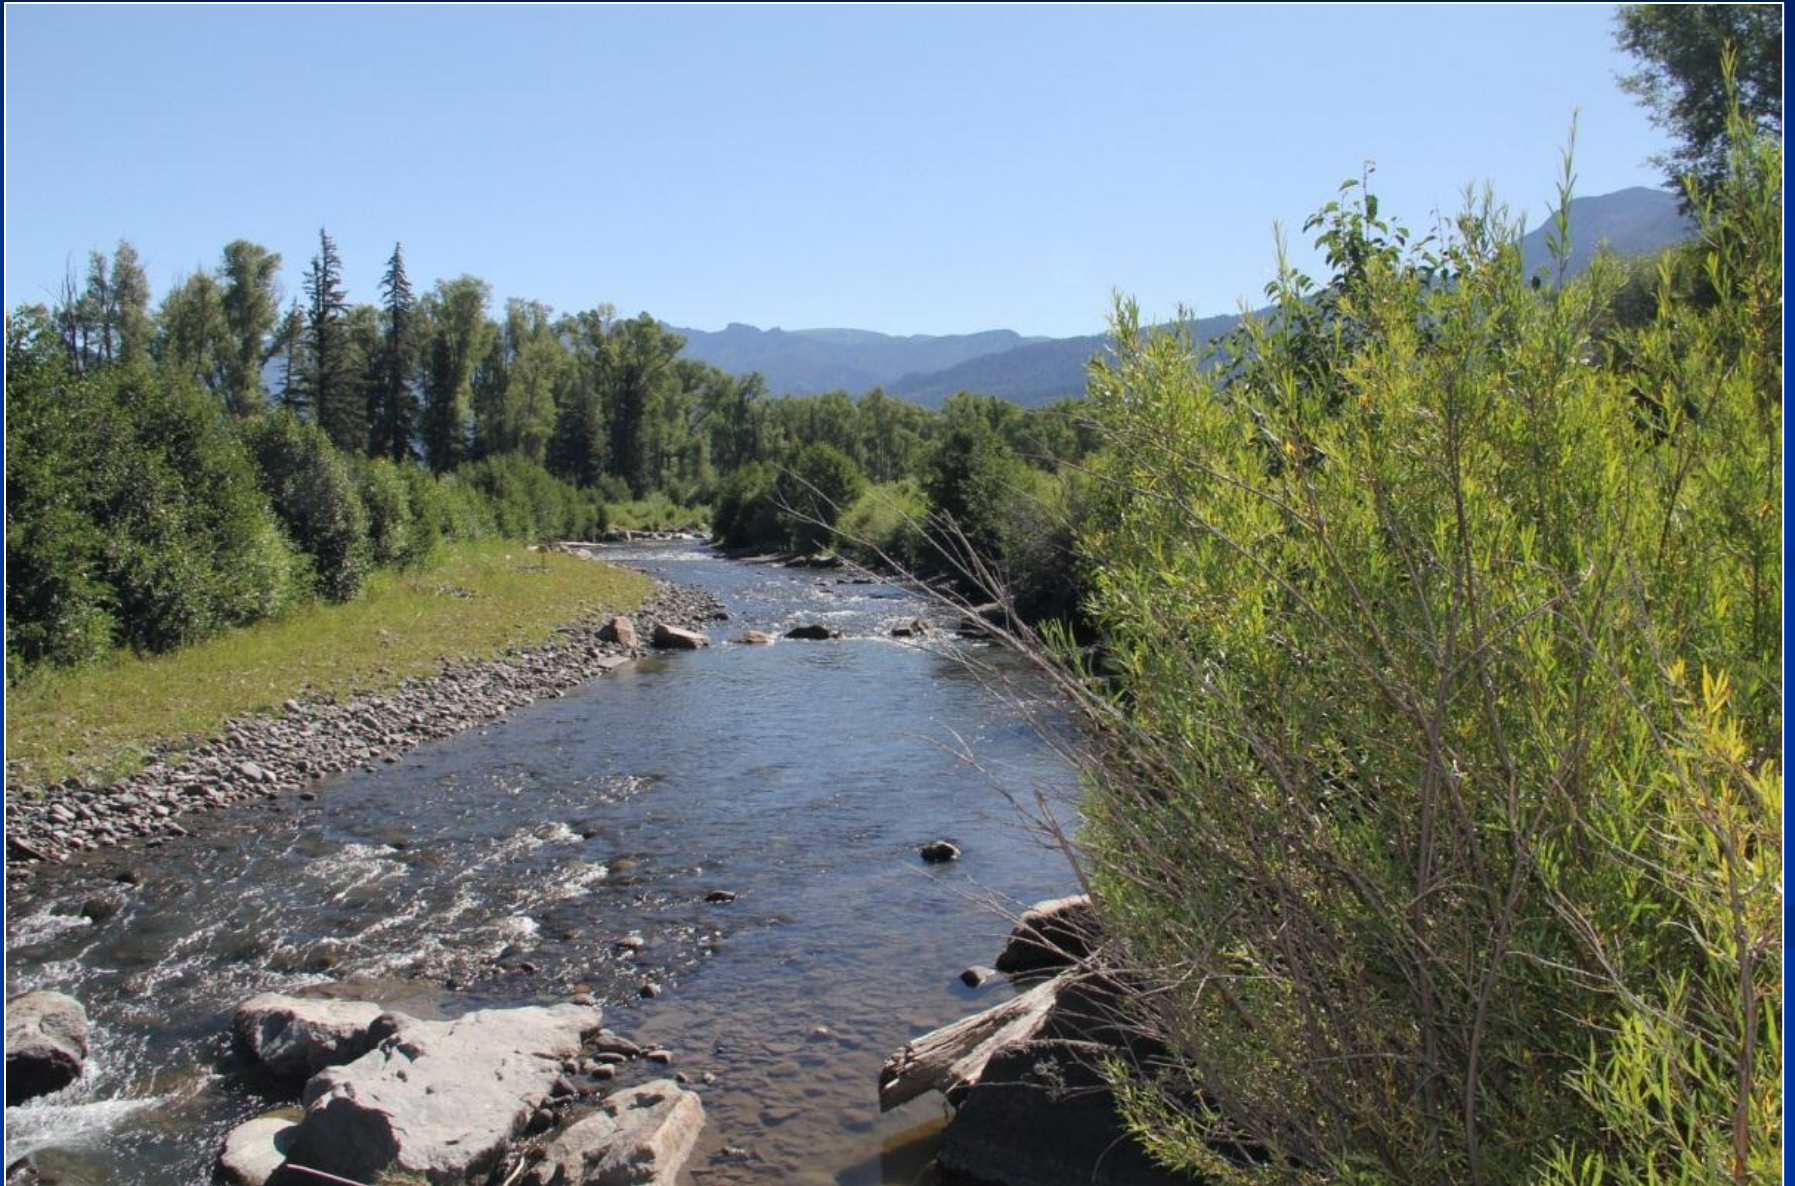
Blanco River floodplain, 24 years after restoration, August, 2011

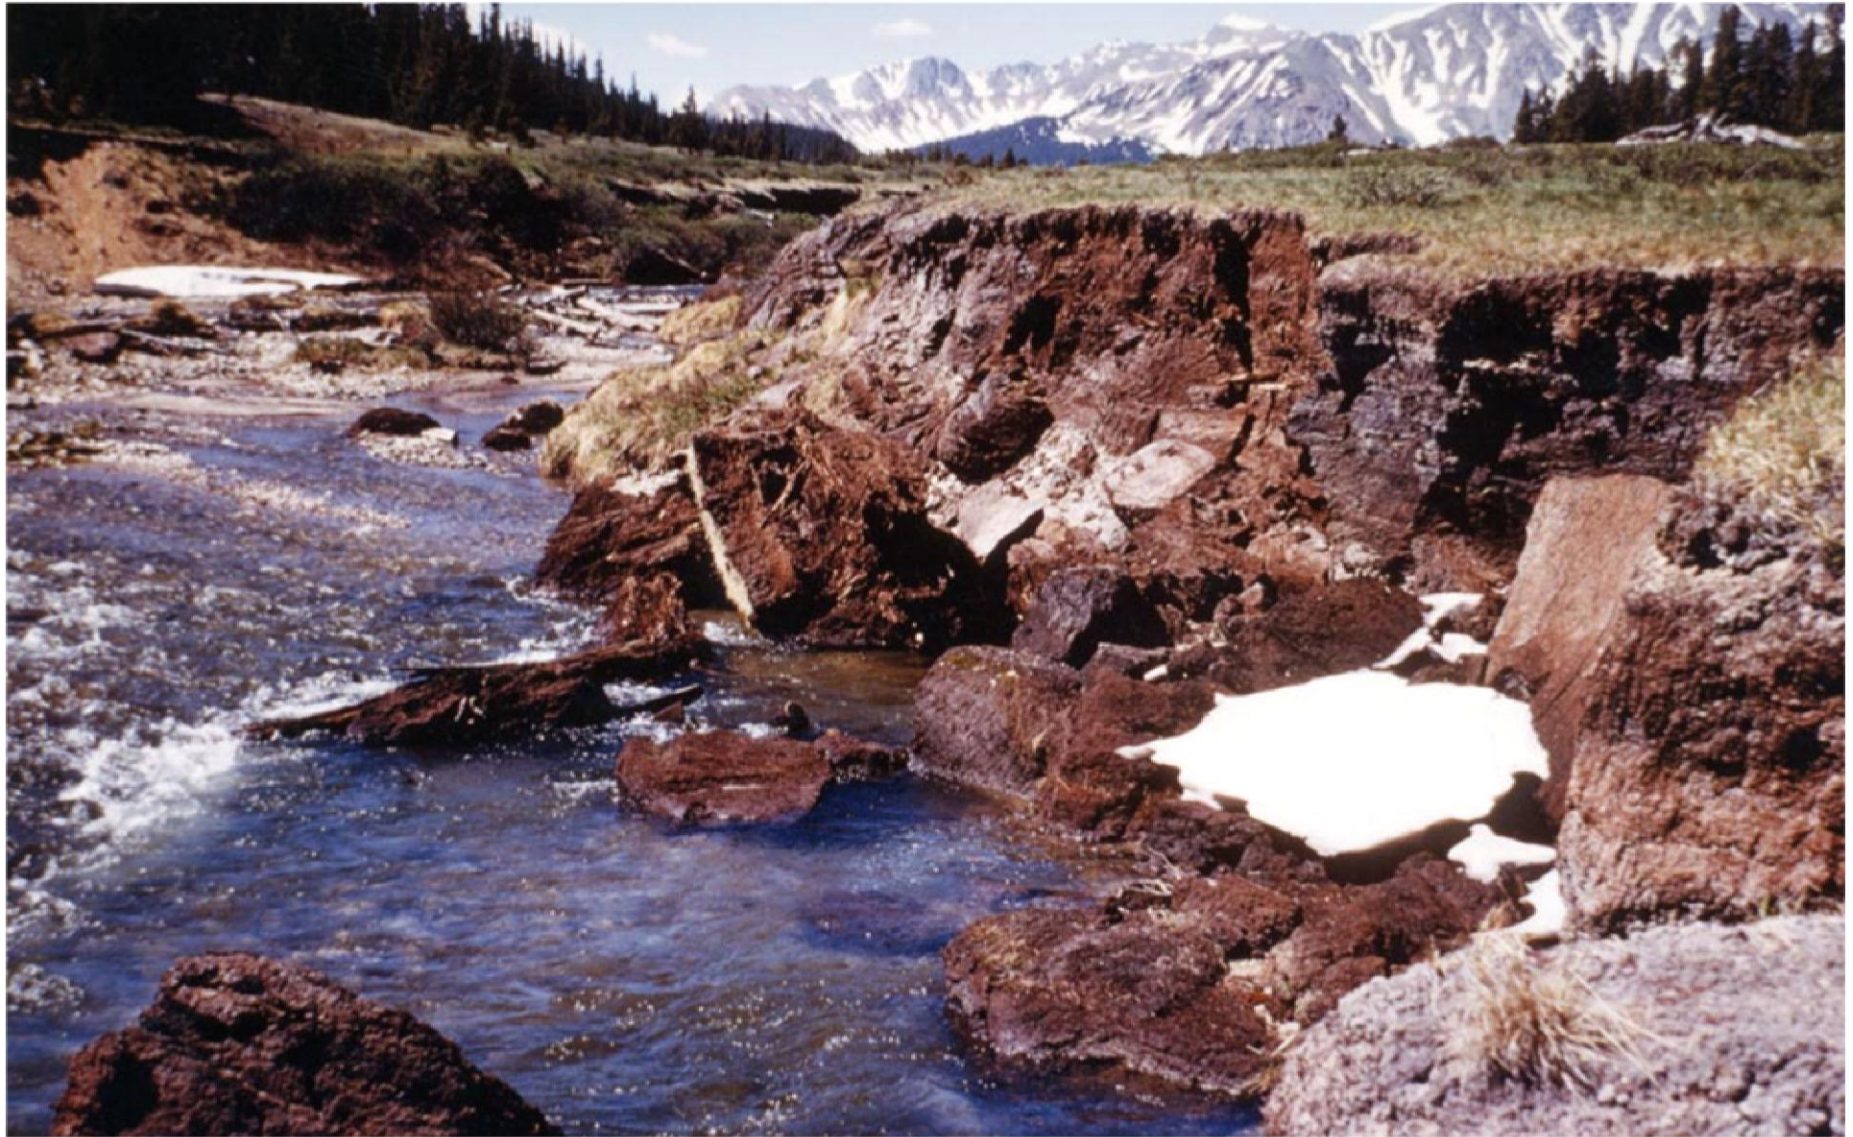
Trans-basin diversion, F4 stream type, 120 years old...
West Slope Cutthroat Fishery, Poudre Pass Creek, CO

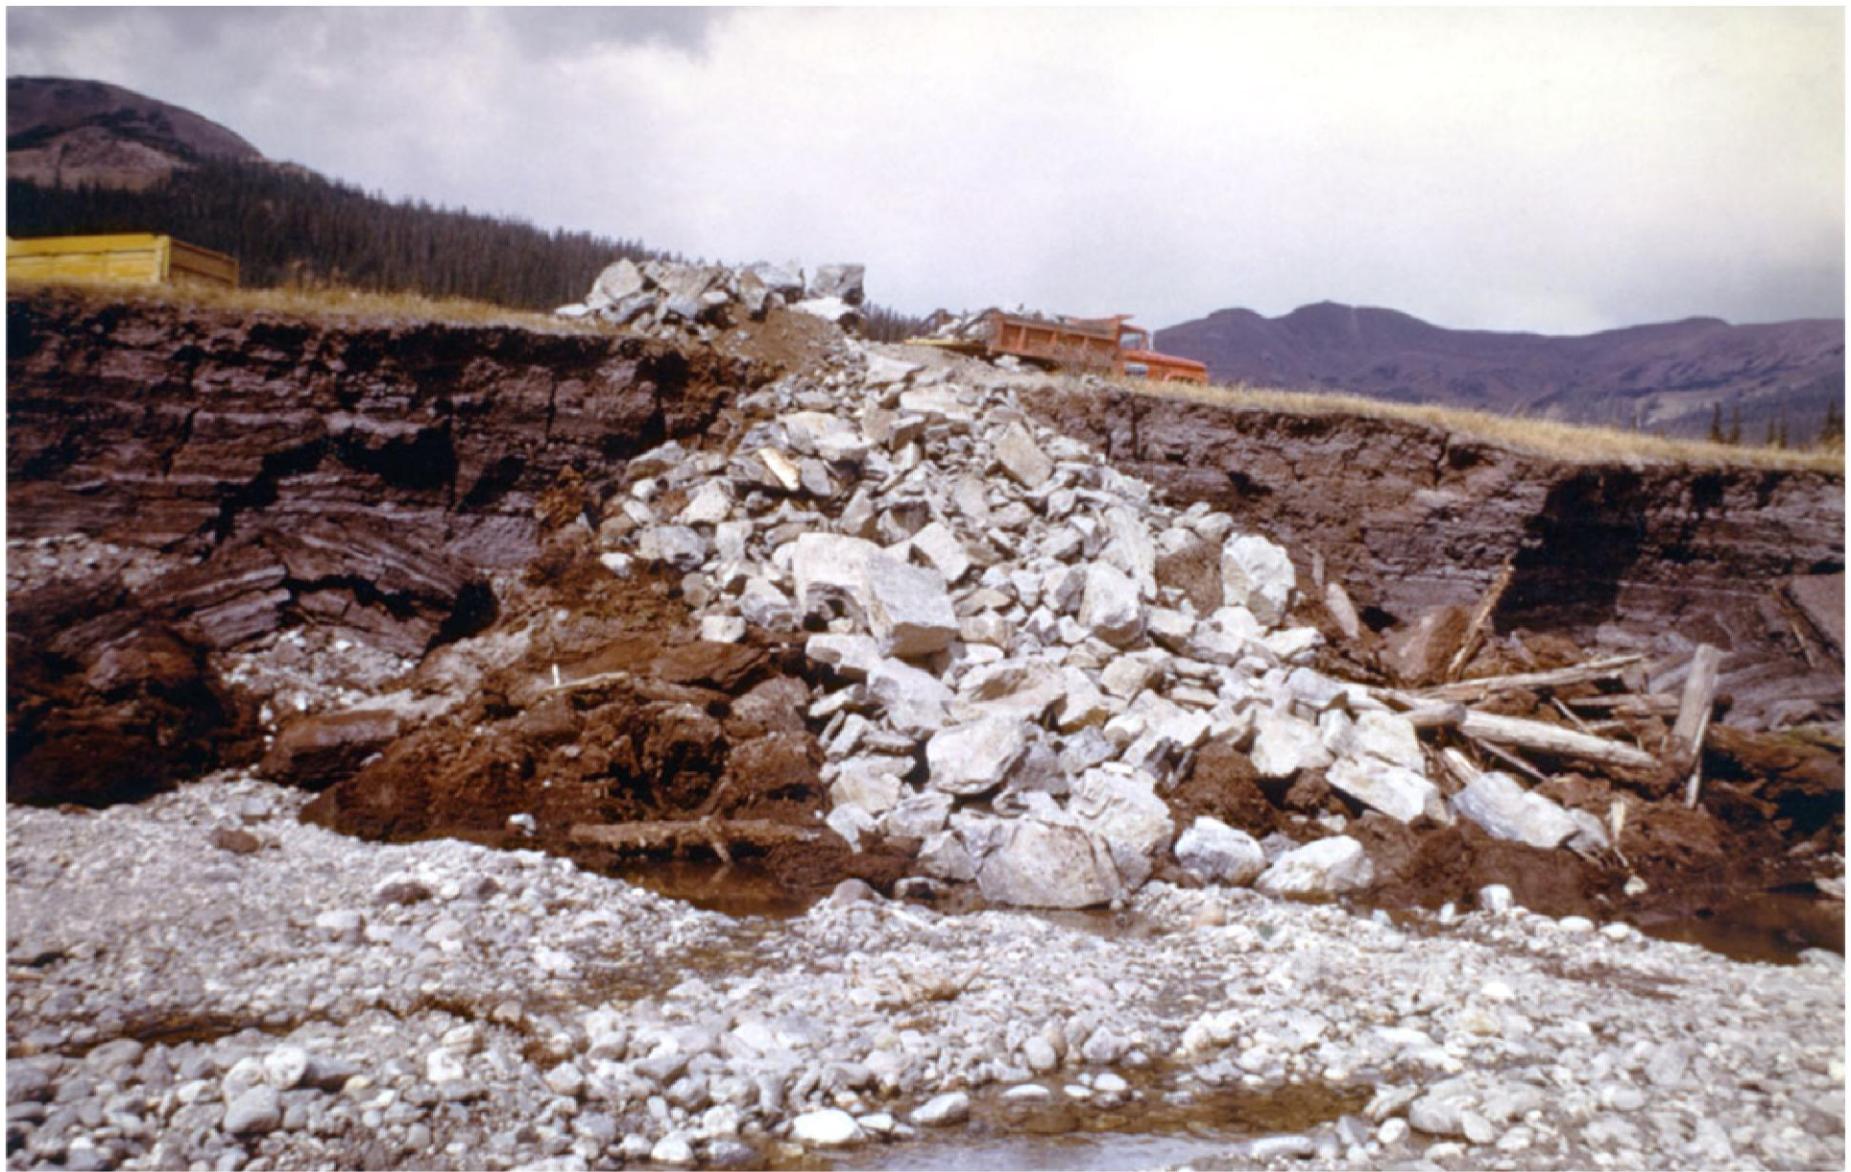
“Stabilization” on Poudre Pass Creek diversion channel
