FLOW 2015
Portland, Oregon, April 29th, 2015

**Solutions to Accommodate Extreme
Ranges of Available Flows under a
Changing Climate and Competition for
a Diminished Water Supply**

*Dave Rosgen, P.H., Ph.D.
Wildland Hydrology
Fort Collins, Colorado*

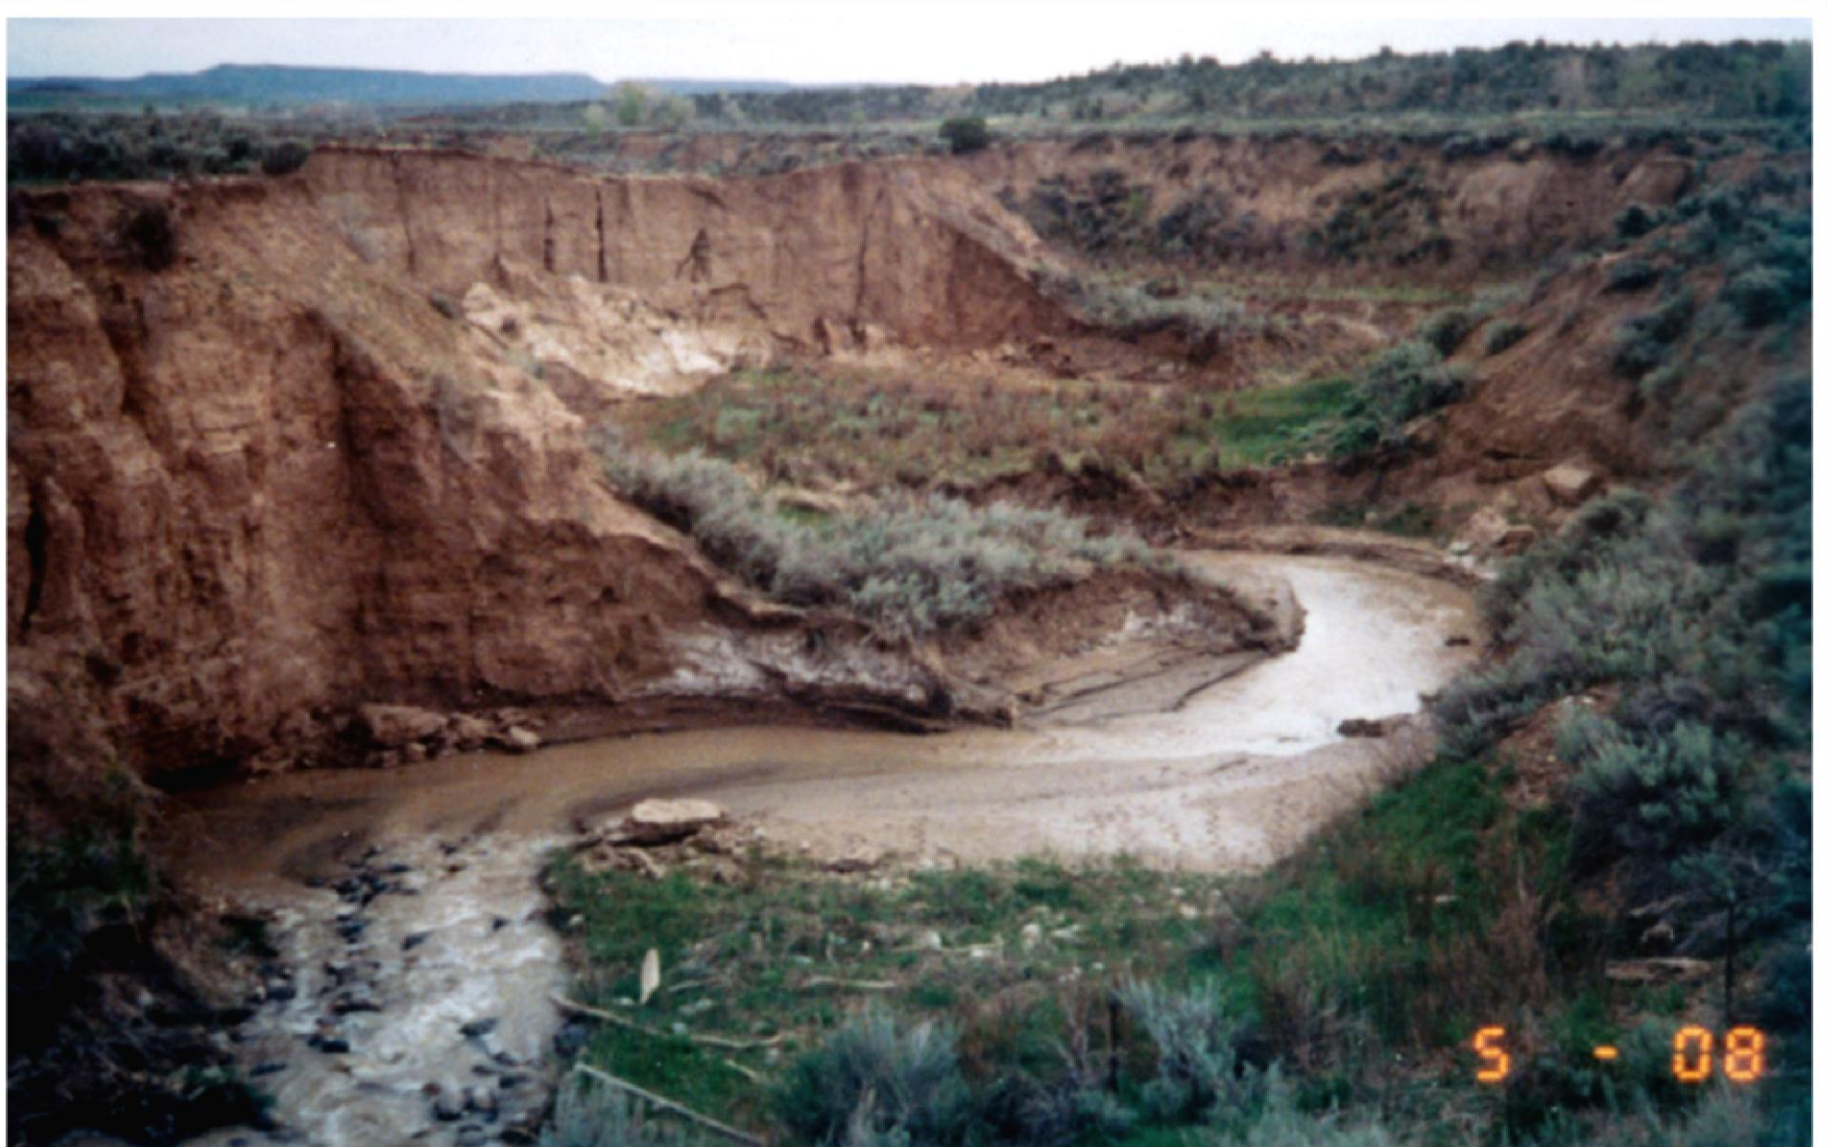
100 feet downstream of culvert –
G4 stream type due to contraction scour

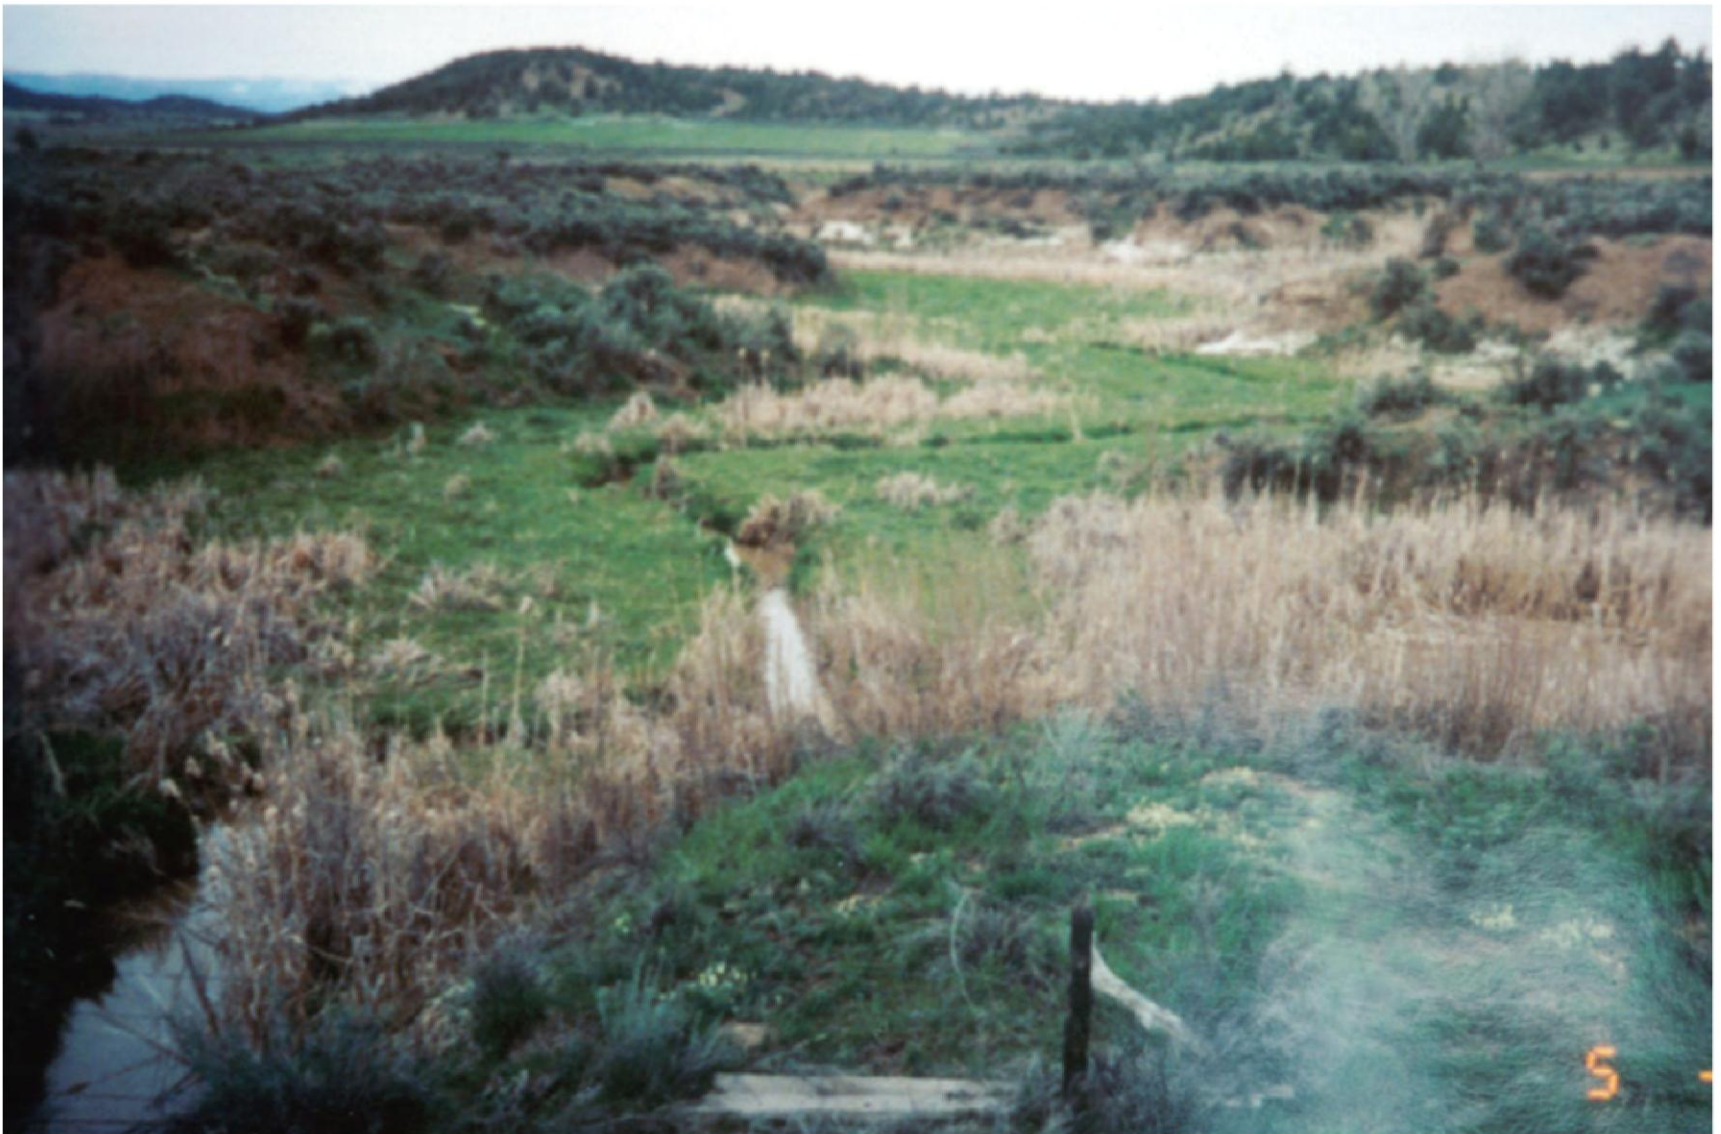
E4 stream type succession inside of previous F4 stream type, above culvert

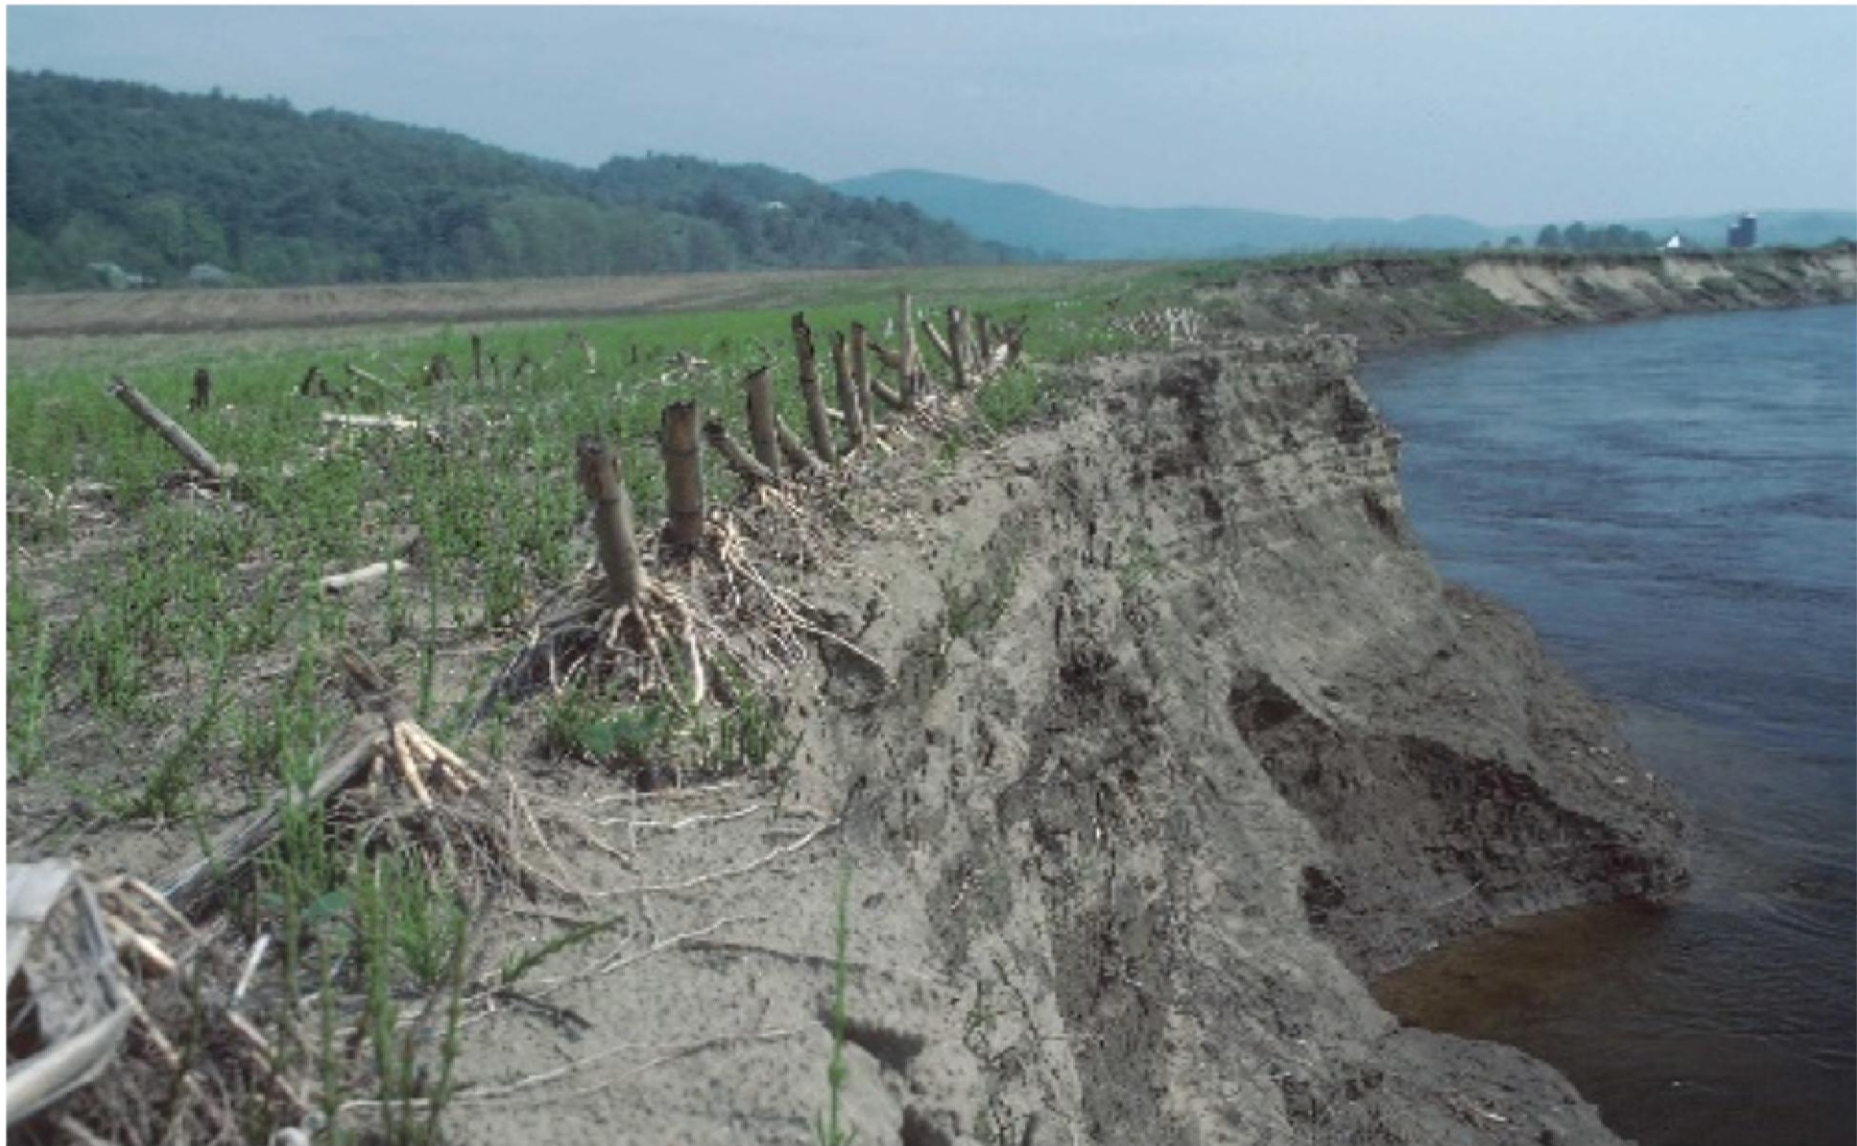
Accelerated streambank erosion due to riparian vegetation removal

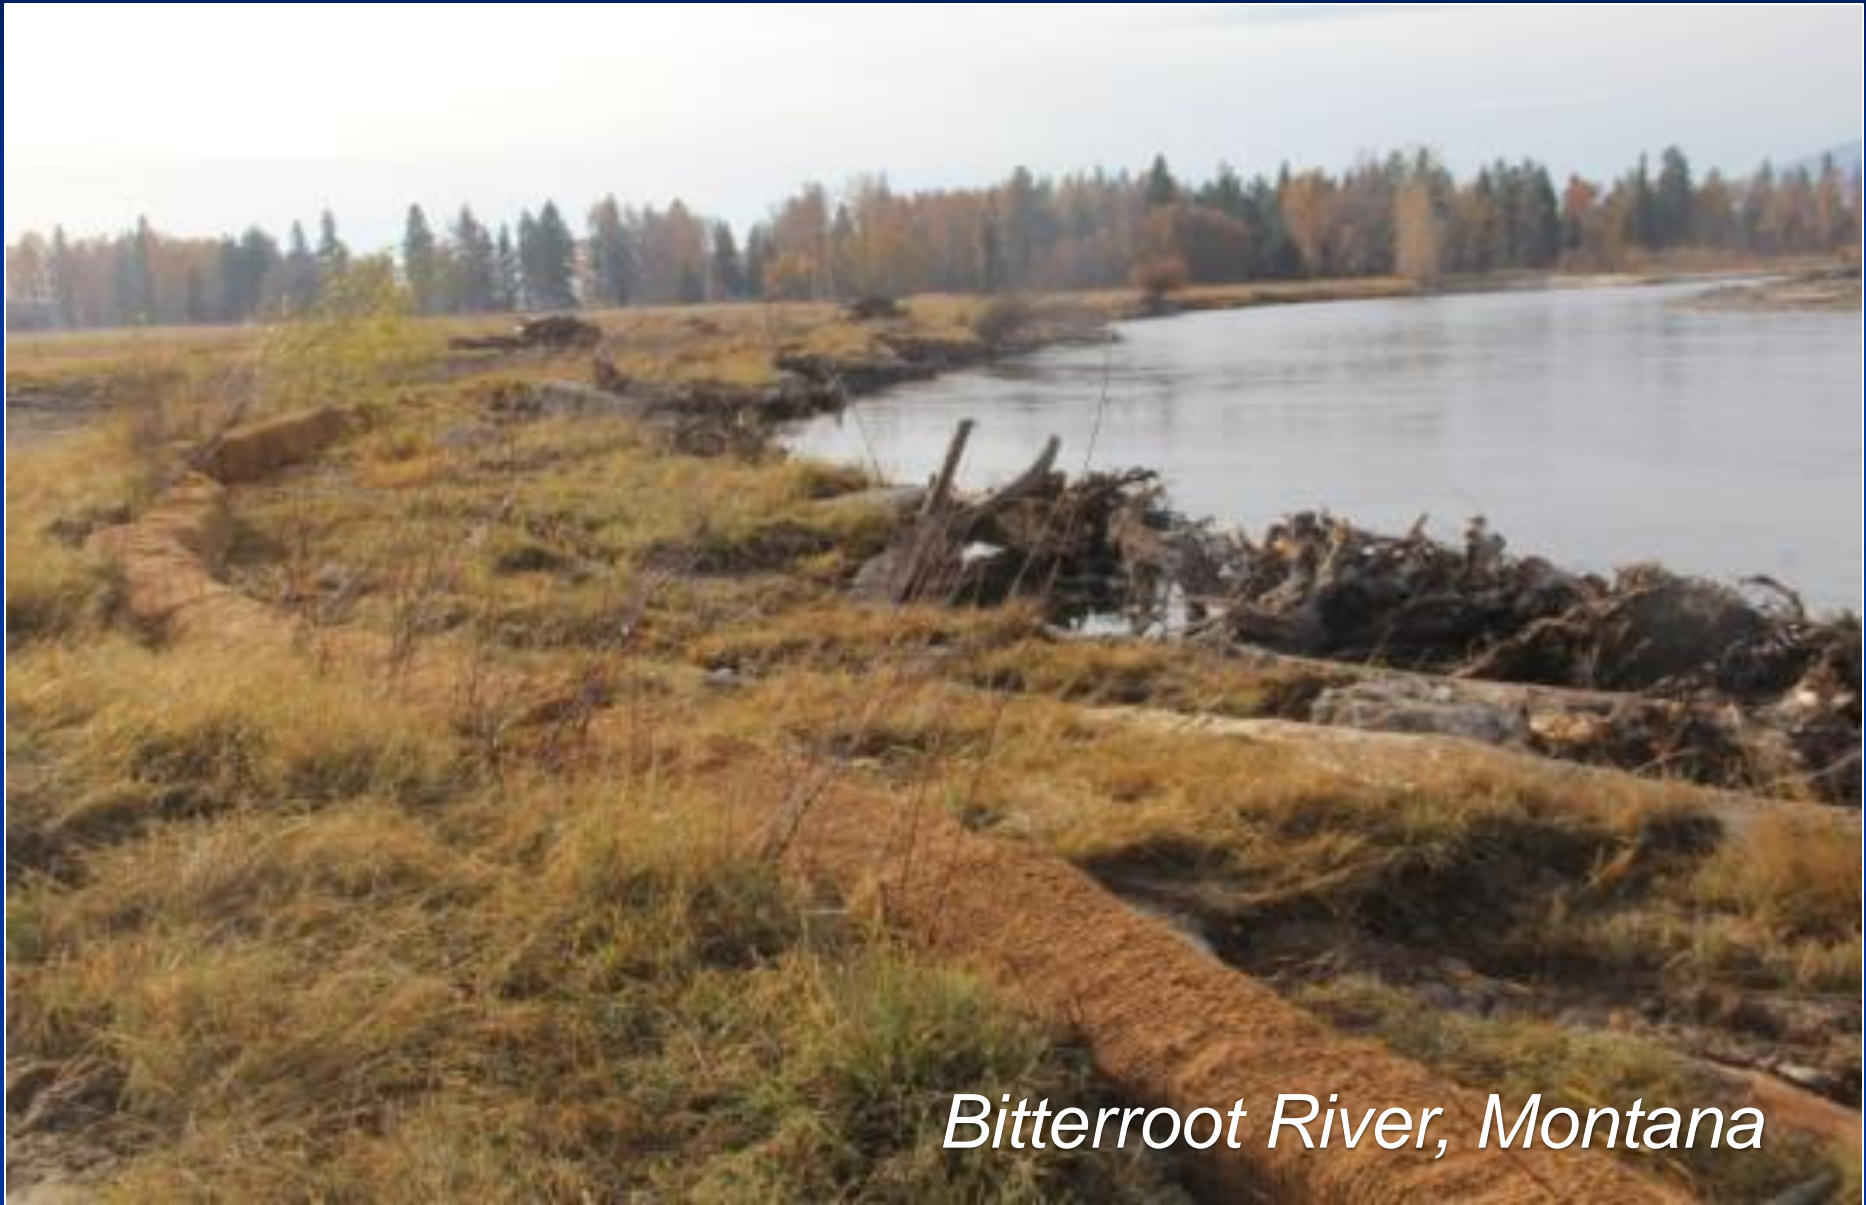
Bitterroot River, Montana

Post-Installation of Toe Wood: Face Logs, Willows, & Coir-Wrapped Bales

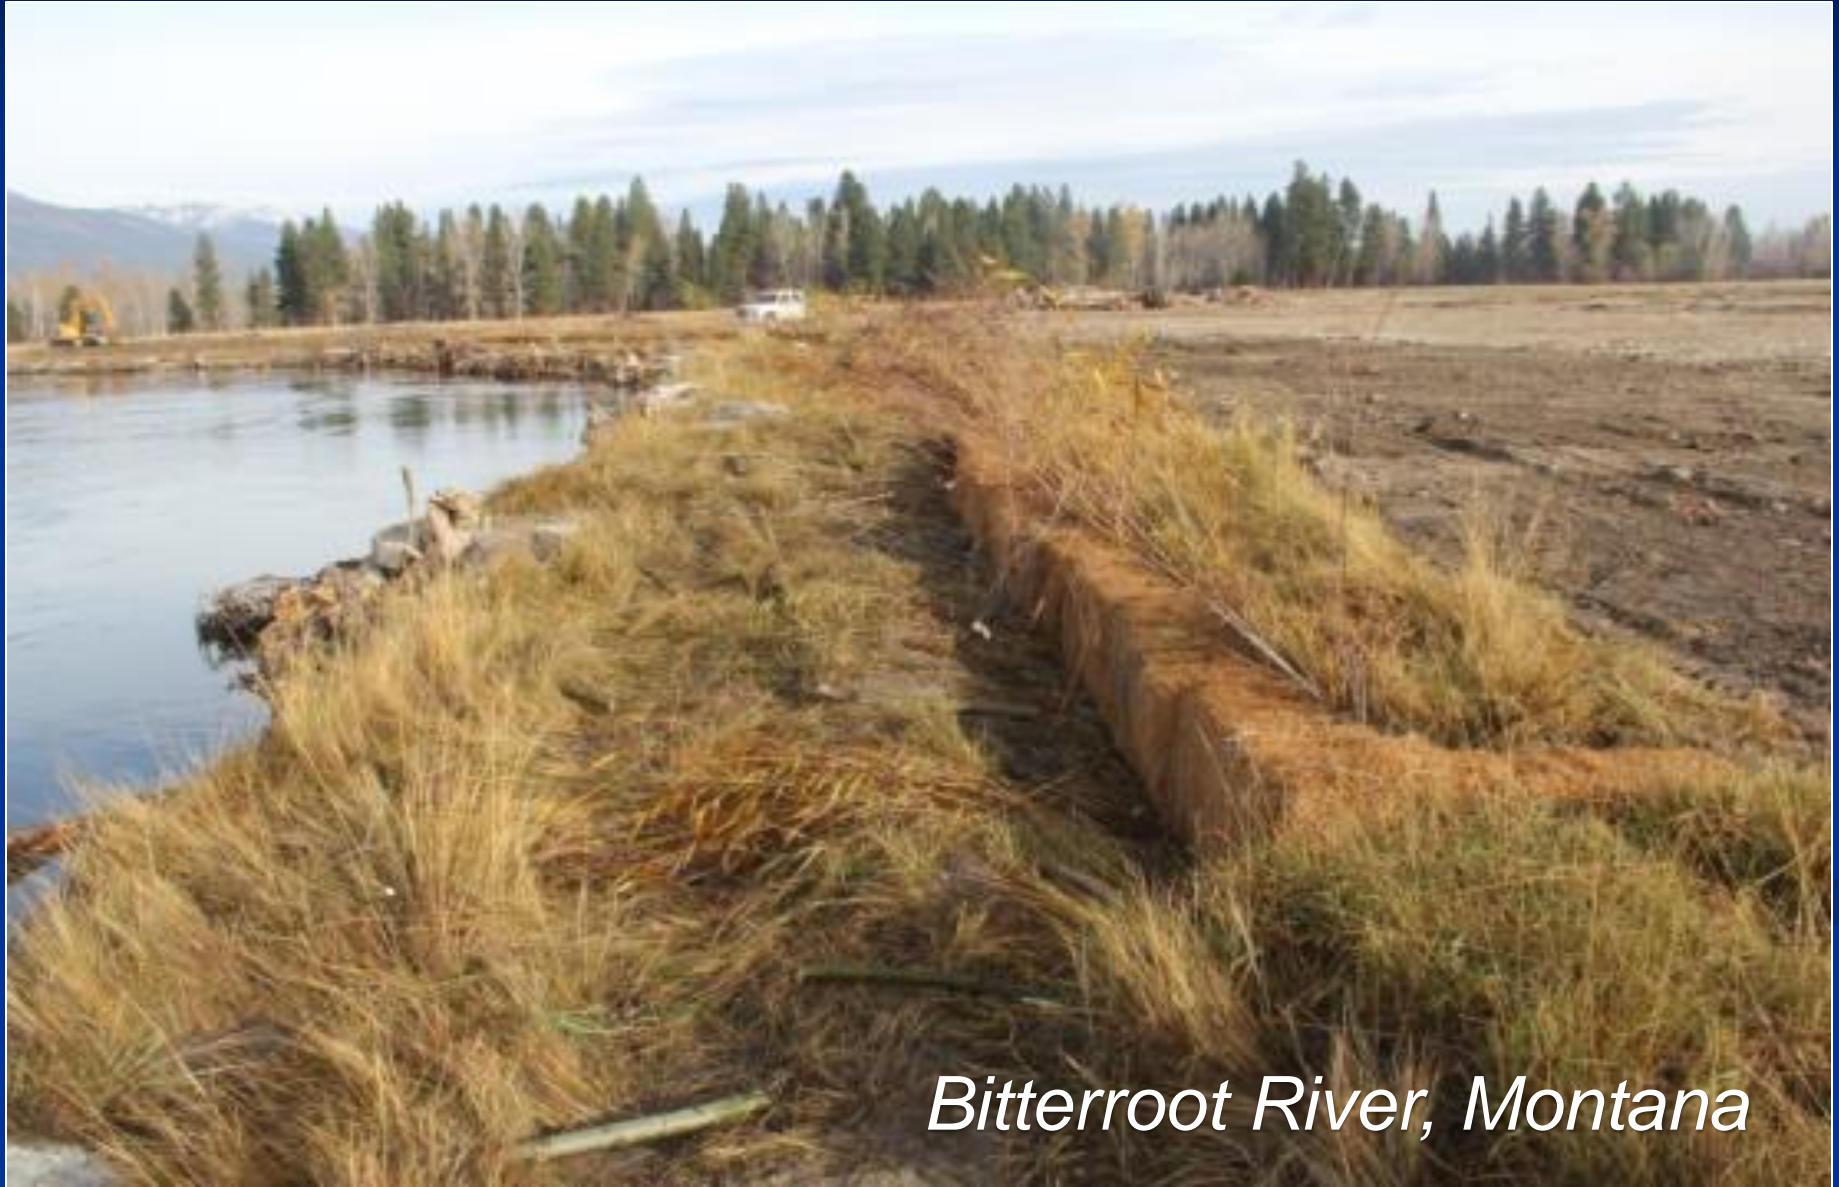
Bitterroot River, Montana

Post-Installation of Toe Wood: Face Logs, Willows, & Coir-Wrapped Bales

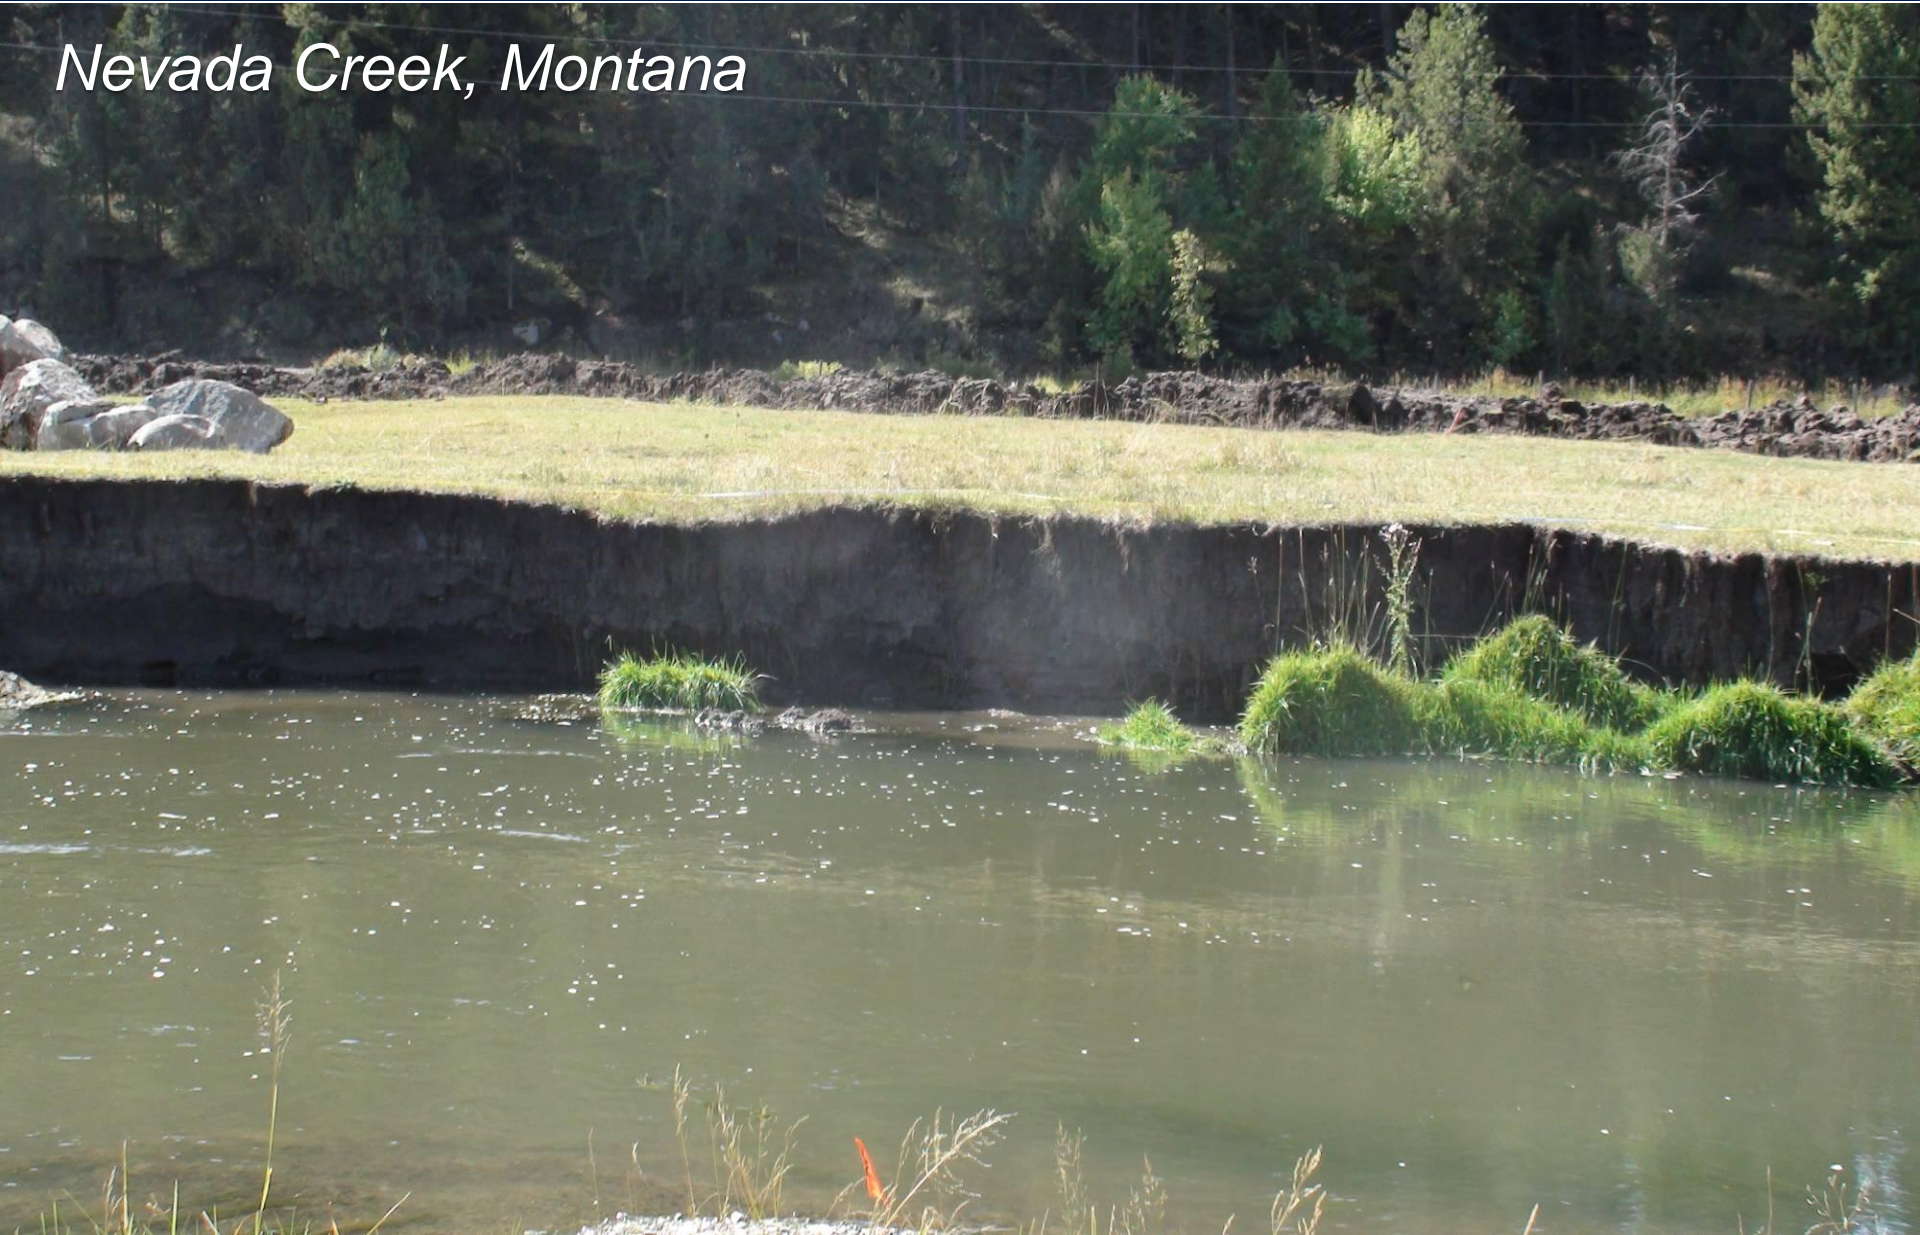
Nevada Creek, Montana

Pre-restoration, existing condition, 9/2010

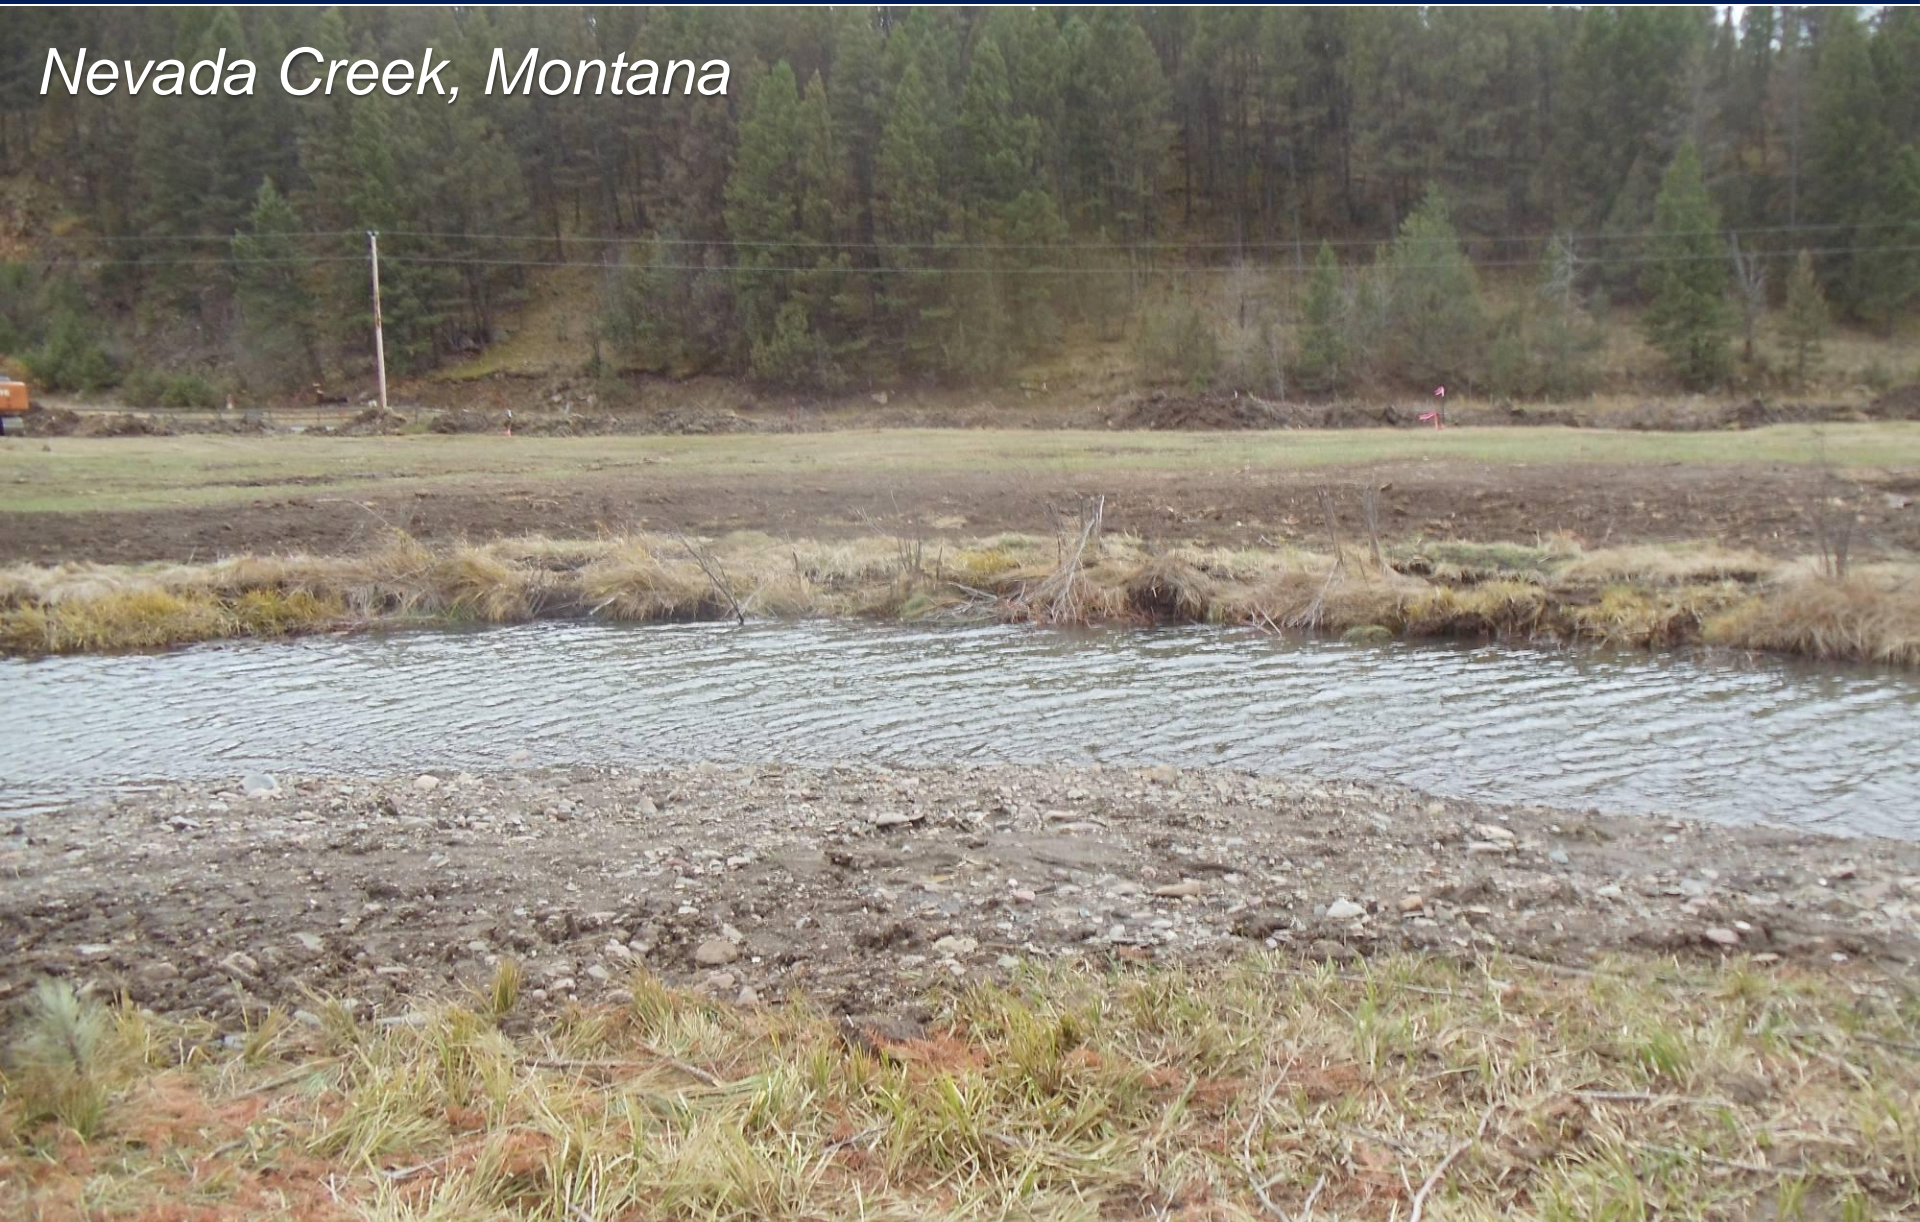
Nevada Creek, Montana

Post-restoration using toe wood with sod mats & willow cuttings on bankfull bench, 11/2010

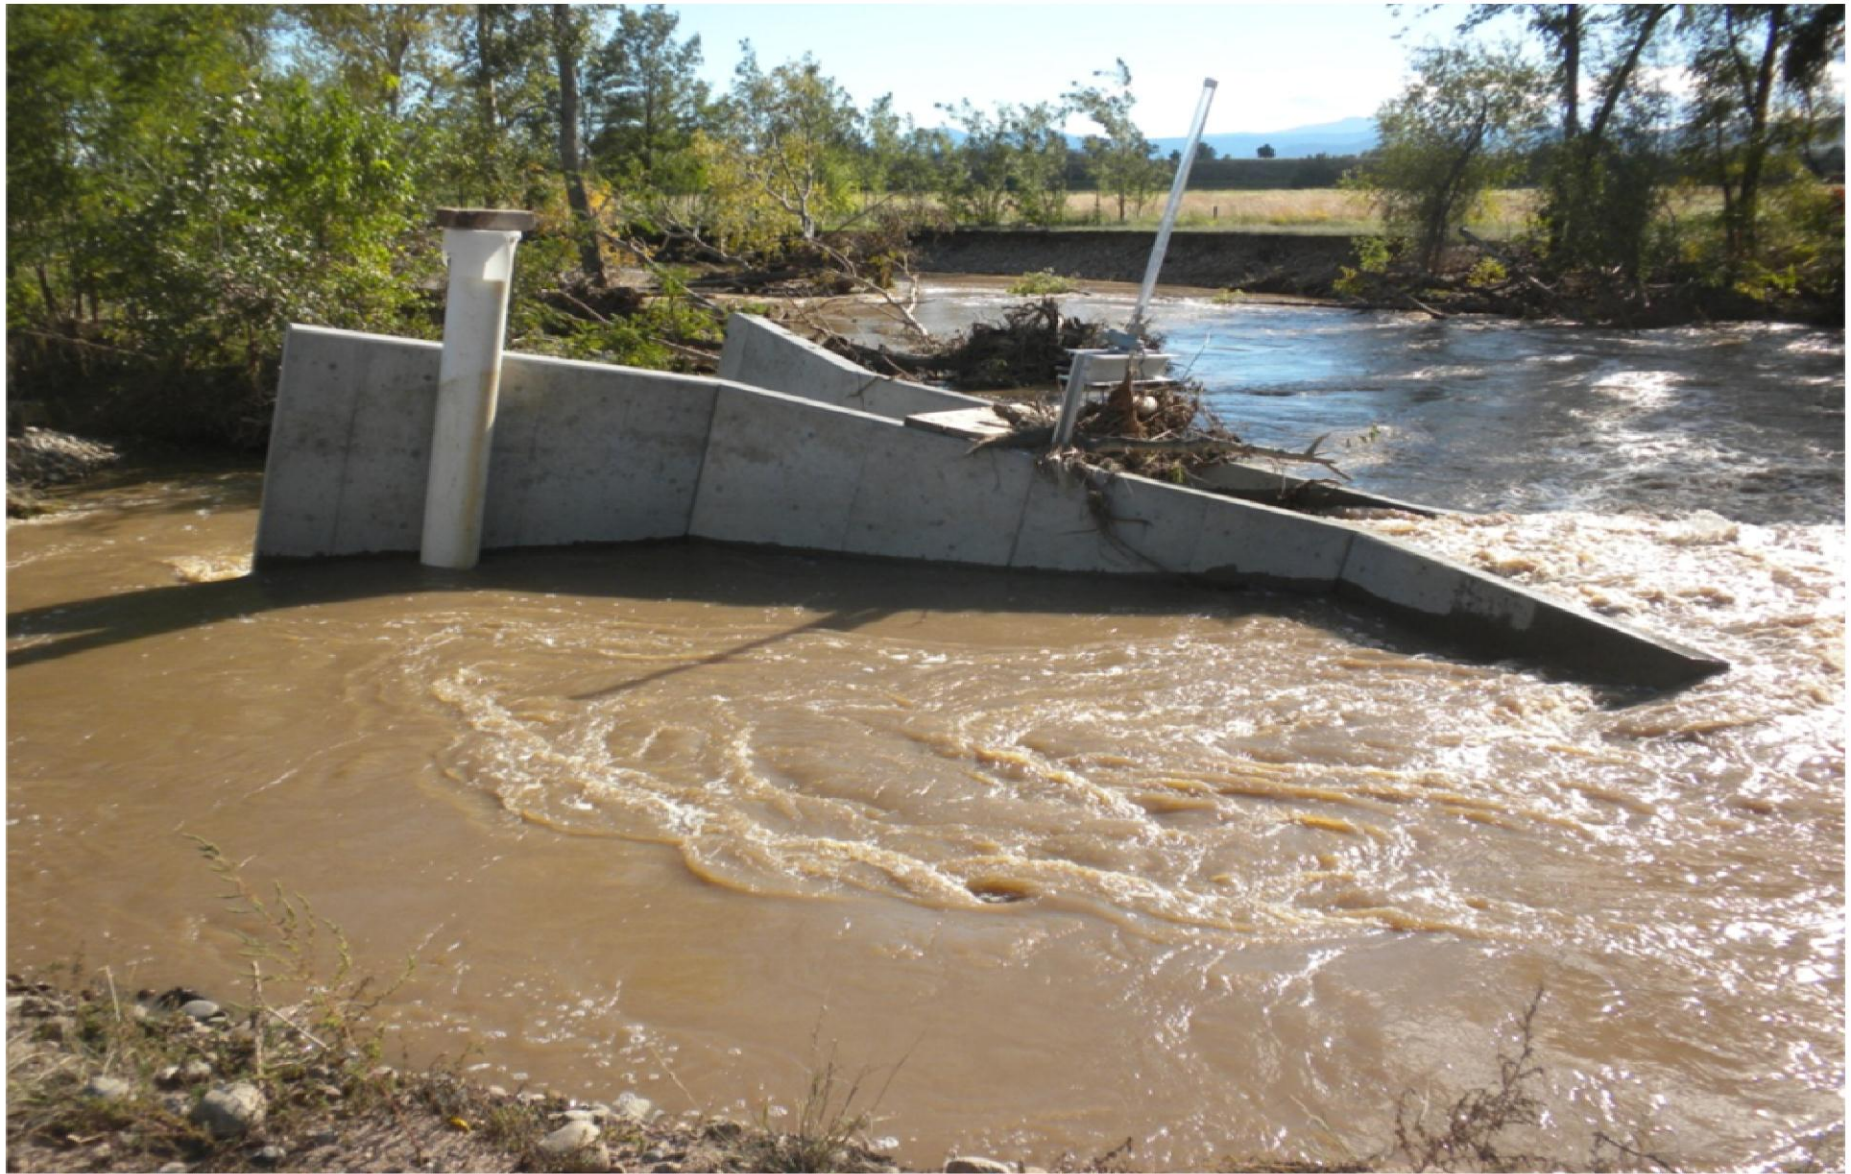
Diversion structure washed out, but same design rebuilt, St. Vrain River, 2013

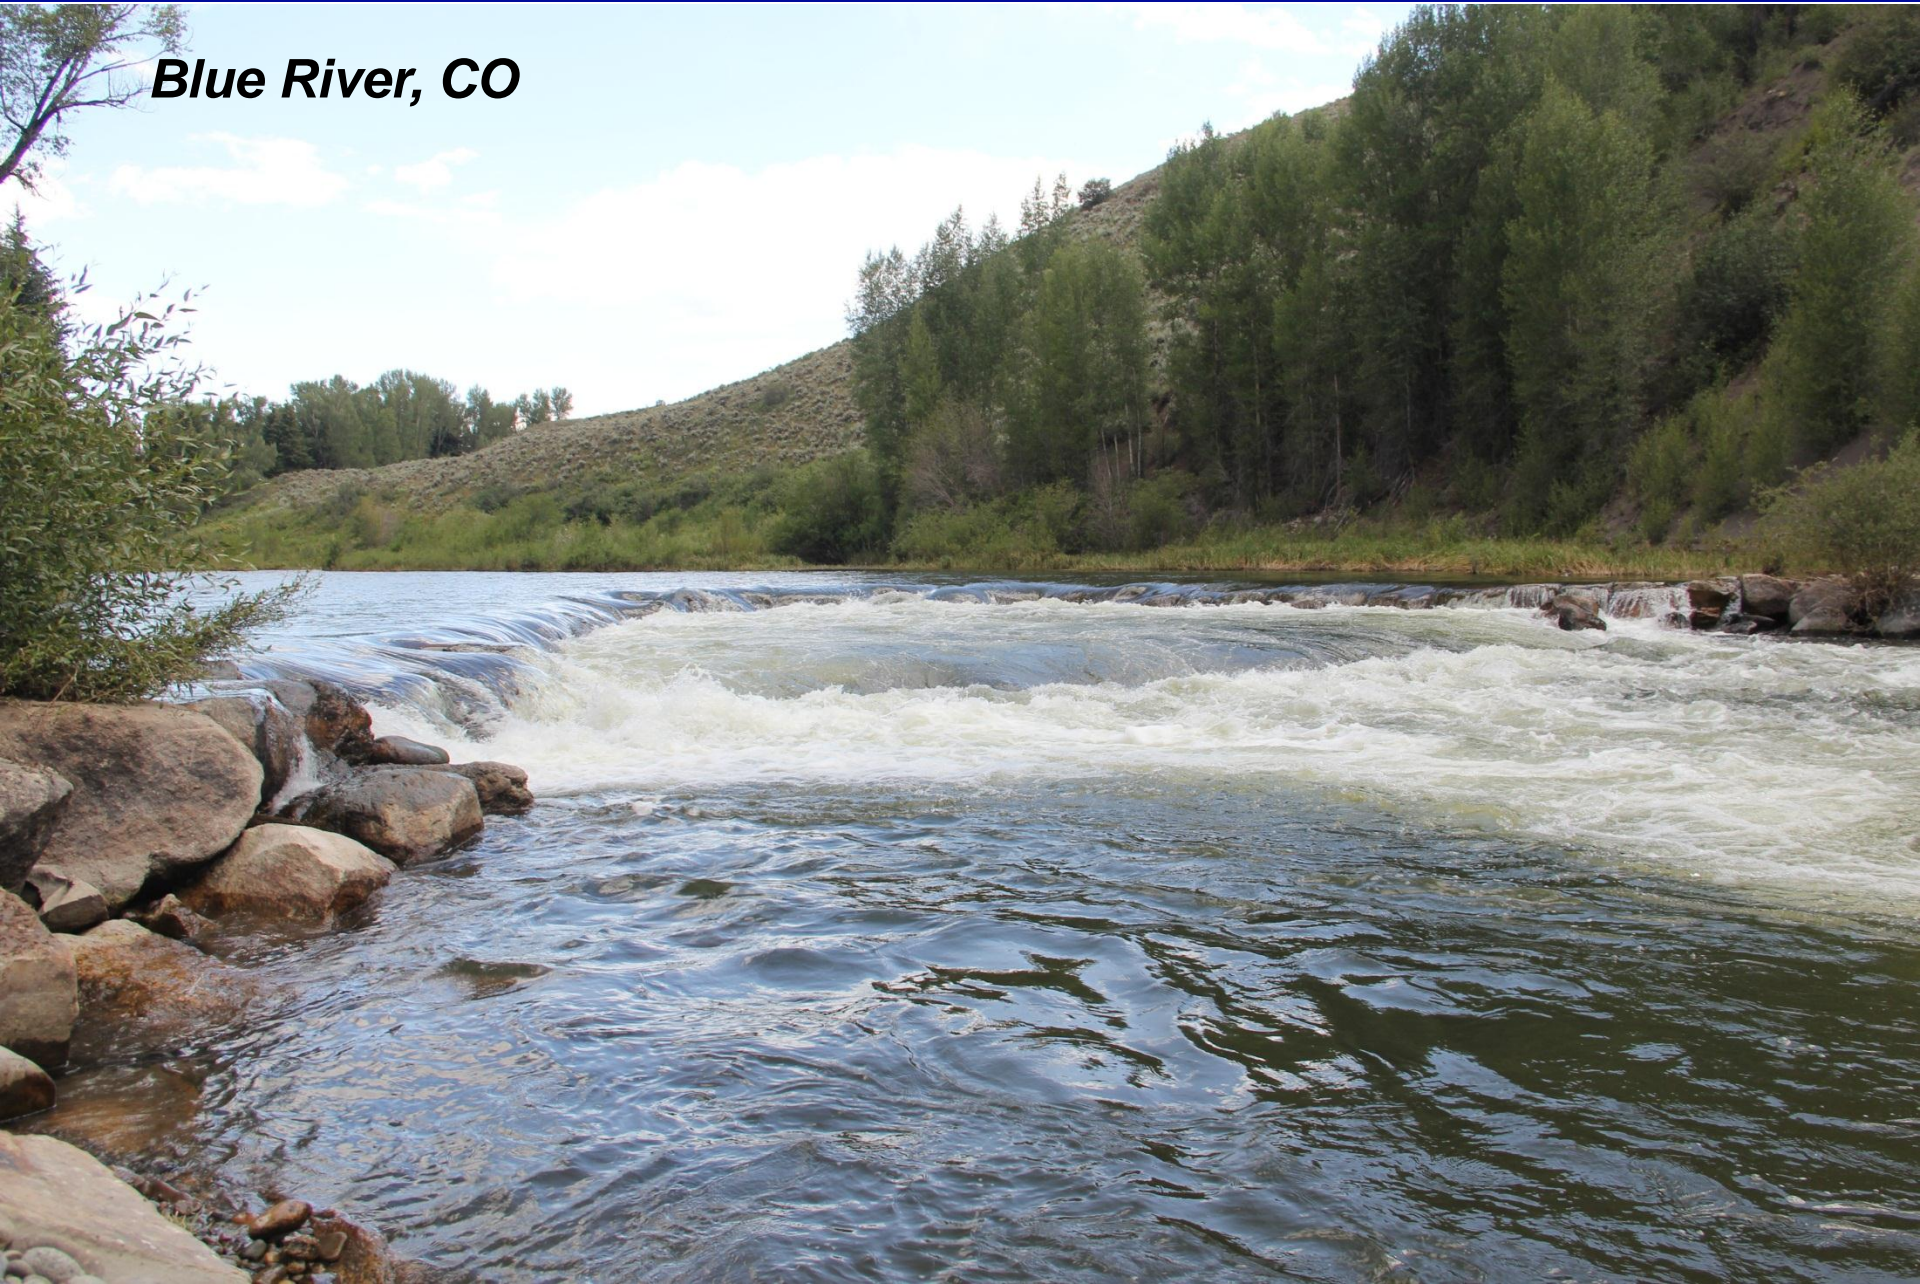
Blue River, CO

Cross-Vane Diversion

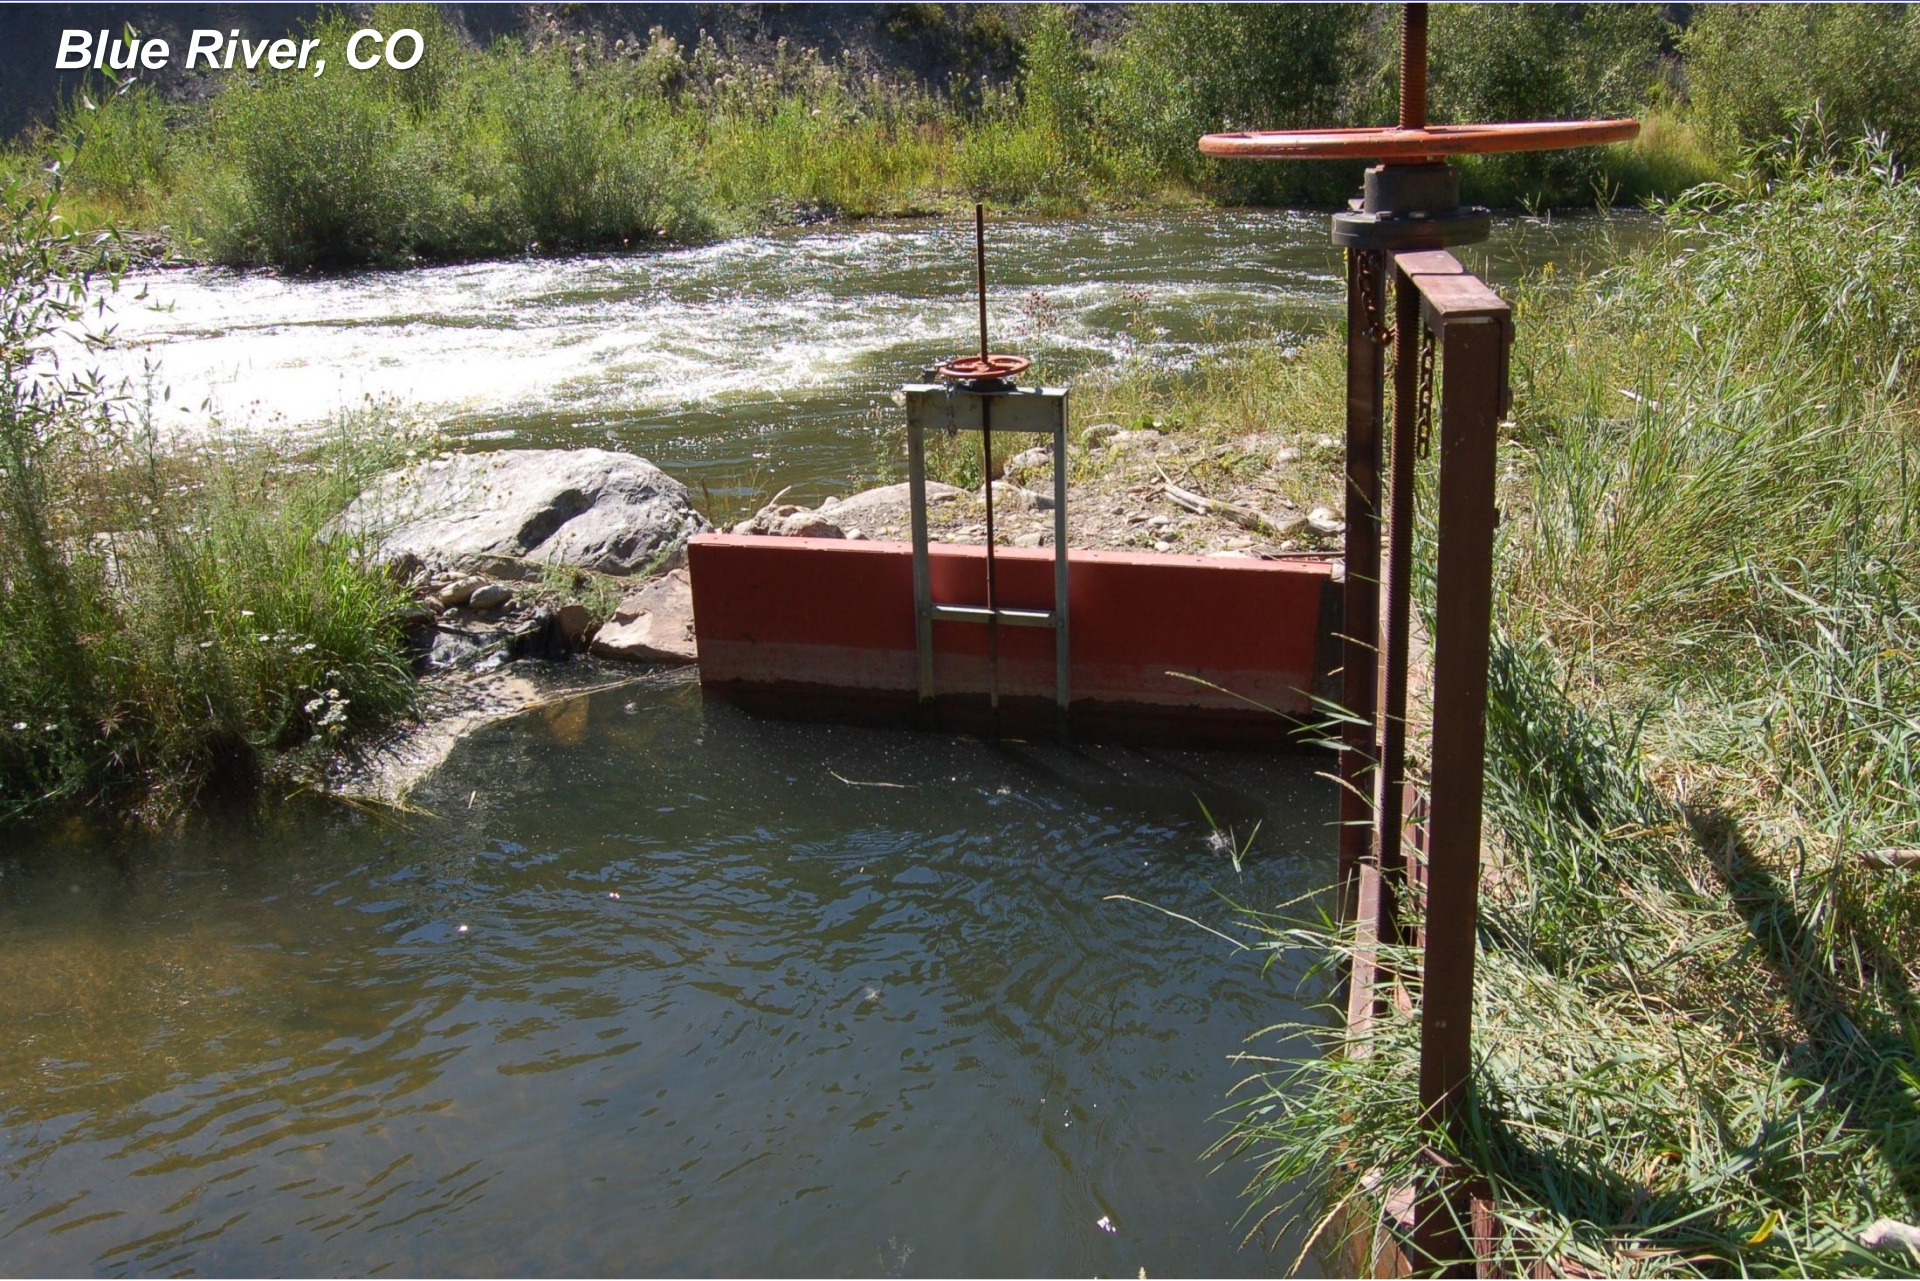
Blue River, CO

Sediment sluice screwgate valve & headgate valve
