FLOW 2015
Portland, Oregon, April 29th, 2015

**Solutions to Accommodate Extreme
Ranges of Available Flows under a
Changing Climate and Competition for
a Diminished Water Supply**

*Dave Rosgen, P.H., Ph.D.
Wildland Hydrology
Fort Collins, Colorado*

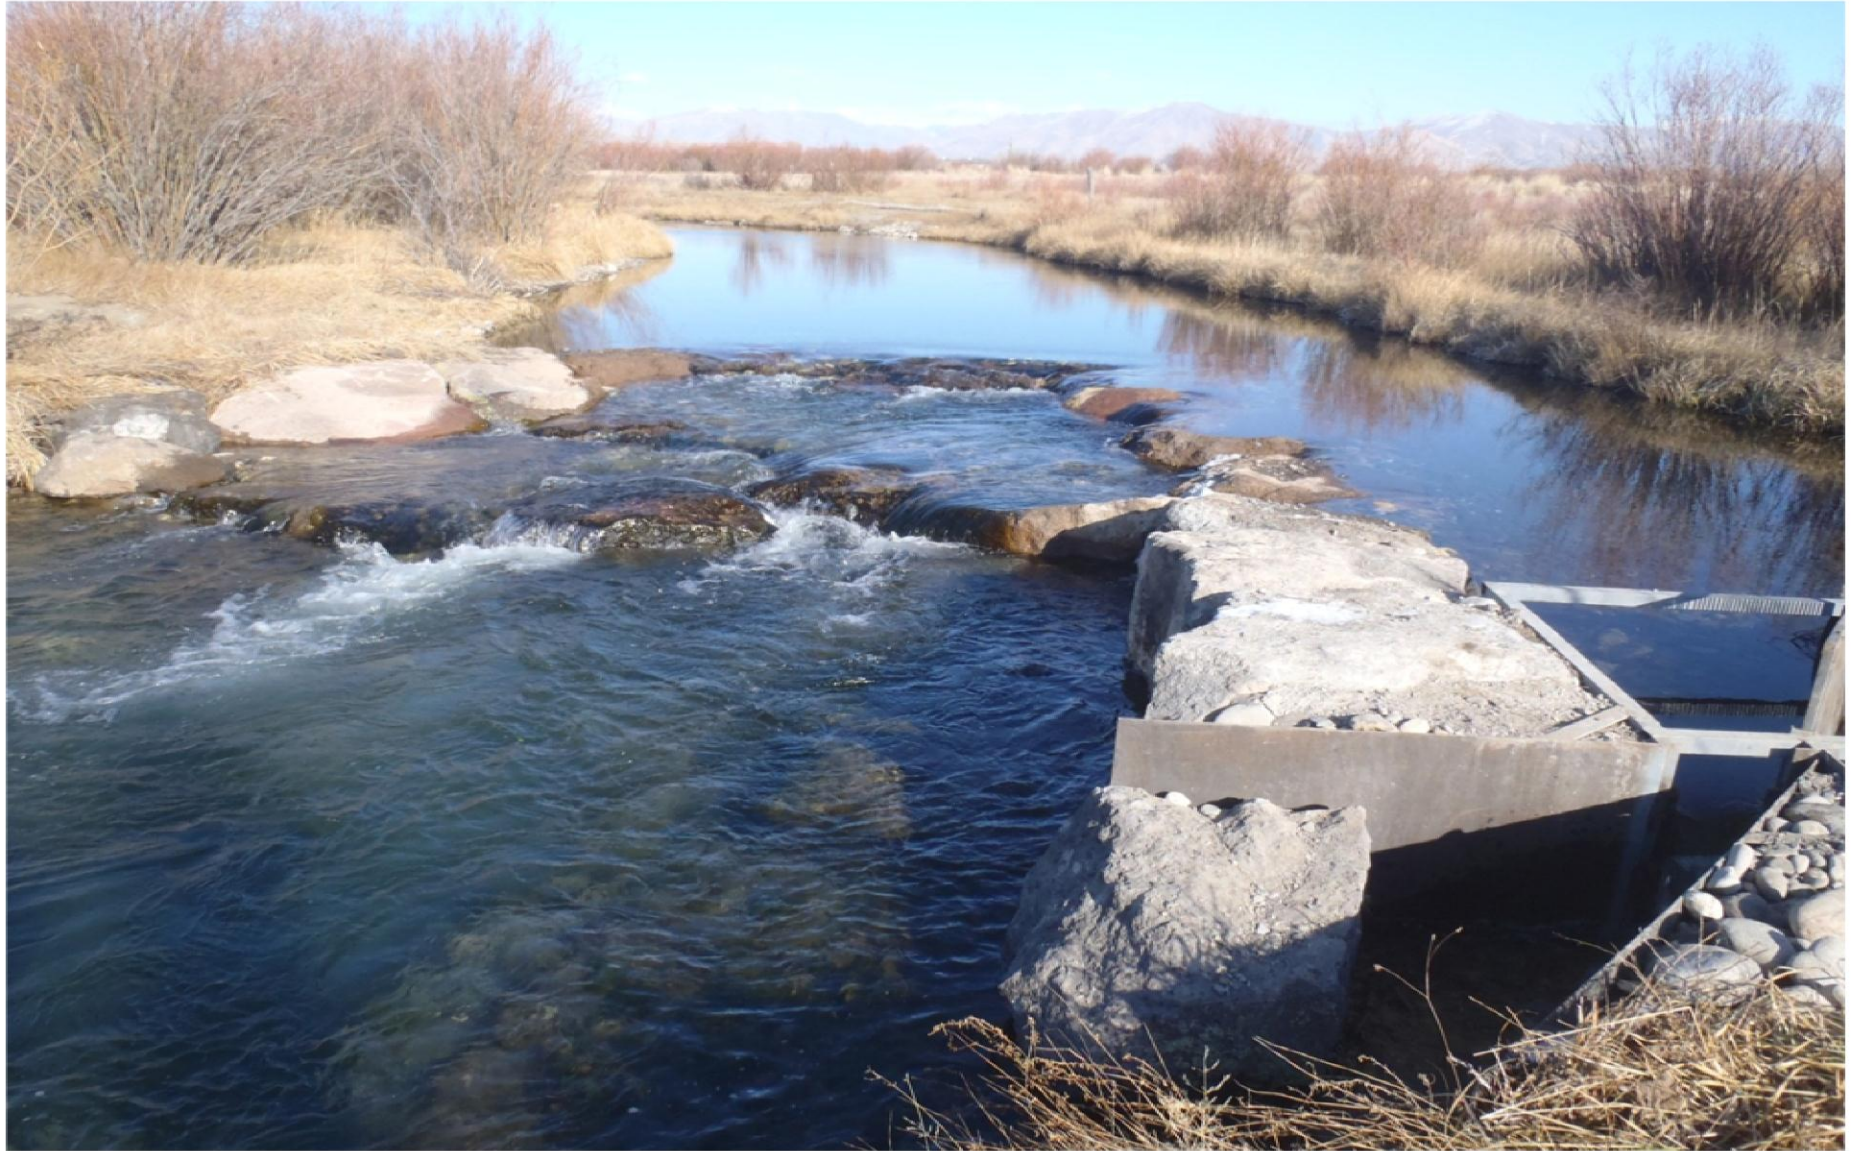
Step/pool Cross-Vane with a fish screen diversion box

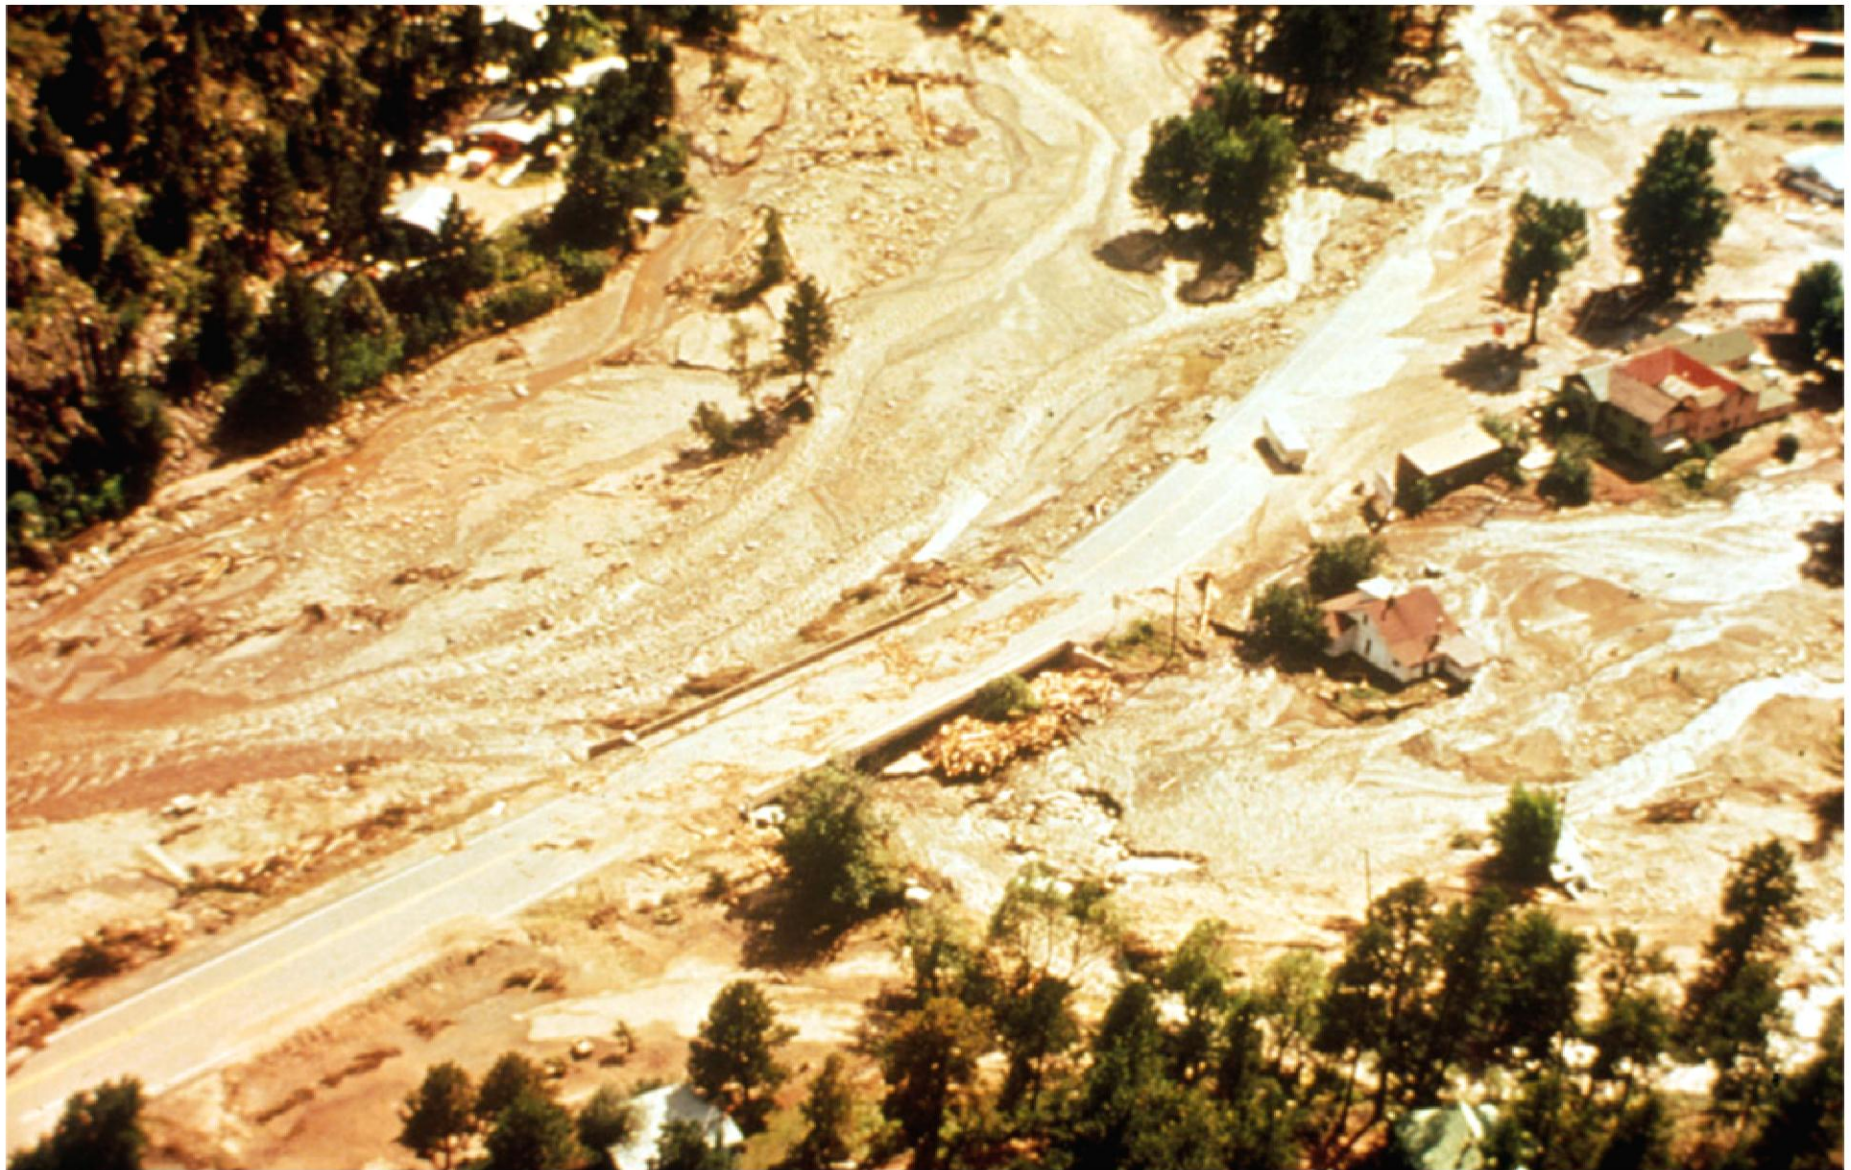
Big Thompson in 1976 at Drake, Colorado

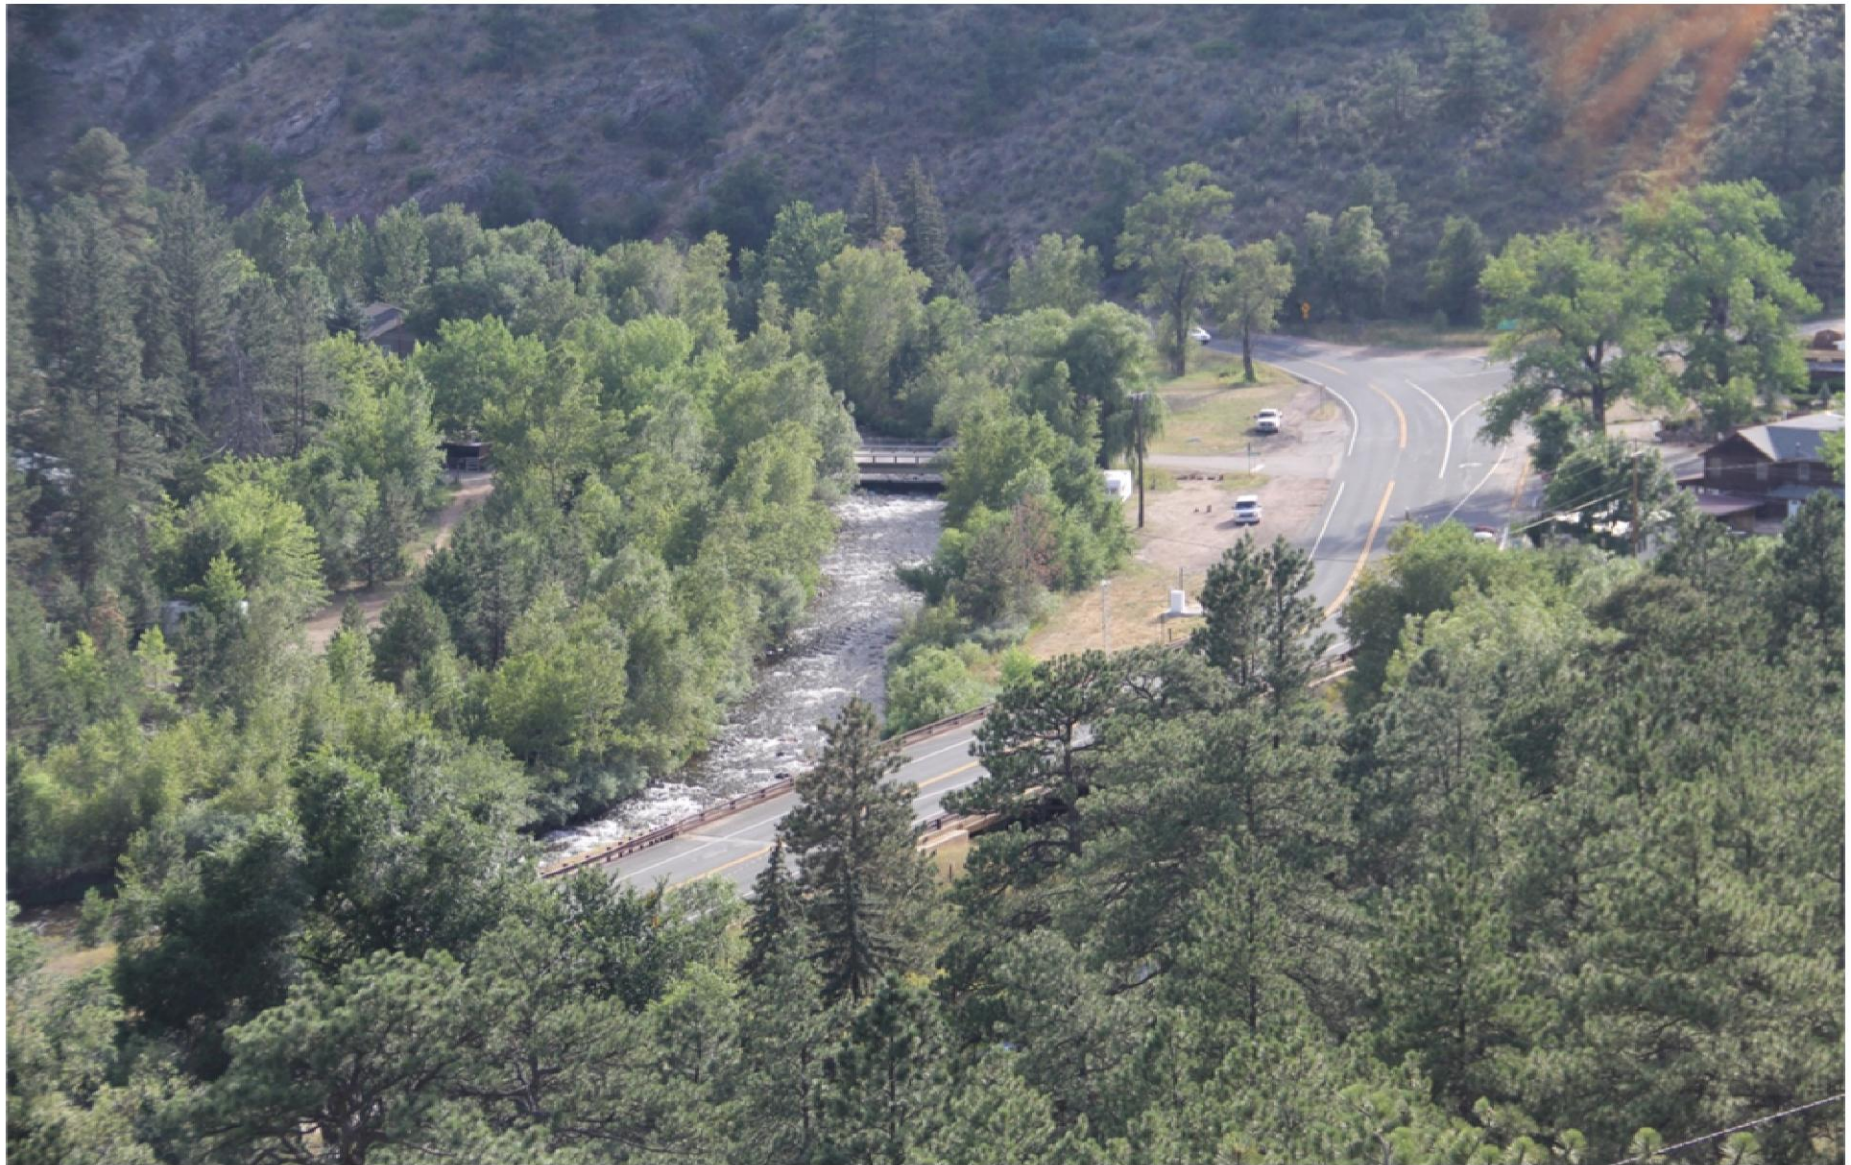
Big Thompson at Drake 35 years later

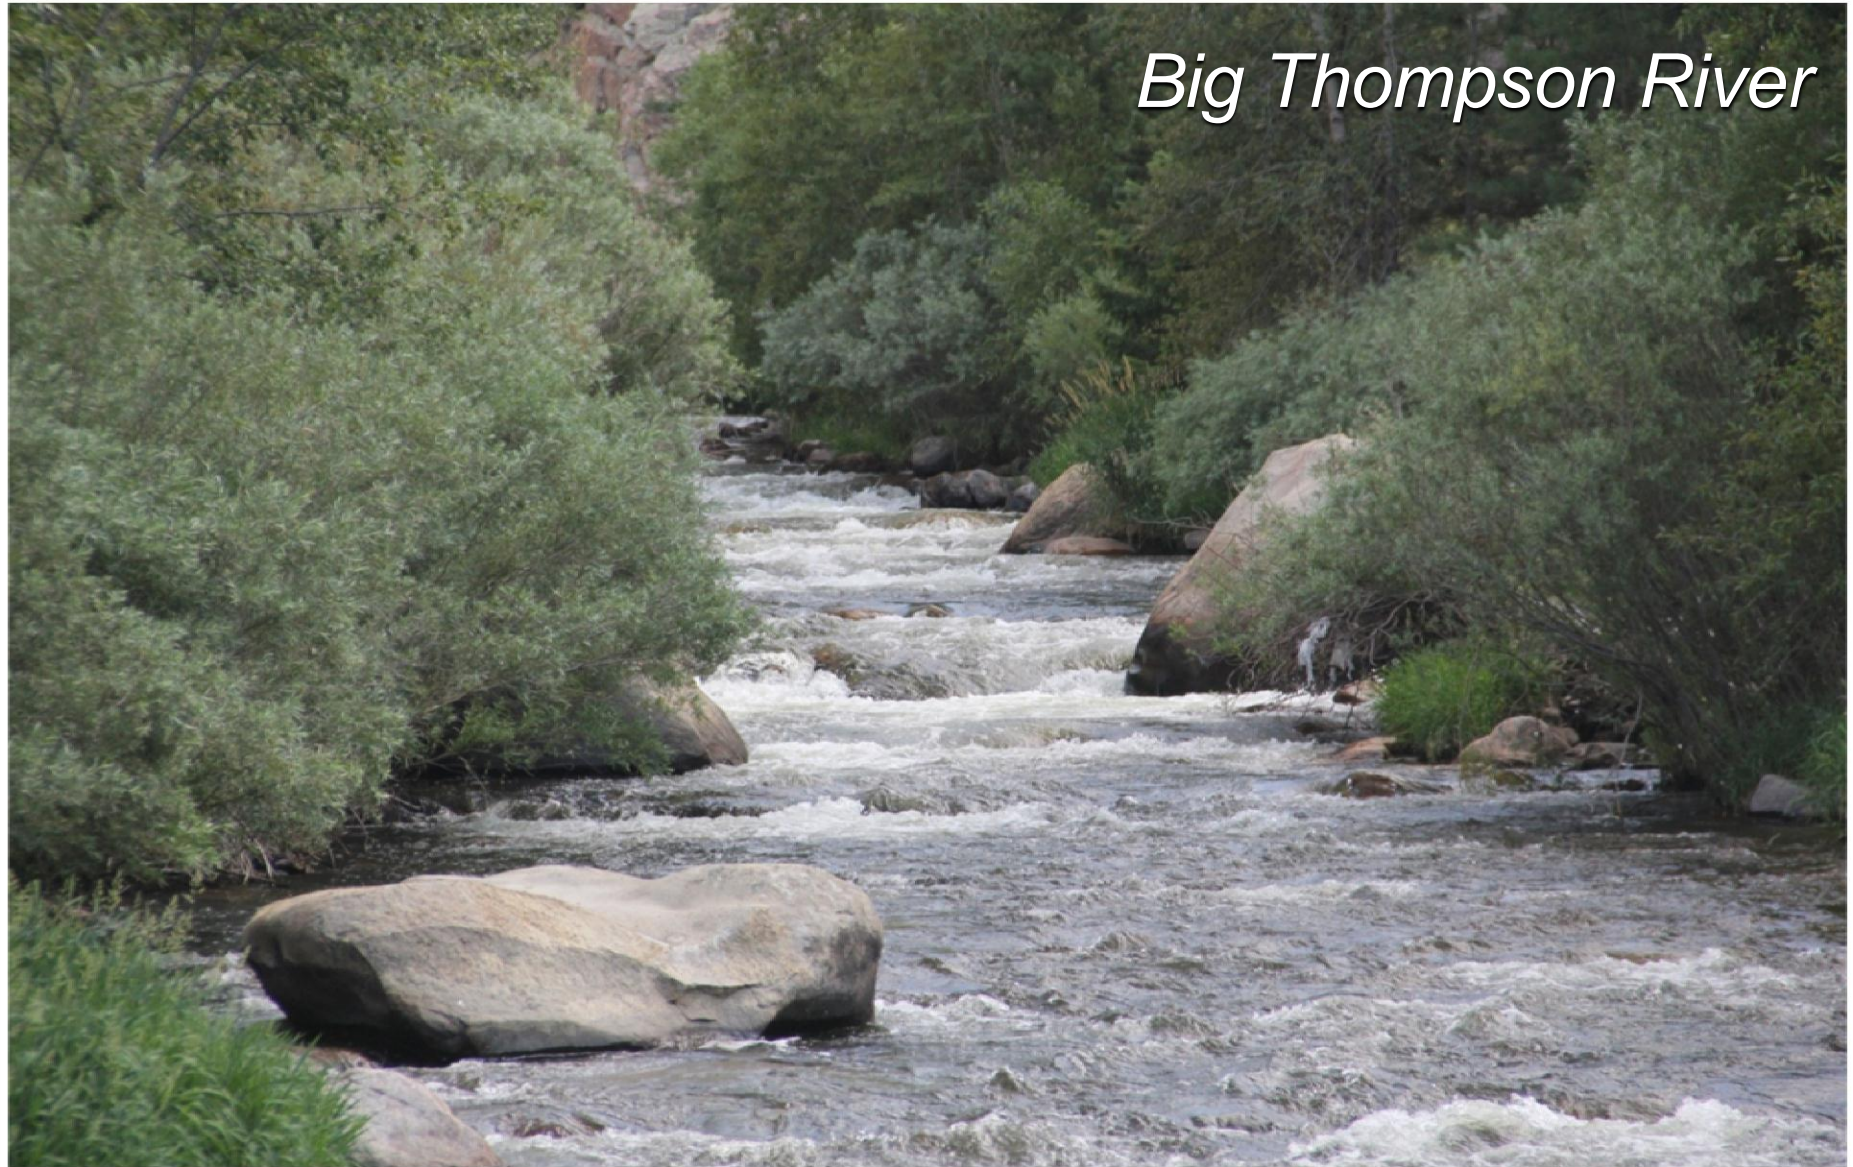
Big Thompson River

Little damage occurred to this restored reach in the 2013 flood due to proximity away from road and debris flows

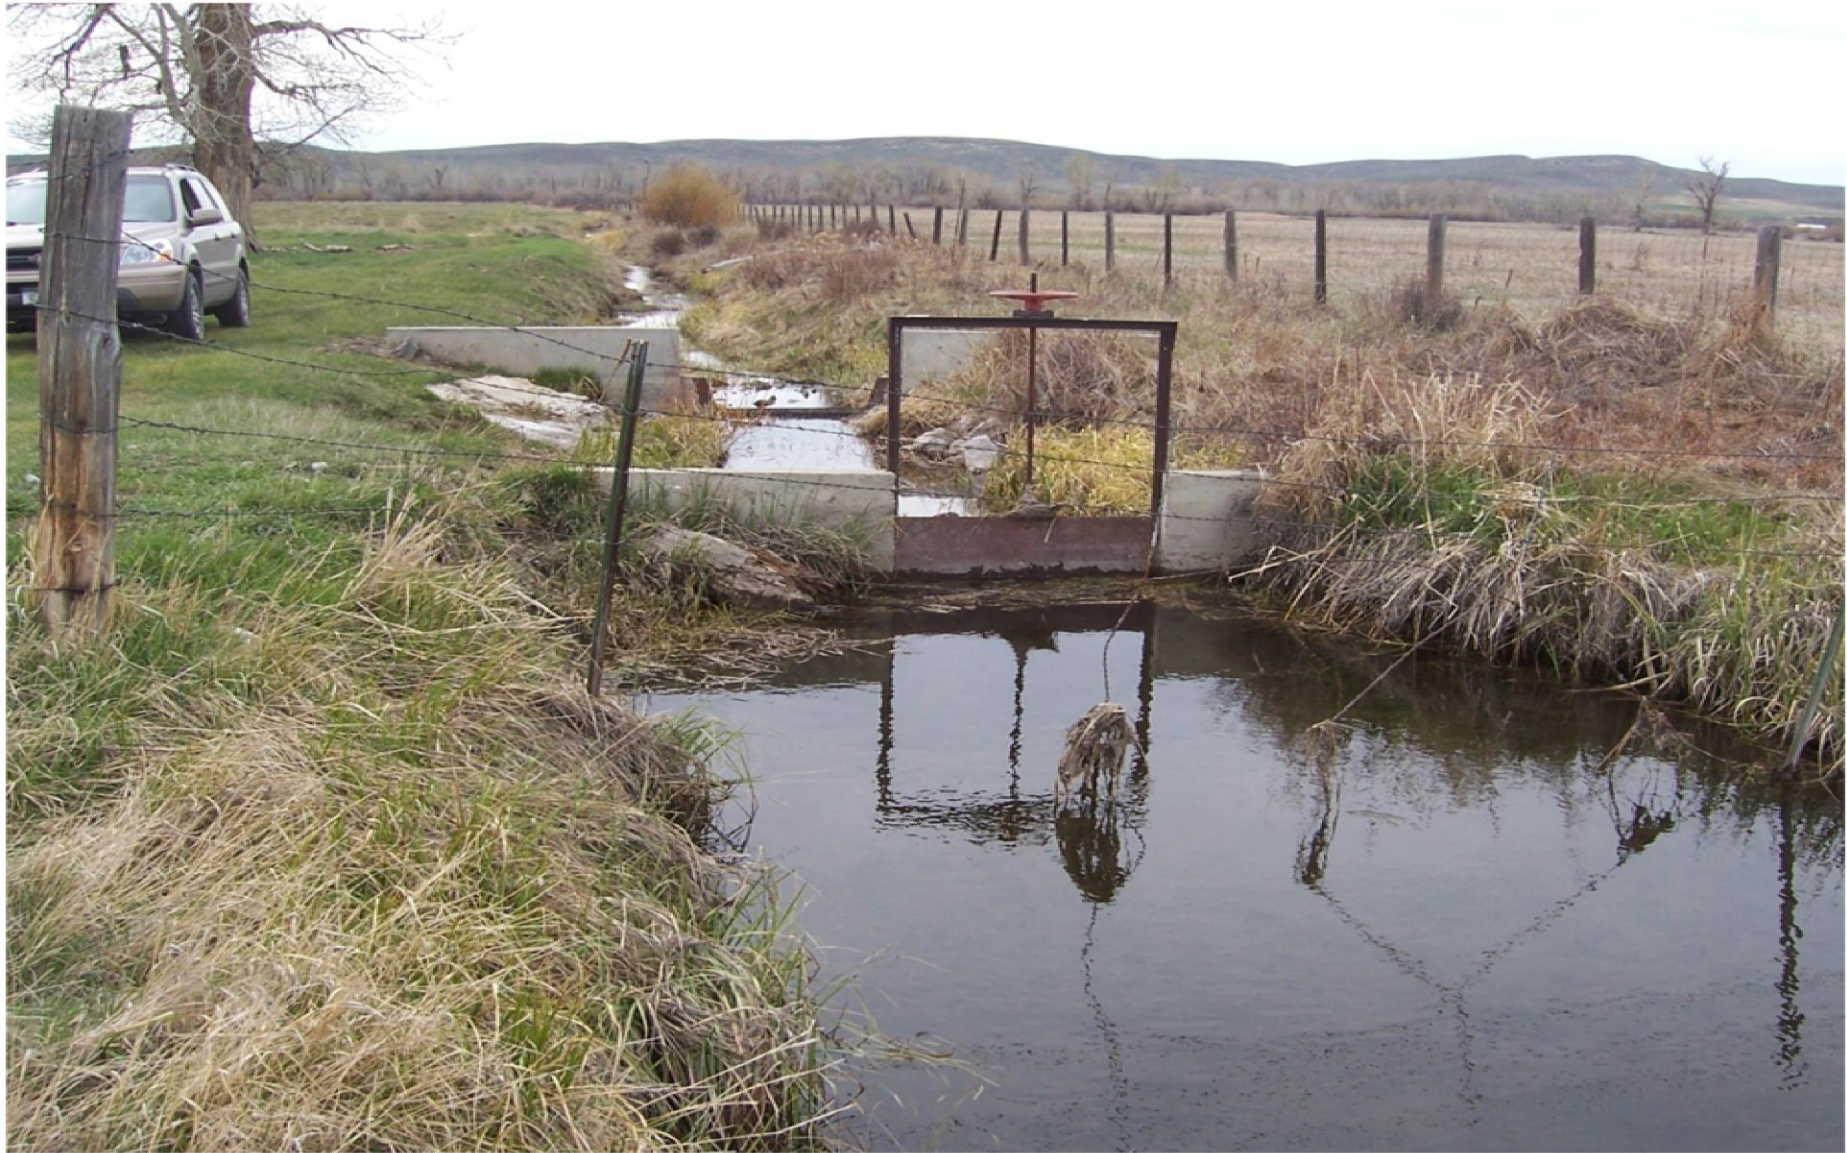
Altered incised channels and flood irrigation gates, Heartrock Ranch, Idaho, 2010

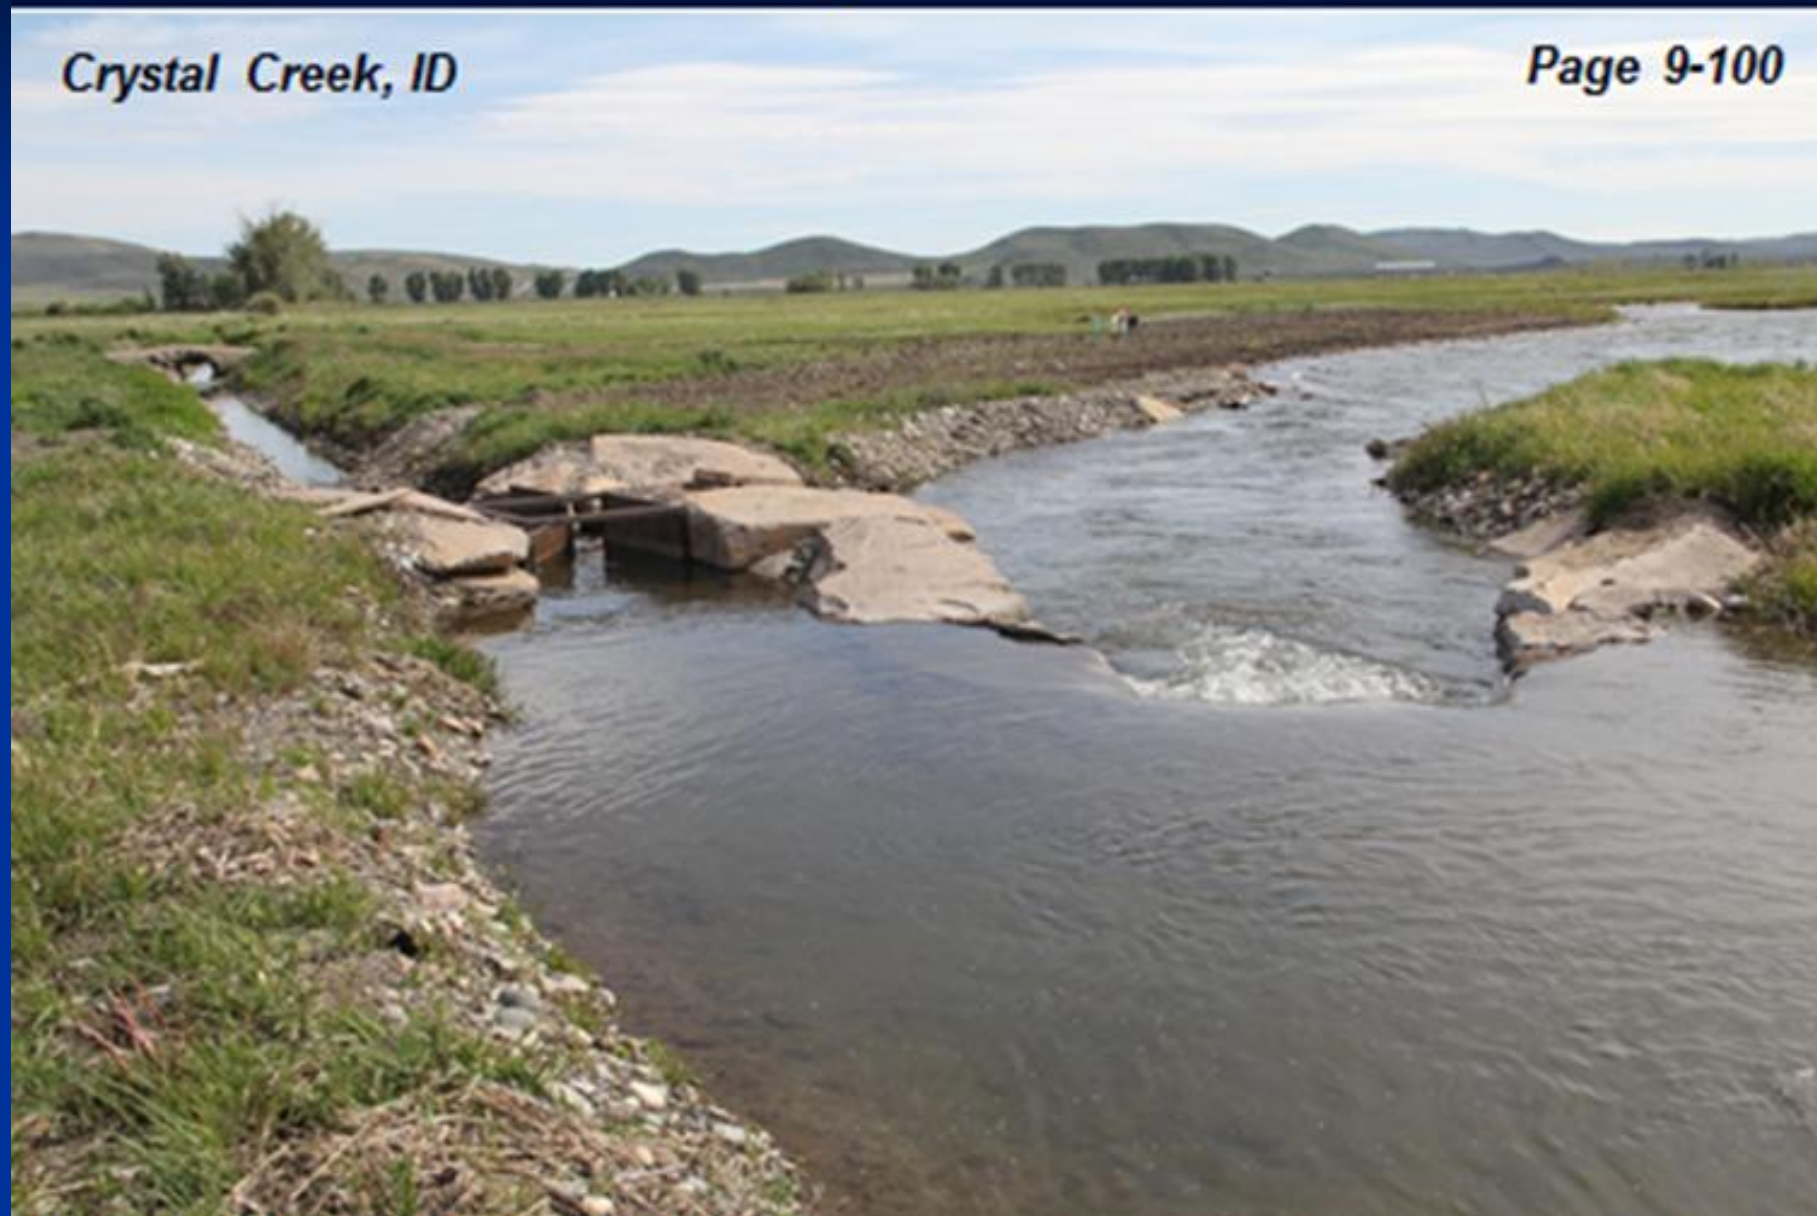
Crystal Creek, ID

Cross-Vane & By-Pass Diversion Box

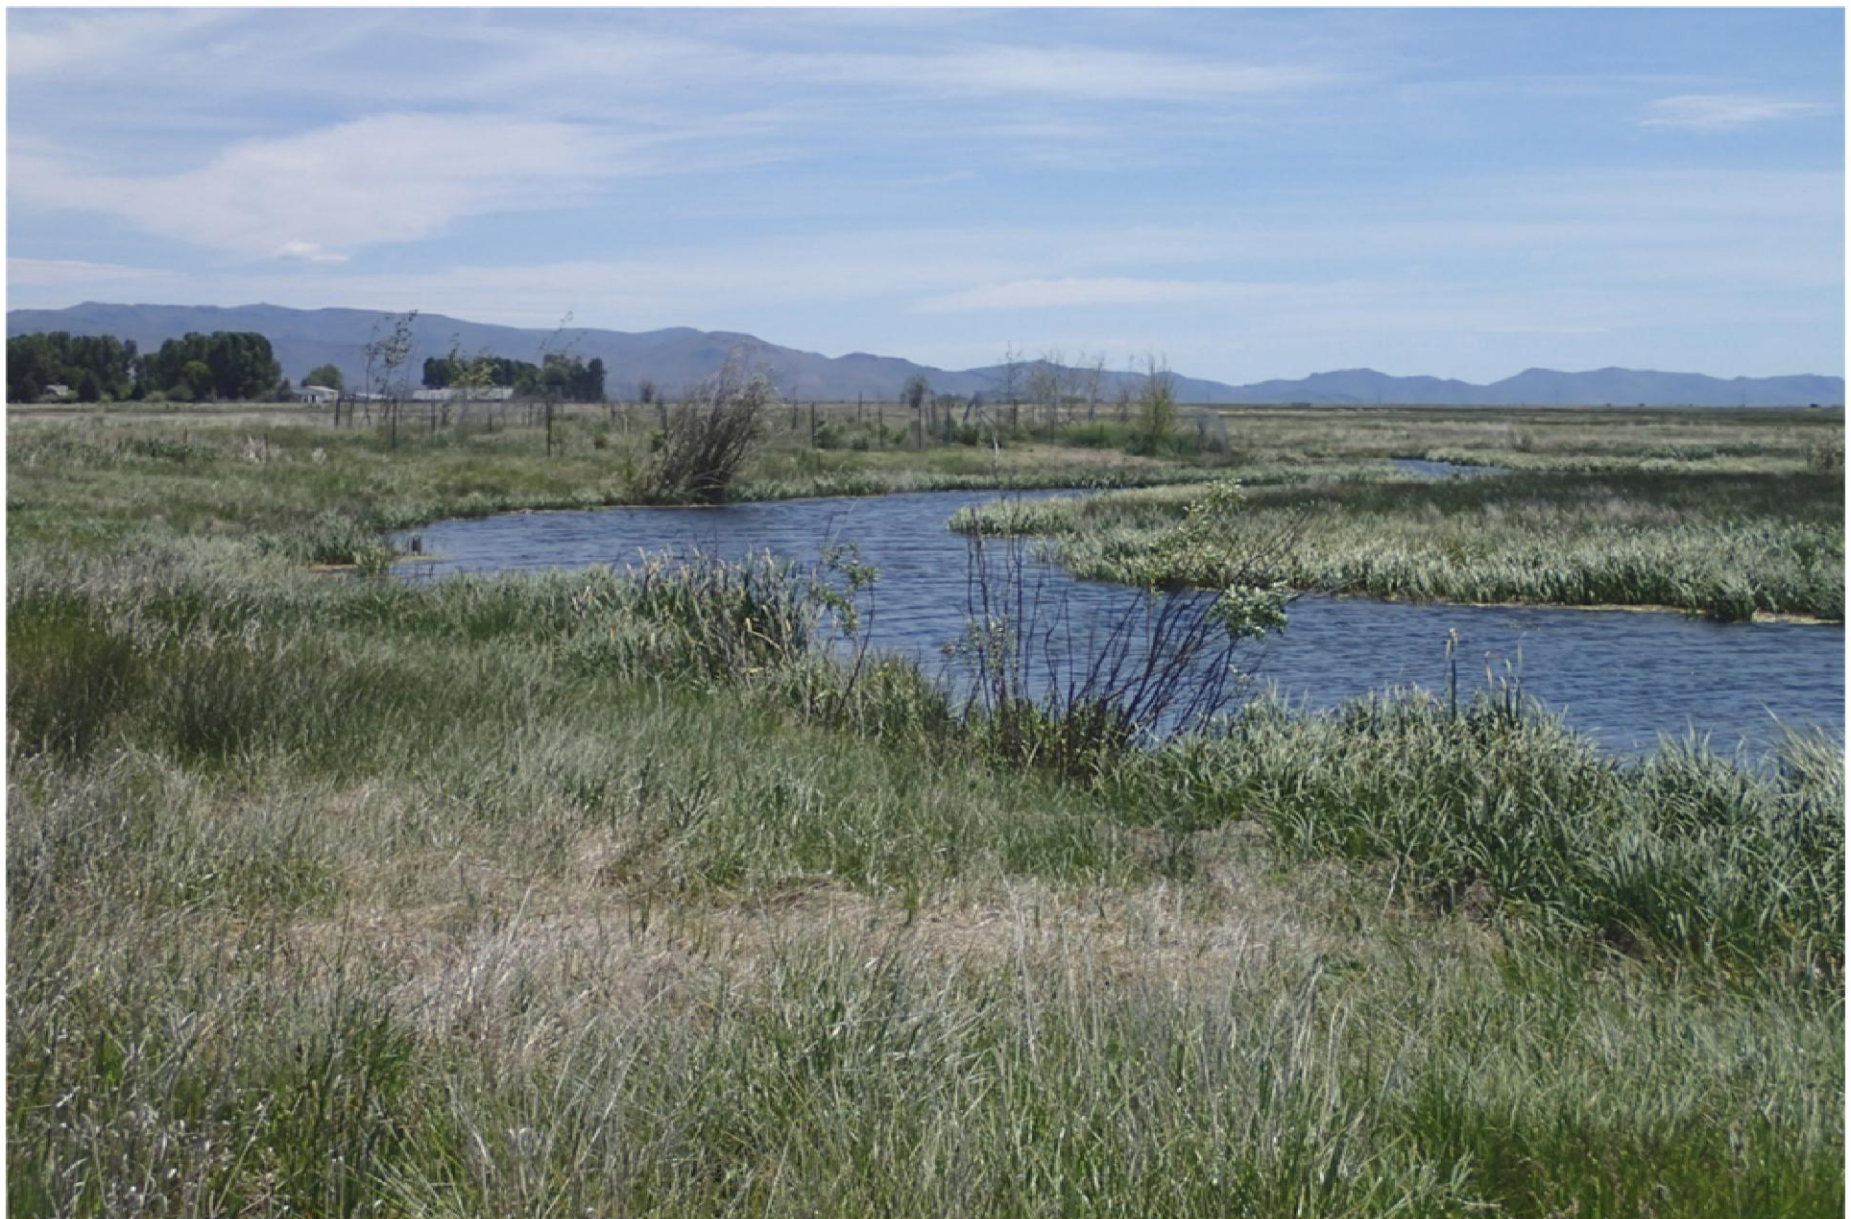
New channel constructed on top of floodplain

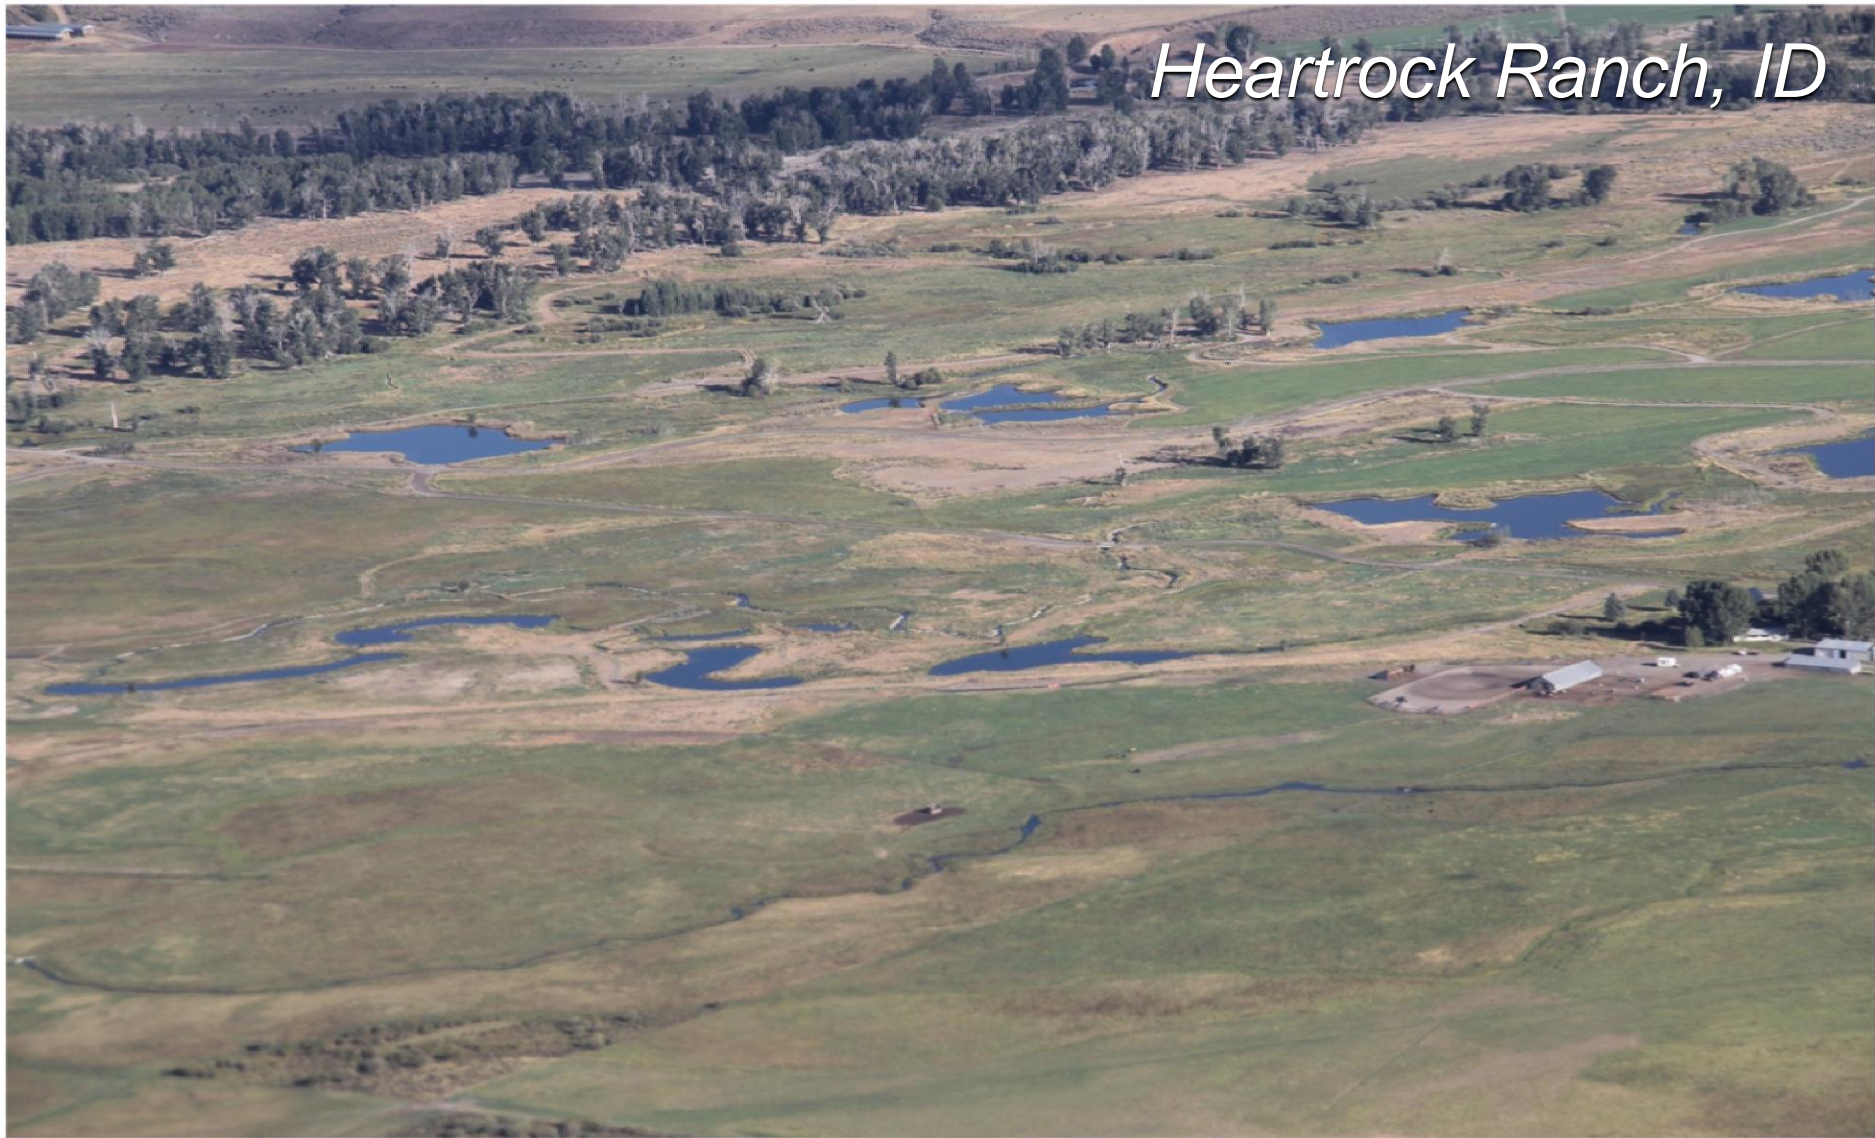
Multiple oxbows and new channels that raised the water table during summer drought with no flood irrigation

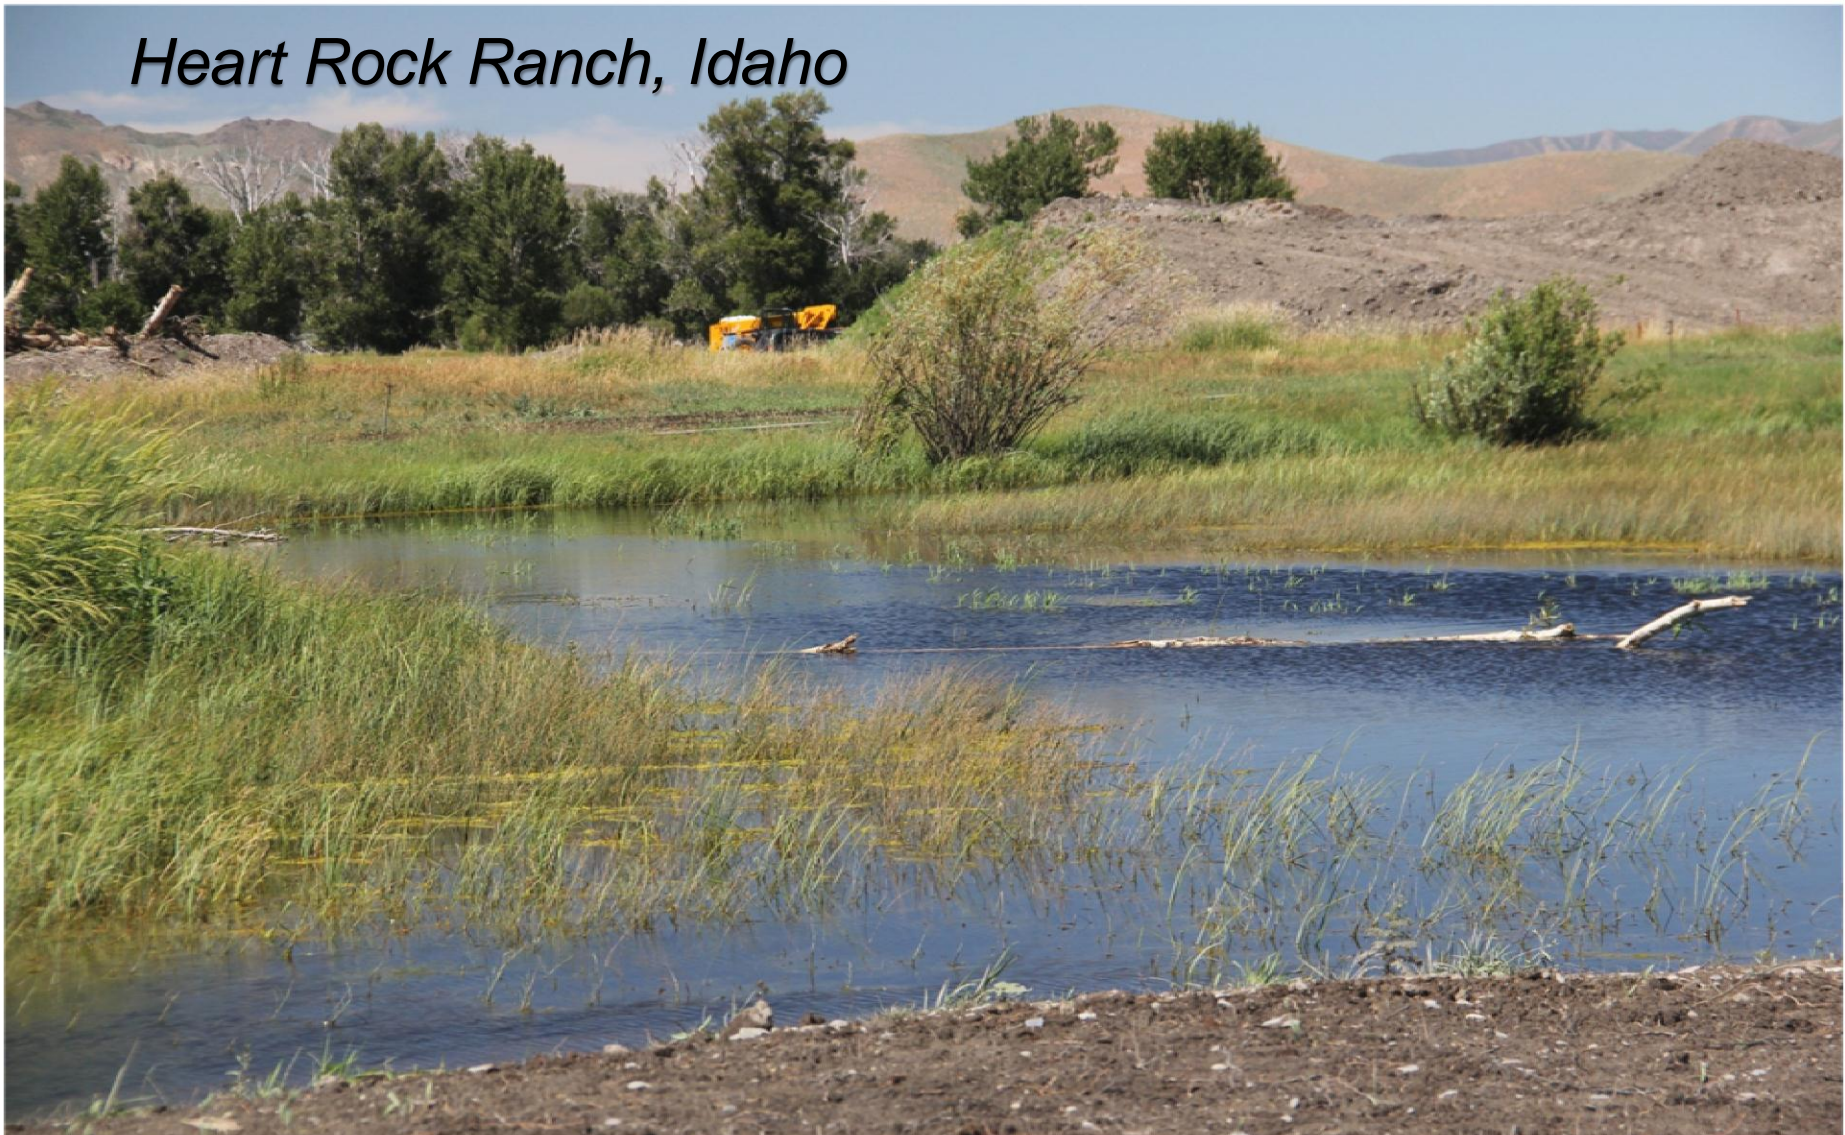
Heart Rock Ranch, Idaho

Constructed waterfowl habitat, emergent wetland, rearing & food plot area from previous incised channel... post-construction,
7/20/11
